**GROUND INVESTIGATION REPORT  
for DEVELOPMENT PHASE V,  
LAND TO THE WEST OF WORTHING ROAD,  
SOUTHWATER, WEST SUSSEX  
on behalf of  
BERKELEY HOMES (SOUTHERN) LIMITED**

| Report: | GROUND INVESTIGATION REPORT |
| Site: | DEVELOPMENT PHASE V, LAND TO THE WEST OF WORTHING ROAD,<br>SOUTHWATER, WEST SUSSEX |
| Reference: | GE17902 – GIRv1JK190301 |

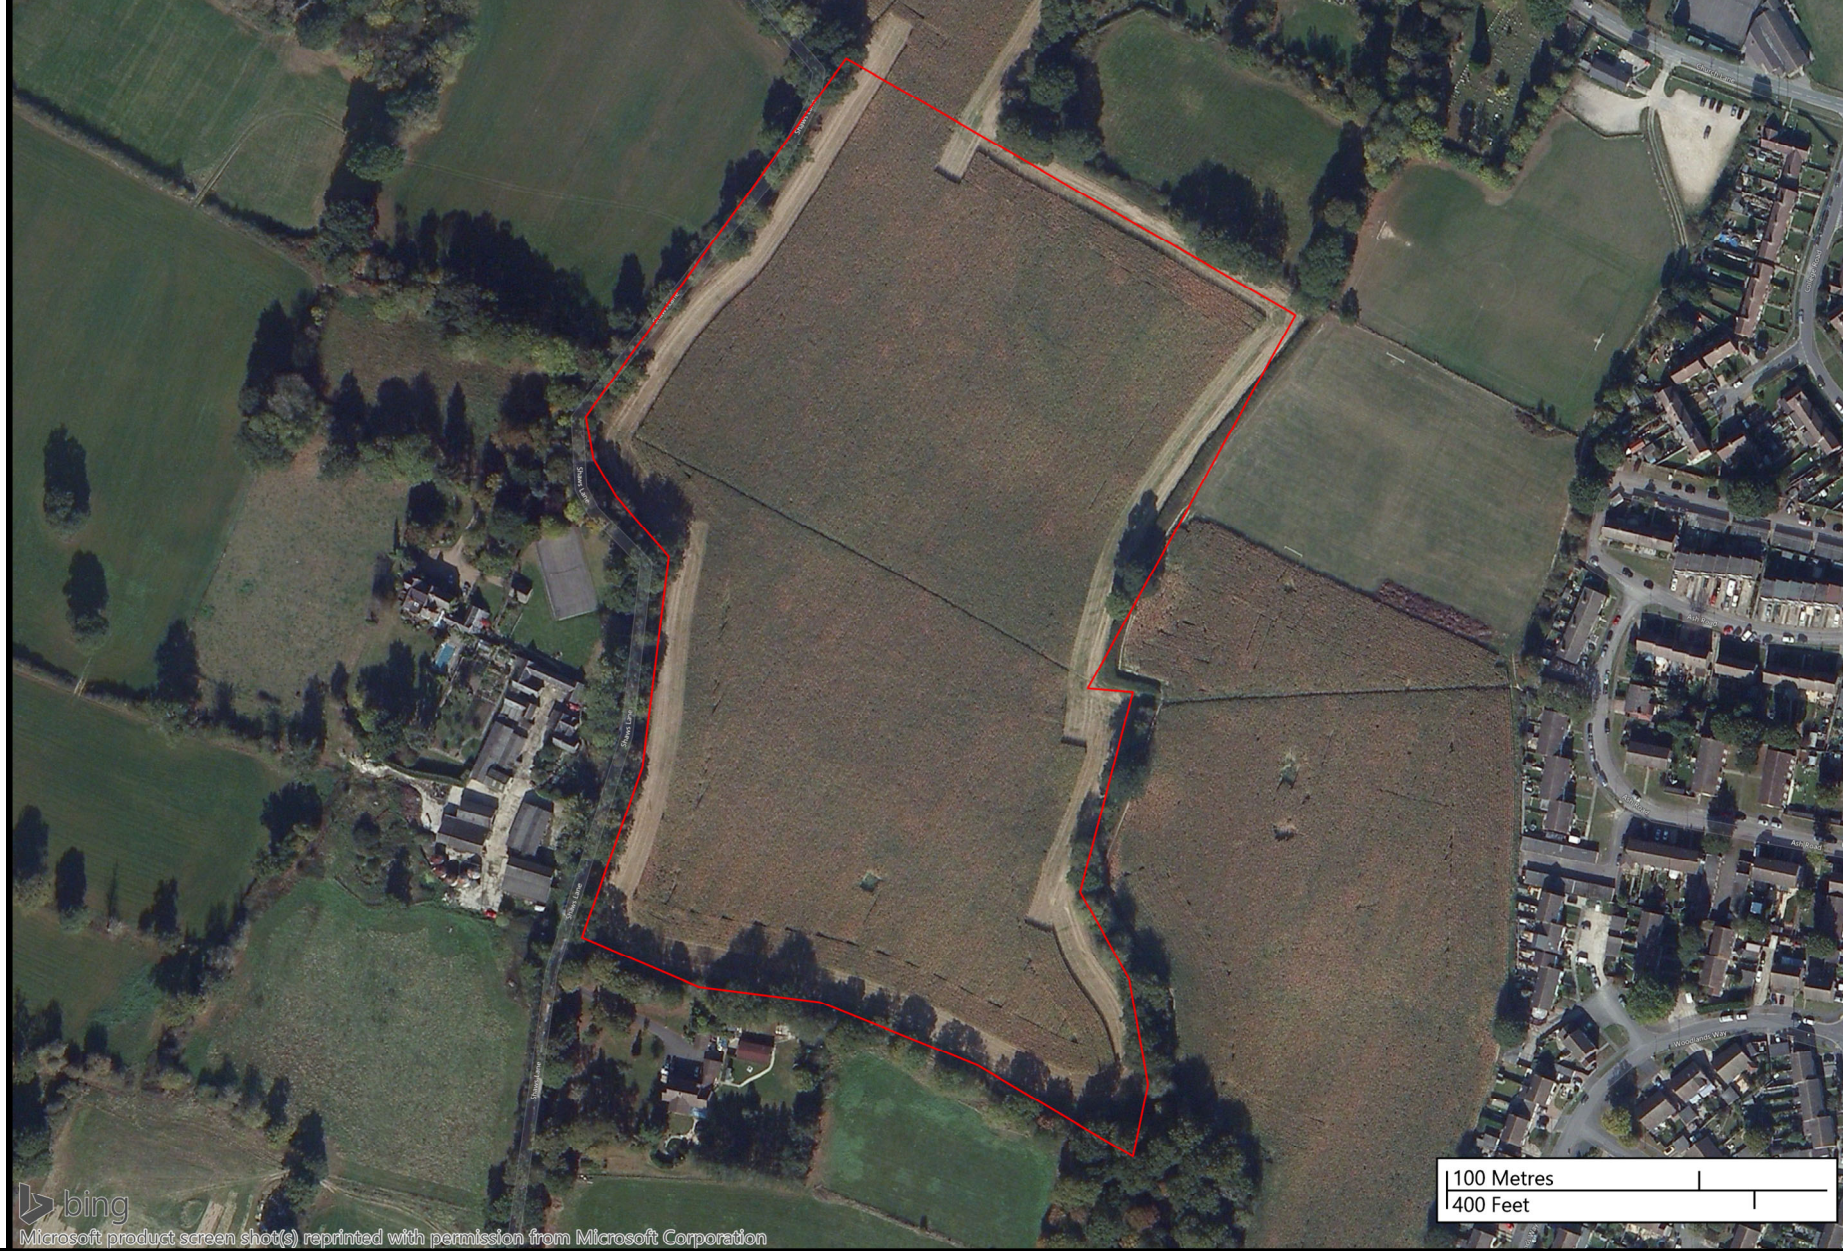
Title : Figure 2 - Exploratory Hole Location Plan  
Scale: 1:3000  
Engineer: GE

- The construction of two cable percussive boreholes (ref: BH01 and BH02) to a depth of 20.0m below ground level (bgl) with regular sampling and in situ testing as appropriate to the conditions encountered.

- The construction of seventeen window sample boreholes (ref: WS01 to WS17) to depths of up to 4.00m (bgl) situated across the site with regular sampling and in situ testing as appropriate to the conditions encountered. It should be noted that several of the windows samples terminated prematurely on the dense siltstone of the Weald Clay Formation at depths of between 2.70m bgl and 3.80m bgl.

- The installation of dual purpose ground gas and groundwater monitoring standpipes to a depth of 4.00m bgl within five window sample positions (WS01, WS03, WS09, WS11 and WS15). It should be noted that the standpipe within WS03 was installed to the maximum depth of the borehole (3.90m bgl).

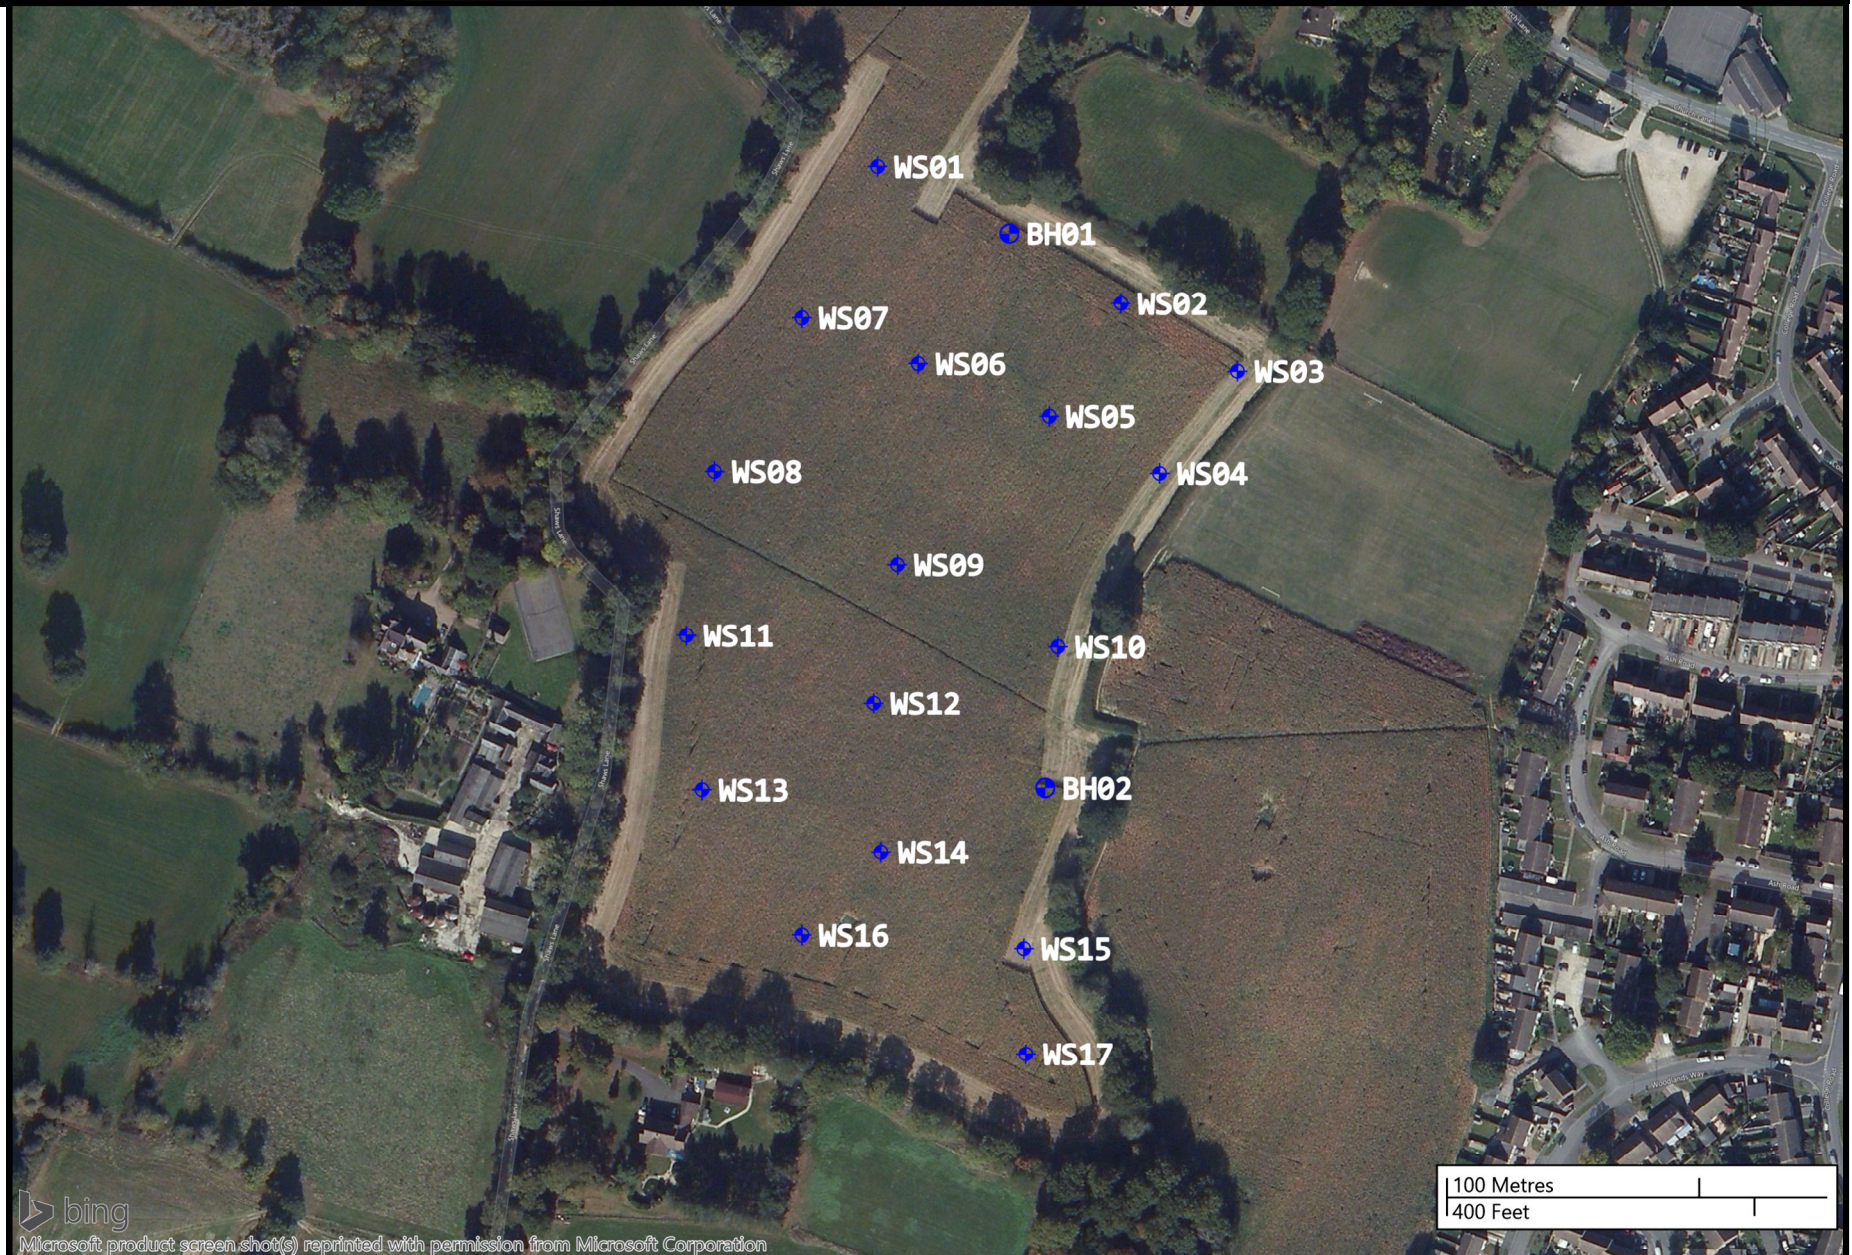
Title : Figure 3 - Site Zones Plan  
Scale: 1:2500  
Engineer: GE

It is therefore recommended that the Weald Clay is considered as being of high volume change over the whole of the site to a depth of 1.0m.

With the exception of WS03 and WS10, all Atterberg Limit tests indicated that the soils from a depth of 1.0m were either low or medium volume change potential. Further investigation is recommended around WS03 and WS10 to delineate these areas where high volume change soils were encountered below 1.00m.

Within the zone of moisture demand of any current, proposed or recently felled trees foundation depths should be deepened in accordance with the NHBC Standards, Chapter 4.2. Where (based on high volume change soils) calculated foundations exceed 1.0m on account of trees, depths for medium volume change soils may be used for the design thereafter (albeit with further classification within the vicinity of WS03 and WS10). Where calculated foundation depths exceed 1.50m on account of trees, heave precaution measures will be required in accordance with the NHBC Standards. Where calculated foundation depths exceed 2.50m, they will be required to be designed by a structural engineer.

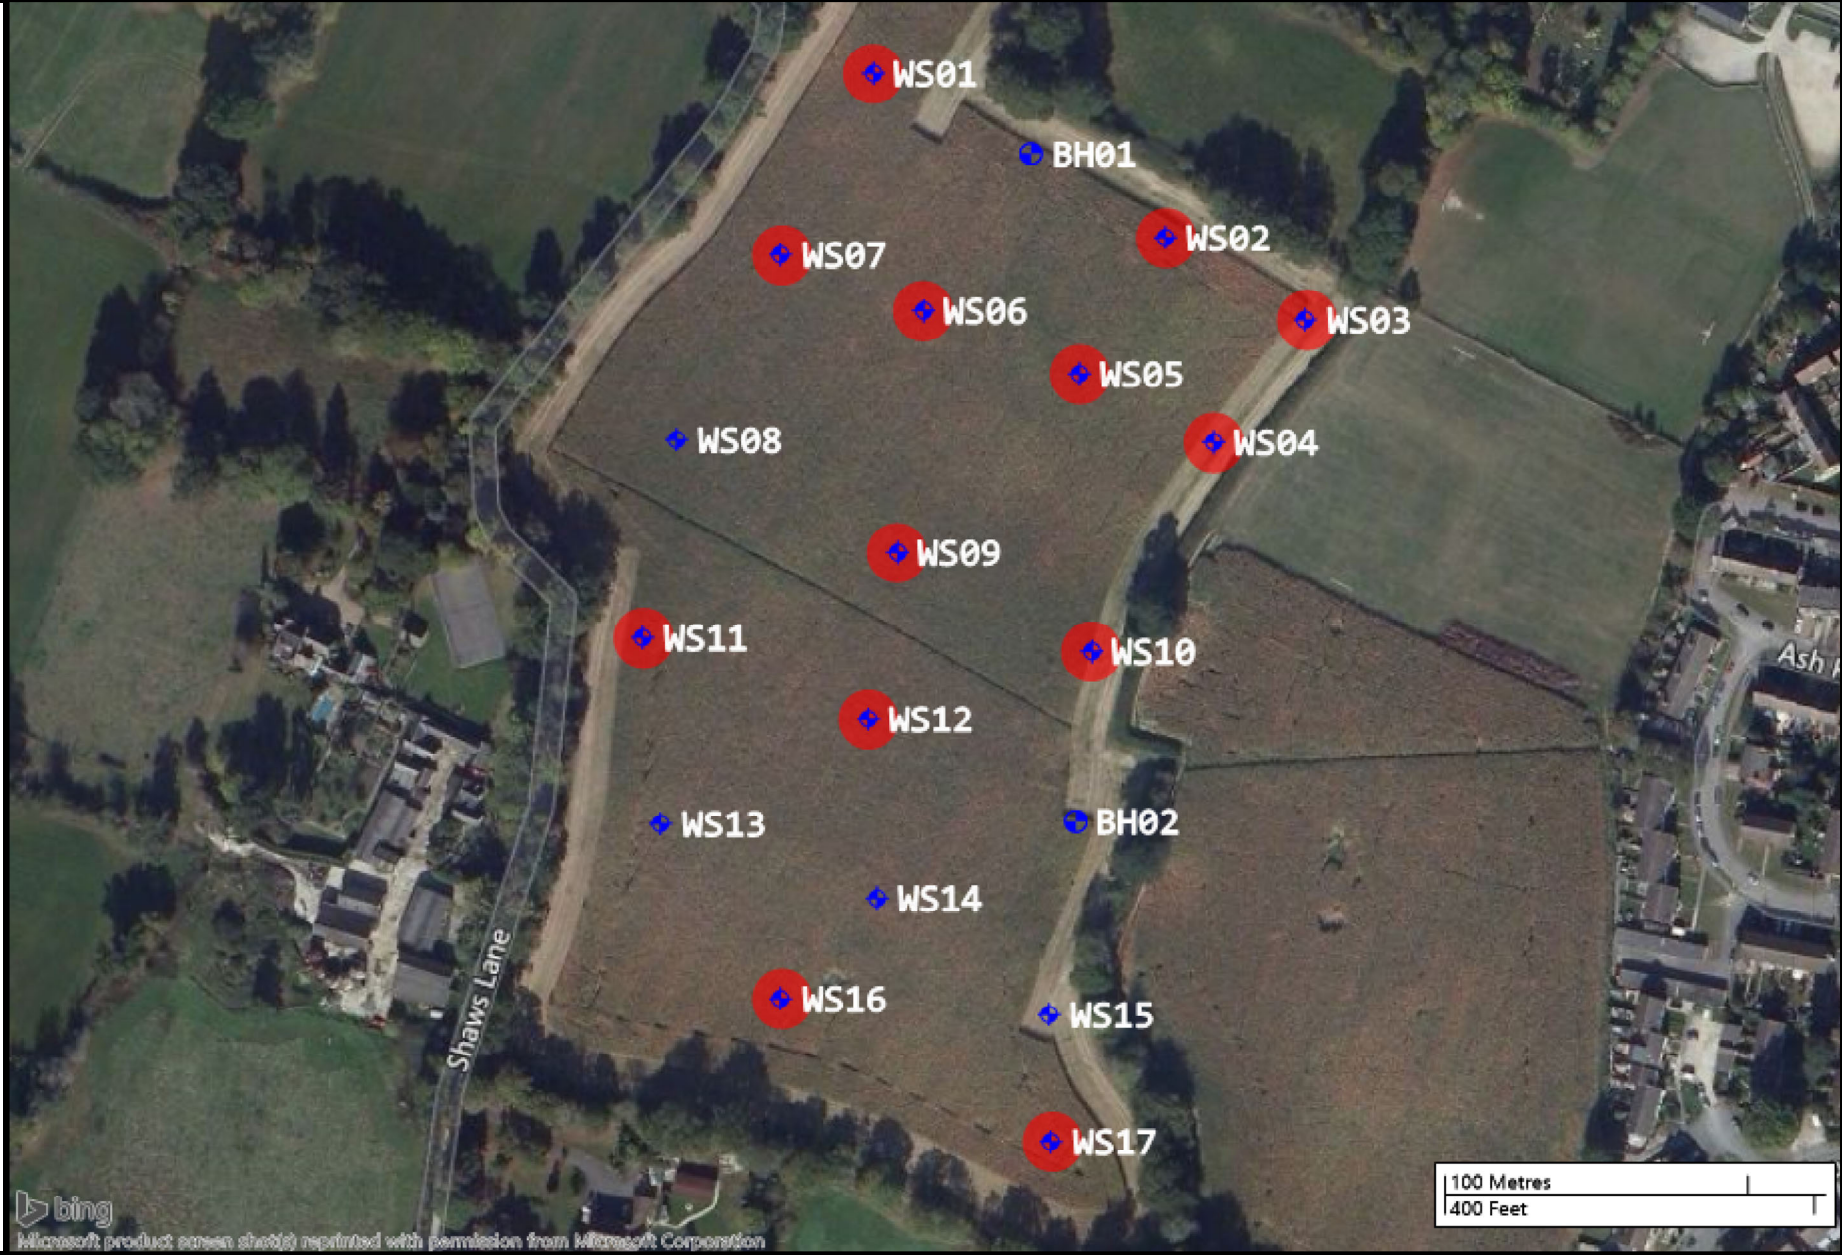
| <b>Project:</b> | Southwater Phase V | | | <b>Title:</b> | CBR Location Plan | |

- Legend Key
- Locations By Type - CP
  - Locations By Type - DP
  - Locations By Type - WLS
  - High VCP less than 1m - High VCP less than 1m
