**RE: DISC/25/0263 – New Place Nurseries, London Road, Pulborough, West Sussex, RH20 1AT**

Please find attached the information for the Discharge of Condition 6 and 9.

**Re: Land to the North East of Glebelands, Pulborough; Soakaway Testing Letter Report**

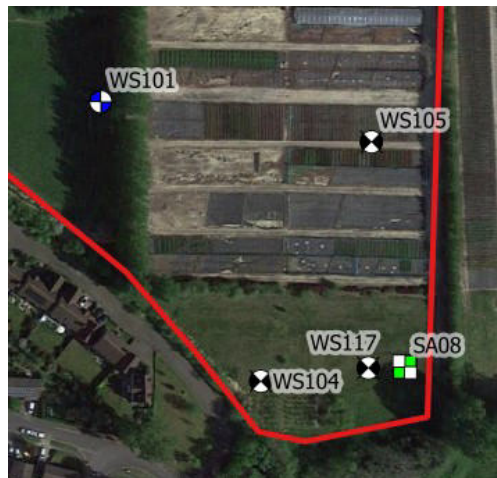
The nearest location to Drovers Lane is WS104 which recorded no groundwater strike to a depth of 1.5m and an infiltration rate of 2.77E-07. Although the rate is not ideal, this is considered a viable secondary drainage system to the support the existing Drovers Lane drainage pipework.
