# **GROUND INVESTIGATION LAND OFF KING'S BARN LANE STEYNING**

**Prepared for: Richborough Estates Limited**

**ASL Report No. 288-20-087-10R1**

**September 2021**

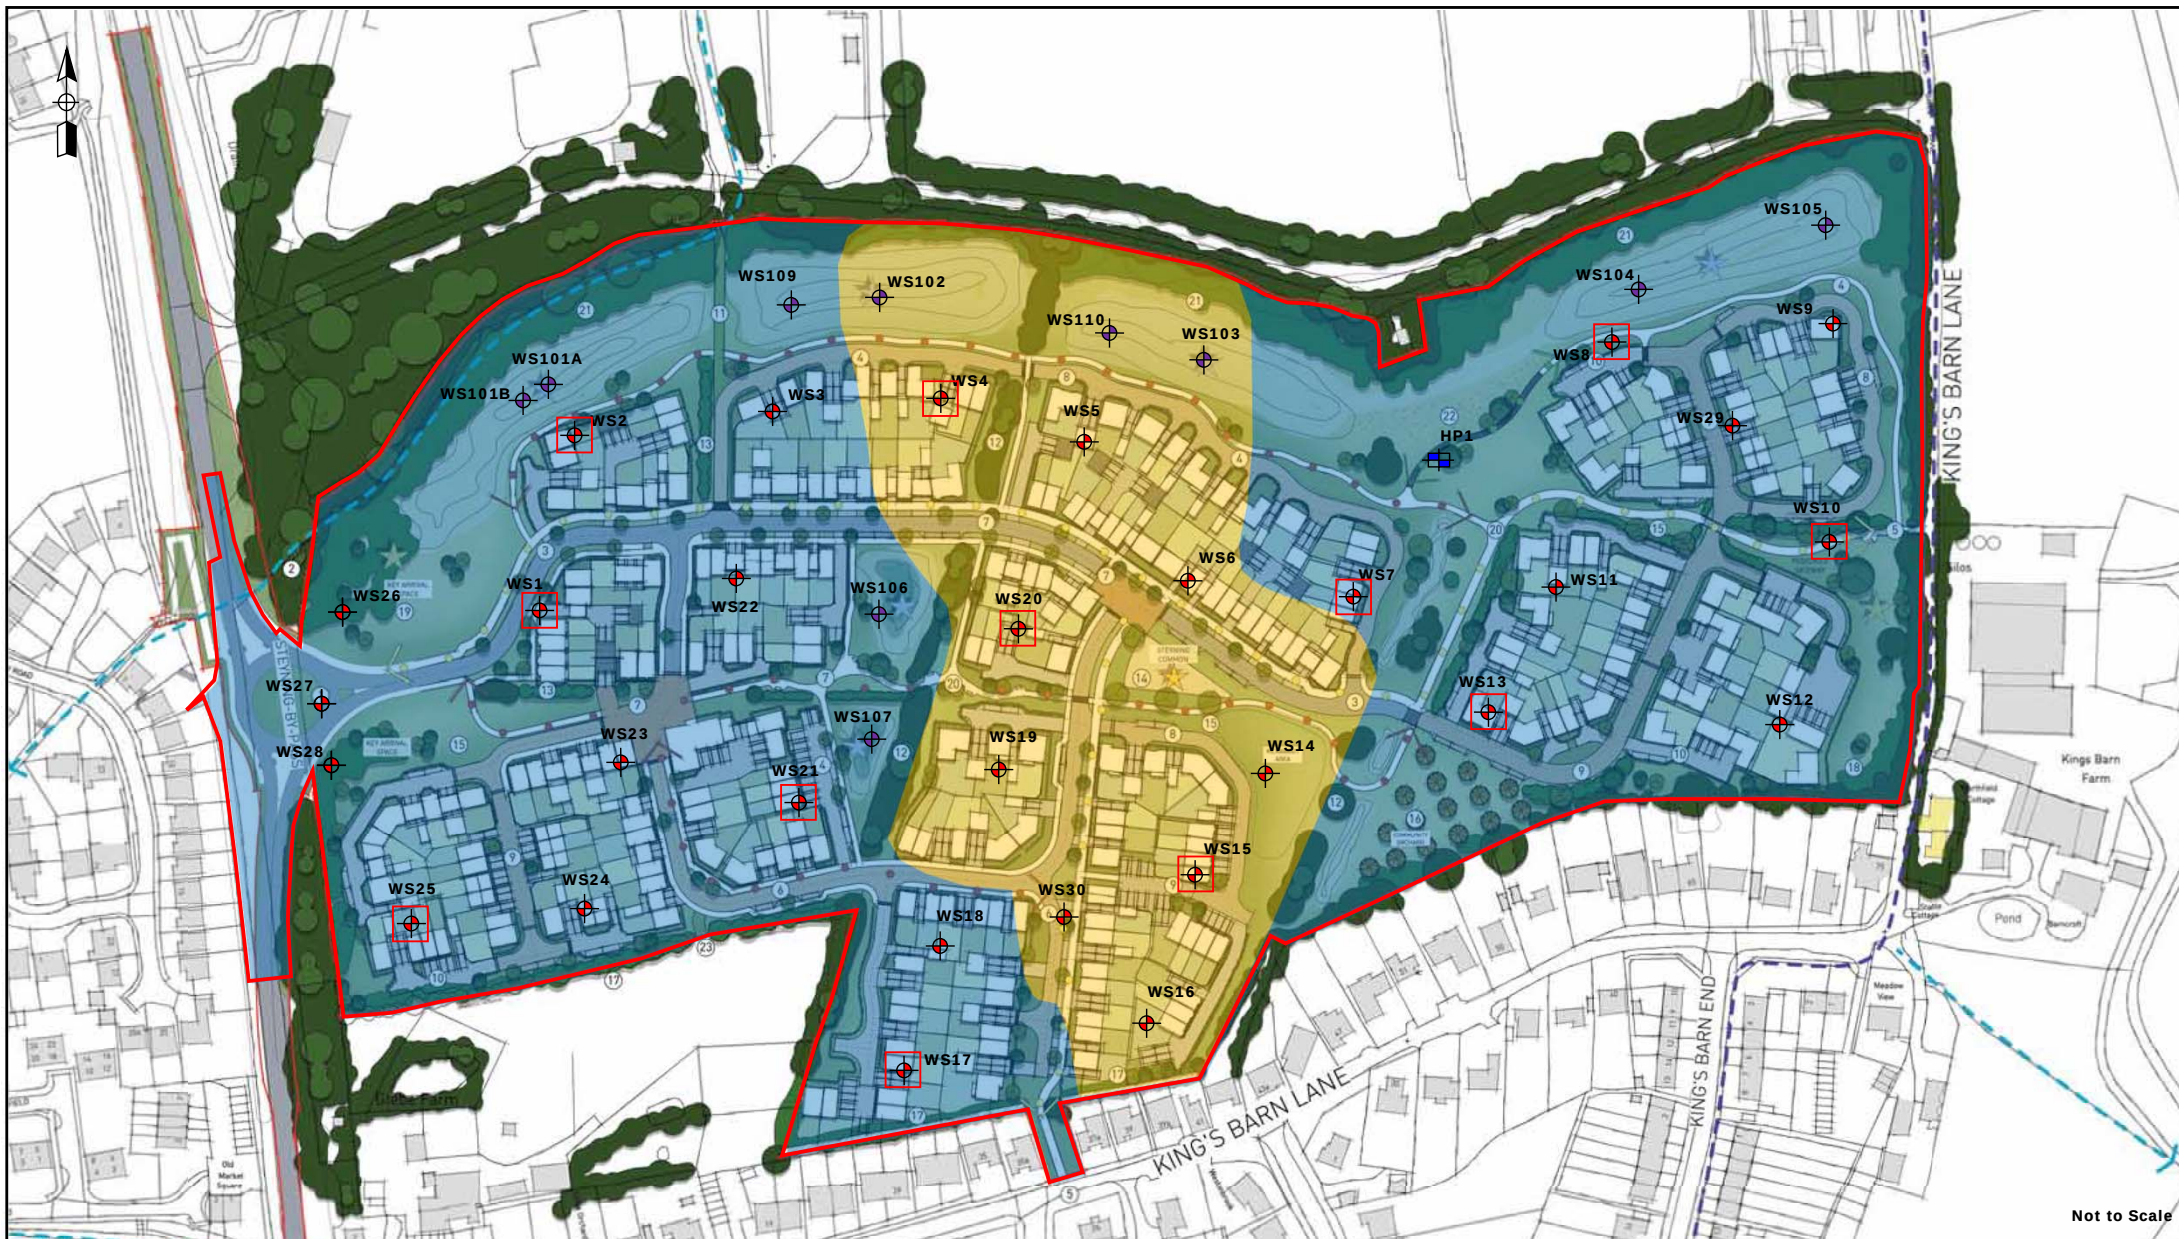
| Drawing Name | <b>Foundation Zoning Plan</b> | | |

Based on the findings of the intrusive investigation, it is considered that traditional strip or pad foundations could be adopted across the central portion of the site and placed within the Possible Head or Gault Formation materials at a minimum depth of approximately 1.0m bgl (assuming foundations are located outside the zone of influence of existing or proposed planting) and designed to a net allowable bearing pressure of 75kN/m<sup>2</sup> to limit total settlements to 25mm and differential settlements to acceptable levels.

Across the remainder of the site, it is considered that traditional strip or pad foundations could be adopted within the Possible Head or Gault Formation materials at a minimum depth of approximately 1.0m bgl (assuming foundations are located outside the zone of influence of existing or proposed planting) and designed to a net allowable bearing pressure of 100kN/m<sup>2</sup> to limit total settlements to 25mm and differential settlements to acceptable levels.

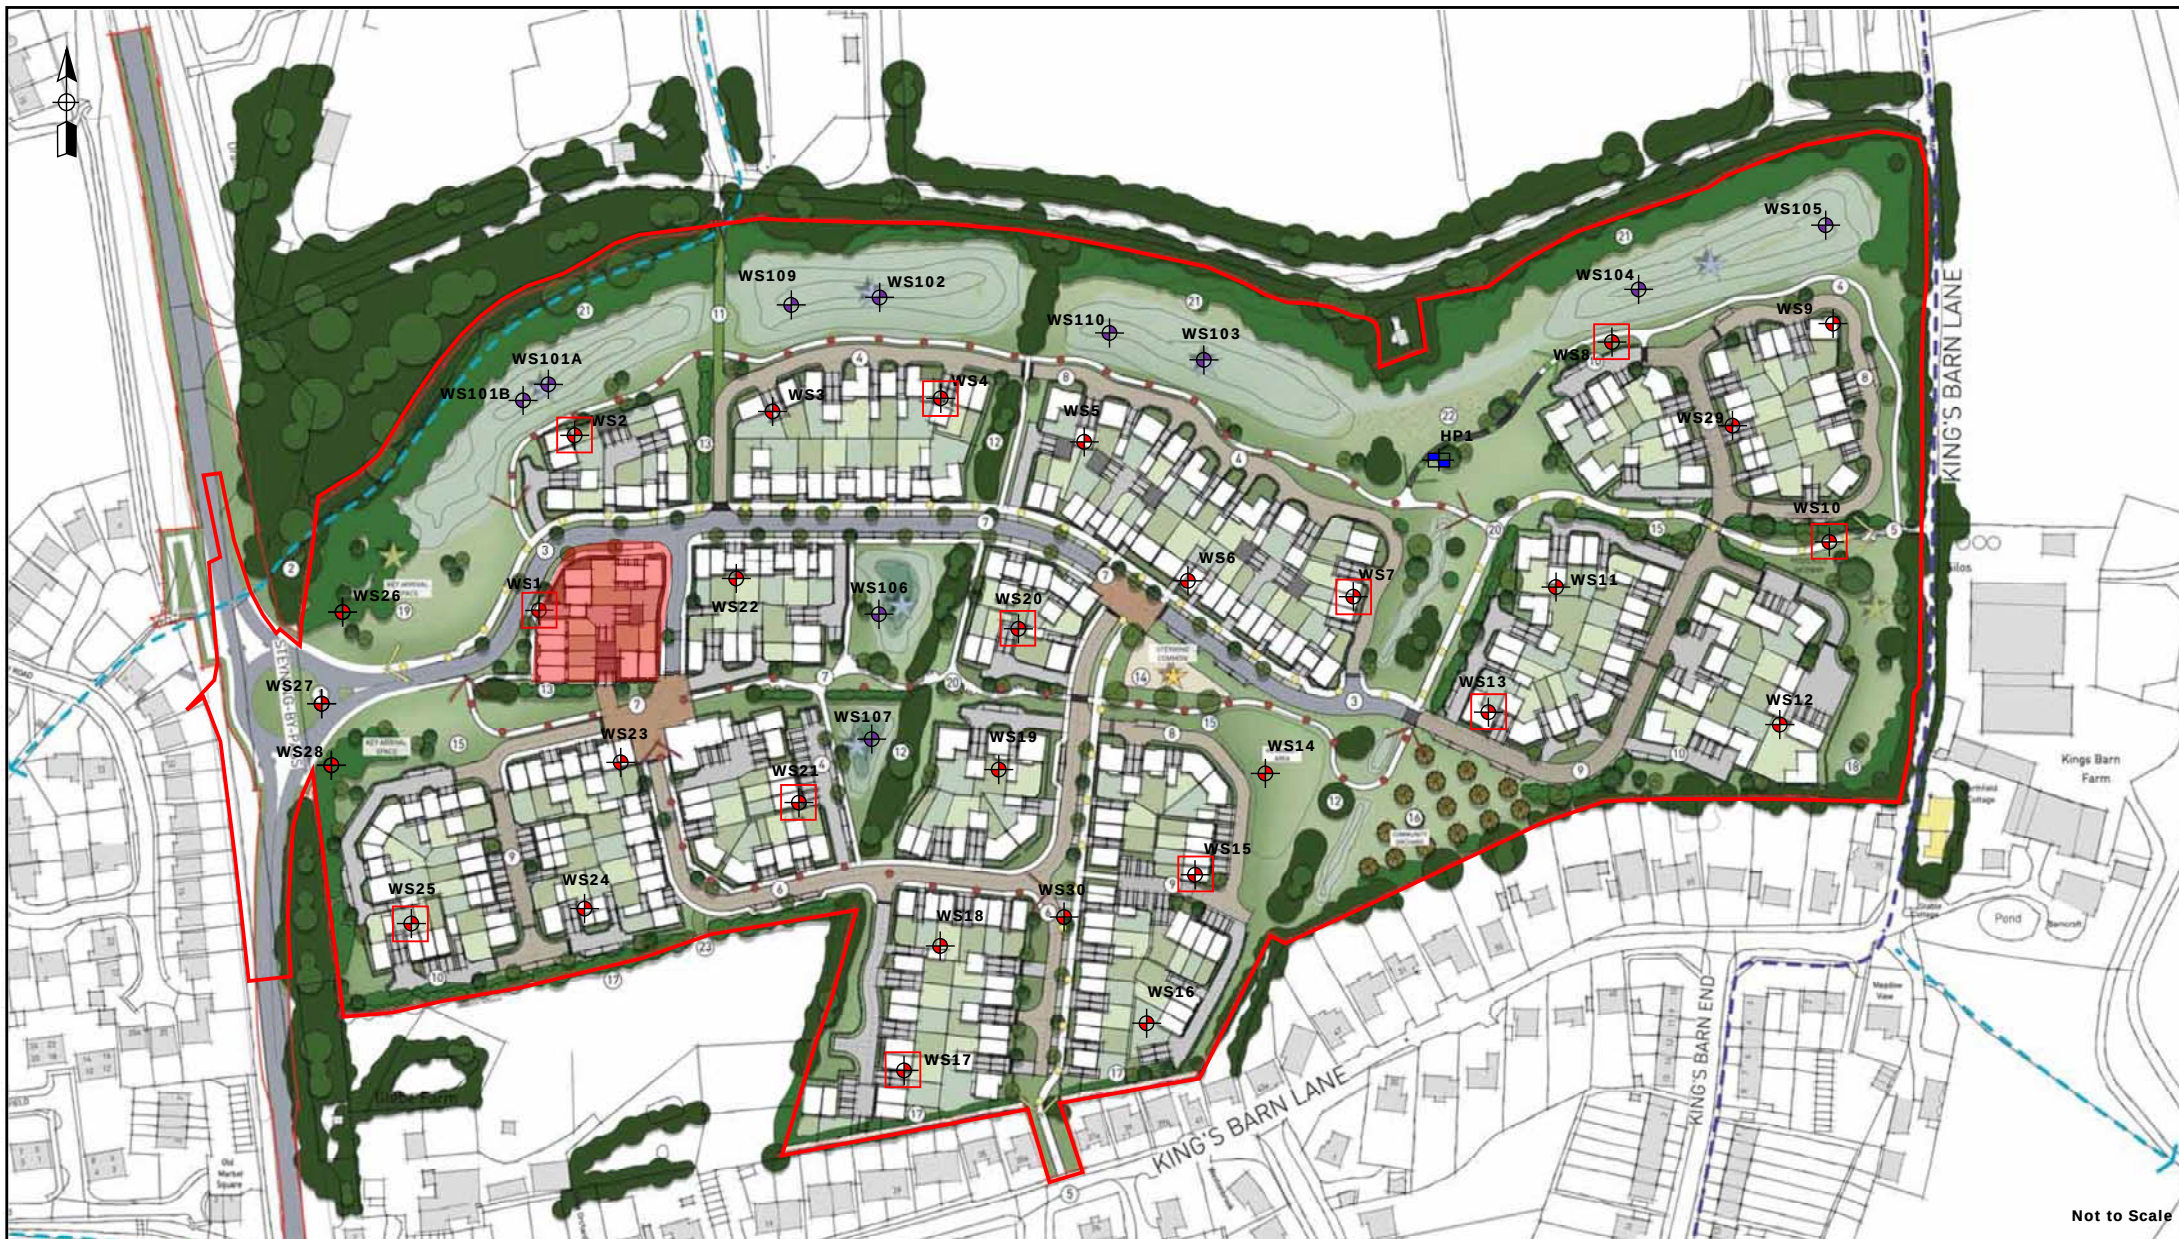
| Drawing Name | <b>Extent of Recommended Gas Protection Measures</b> | | | | |

However, based on the results of the ground gas monitoring, it is recommended that gas protection measures to CS2 (characterised low potential hazard) are incorporated into the proposed development in the vicinity of WS1, located centrally in the west of the site. The extent of the recommended gas protection measures is presented on Figure 6.
