# THE GROOM'S HOUSE HOPE FARM, BILLINGSHURST,

## Updated Preliminary Roost Appraisal Report

*October 2025*

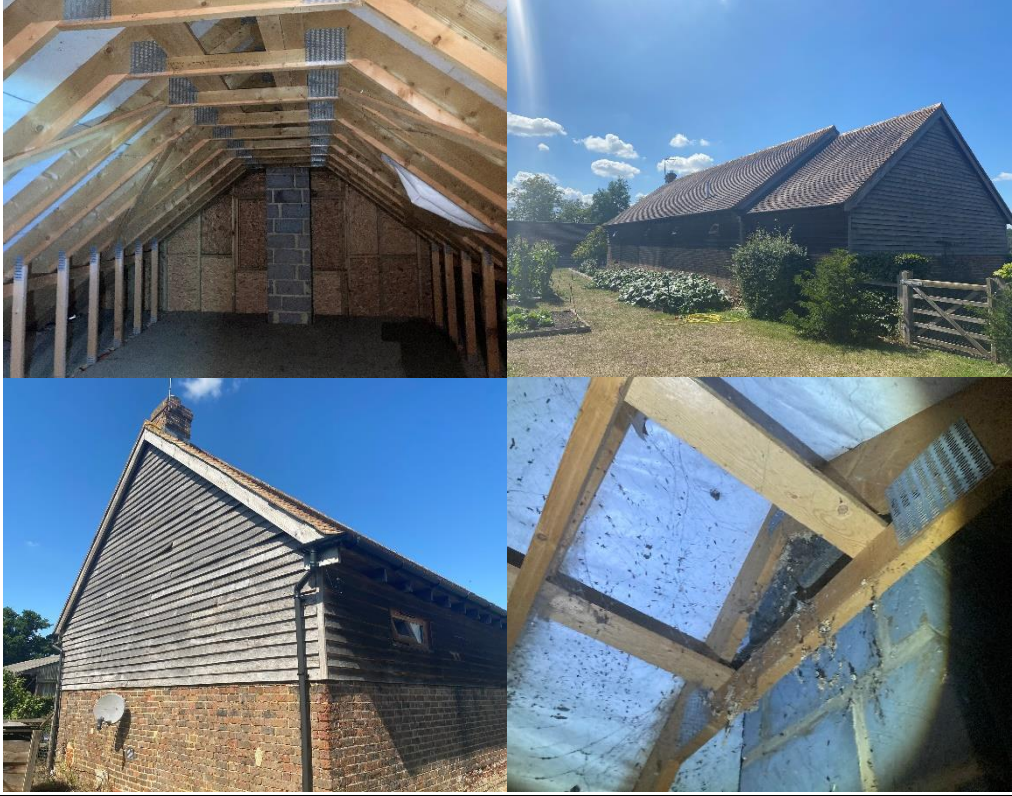
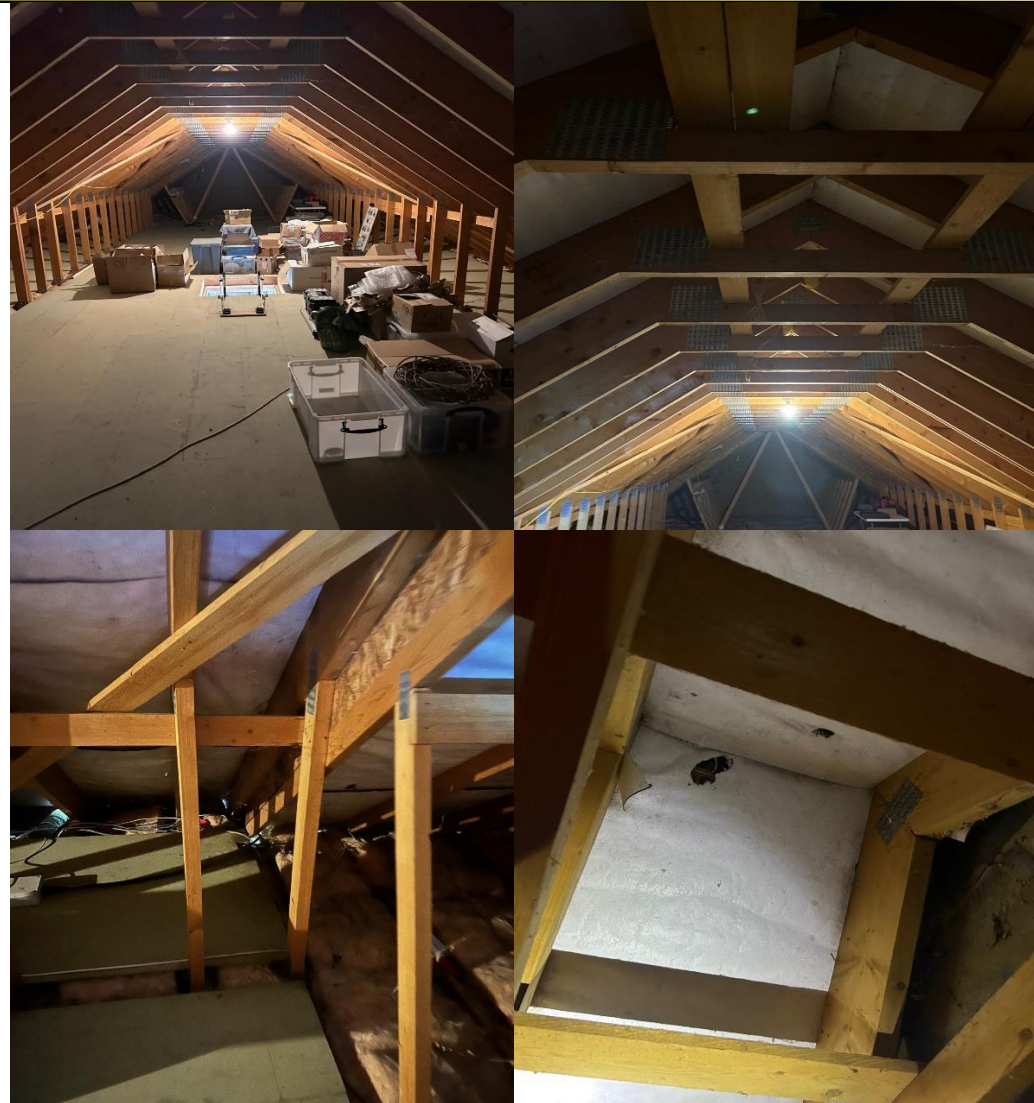
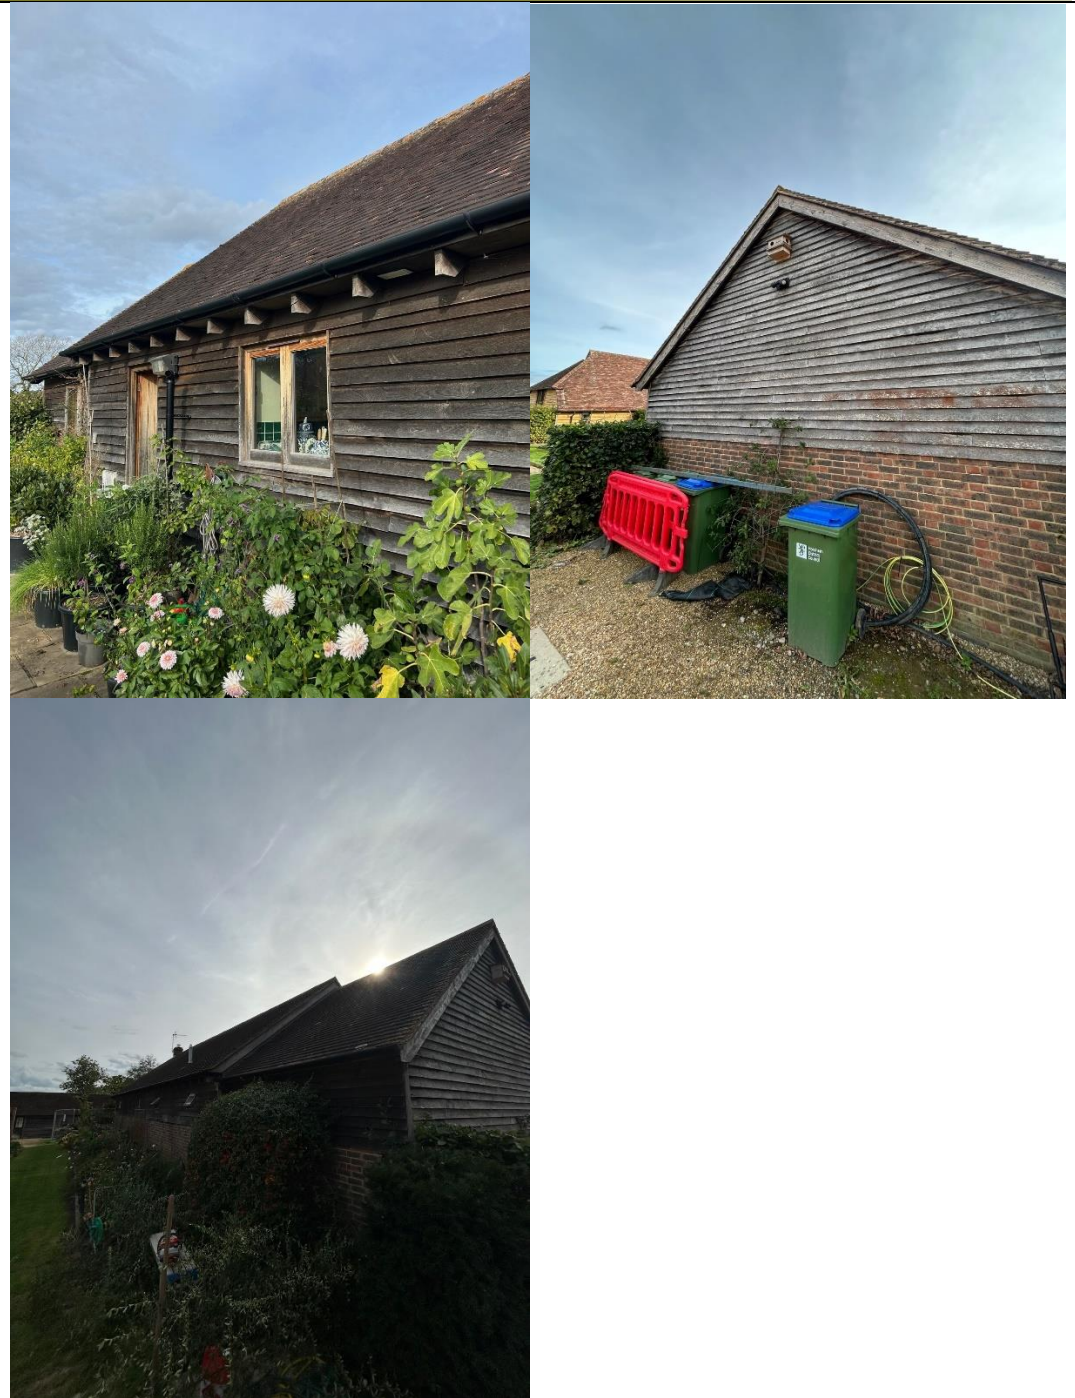
Table 3.1 PRA findings

| Feature | Photograph |
|---|---|
| <p><u>Excerpt from original PRA undertaken on 26/08/2022- Referred to as Building 3, due to original survey encompassing entirety of the hope farm site buildings.</u></p> <p><i>Single storey building which was used as a residential dwelling. The foundations were bare brick which were generally in good condition. Wooden cladding timbers were present on all aspects of the building, with multiple gaps present, where it has lifted and provide cavities for roosting bats.</i></p> <p><i>The roof was pitched with clay roof tiles and overhanging eaves where guttering was present. The tiles were generally in good condition, with no slipped or broken tiles observed. Gaps were present between the roof structure and brick work which may provide internal access to the building.</i></p> <p><i>An internal inspection was completed, and the loft was large, with an approximate height of 2.2m. It was one large void, with exposed breathable membrane liner and wooden beams supporting the roof. Light gaps were observed in relation to the wall plate and eaves union. The walls on the northern and southern aspect were constructed of breeze block with no PRFs observed.</i></p> <p><i>PRFs were present in relation to the wooden timber beams, and between the tiles and roofing felt which had holes in some parts due to rodents. No field signs of roosting bats were observed internally.</i></p> <p><i>Due to the wooden cladding and access points to the loft, the building was assessed as having <b>Moderate bat roosting potential.</b></i></p> | |

The conditions on site had changed little since the original survey and the building was found to be in near identical condition to the original site visit.

The occupier has been using the internal space for storage and there is now artificial lighting within the open plan loft space. No evidence of droppings, urine staining or live bats was encountered and the presence of only rat and mouse droppings and extensive damage to the breathable membrane indicates that there is still a rodent population within the loft and offers external to internal access.

The northern end is heavily covered in cobwebs and has no boarding over the exposed insulation, whereas the central area including the loft hatch and the southern end are fully boarded meaning a detailed inspection and full access was possible to all parts of the loft void.

The external access previously noted was visible with natural light spill observed between the roof eaves and wall plate, this offers void dwelling species known to be present on site such as Brown long eared bats potential internal access.

The external facades have not altered since the original visit, and the garden has matured with shrubs and some vegetation now obscuring the timber cladding.

Multiple lifted and warped timbers were observed, and these correspond to the original findings. The roof covering of clay tiles remains in good condition with only minimal slipped and lifted tiles.

An inspection with a high-powered torch under the timber cladding in the known roost locations failed to positively identify any live bats.

Due to the existing survey data confirming that there are multiple roosts within the timber cladding **the building is classed as a known roost, therefore it is rated as holding High bat roosting potential.**

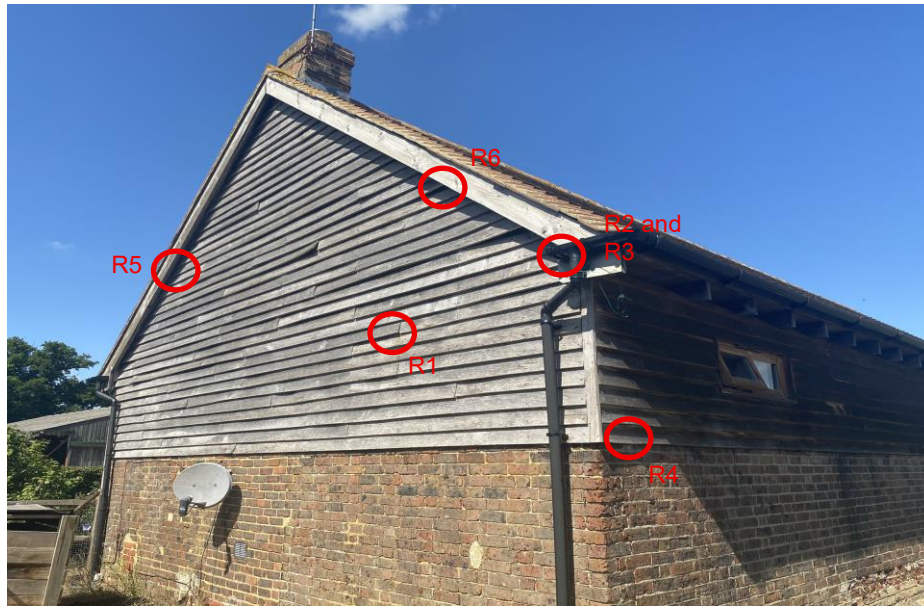
Figure 4.1- Roost locations.

- 4.2.2. Two roost locations were observed throughout the survey; a single brown long eared bat was observed re-entering the soffit and fascia area around R2 at 06:11am this is referred to as R3 due to it involving a separate species. One common pipistrelle bat was observed re-entering the timber cladding on the eastern elevation at 06:14am referred to as R4 (see figure 4.1 below)

- 4.3.2. Two roost locations were observed during the survey; one soprano pipistrelle was observed re-entering the timber cladding at the southwestern verge to fascia union at 03:47am referred to as R5. Two soprano pipistrelles were observed re-entering under the wooden cladding at 04:06am and 04:16am on the southeast verge and fascia referred to as R6. (see figure 4.1 below)

| Roost No. | Peak count of bats | Species | Date(s) | Roost location |
|---|---|---|---|---|
| R1 | 6 | Common pipistrelle | 30.08.22 | From the timber cladding on the southern gable end aspect of the building. |
| R2 | 1 | Common pipistrelle | 30.08.22 | From the soffit and fascia area on the southeastern corner aspect of the southern gable end of the building. |
| R3 | 1 | Brown long-eared bat | 15.09.22 | Into the soffit and fascia area on the southeastern corner aspect of the southern gable end of the building. |
| R4 | 1 | Common pipistrelle | 15.09.22 | Into the timber cladding on the southeastern corner of the eastern elevation where the cladding meets the brickwork |
| R5 | 1 | Soprano pipistrelle | 13.06.23 | Into the timber cladding at fascia timber union on the southwestern verge of the southern gable end of the building. |
| R6 | 2 | Soprano pipistrelle | 13.06.23 | Into the timber cladding at fascia timber union on the southeastern verge of the southern gable end of the building. |
