Church lane Grill AD-T-049 [532934]

APSRAT2500258

\*\*Inspection Type: PSRA Tree

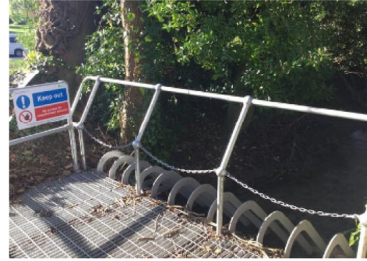
Tree work is required for removal of the small tree dead/dying leaning across the channel in front of the trash screen and removal of the J-curve limb growing from mature Ash tree, the limb is growing out towards the public footpath. There is a small amount of lvy growing on the tree nearest to the screen.
