# **PRELIMINARY ROOST ASSESSMENT**

## **5 Ivy Cottages, Billingshurst**

| <b>Reference:</b> | LLD3864-ECO-REP-001-02-PRA | | | |

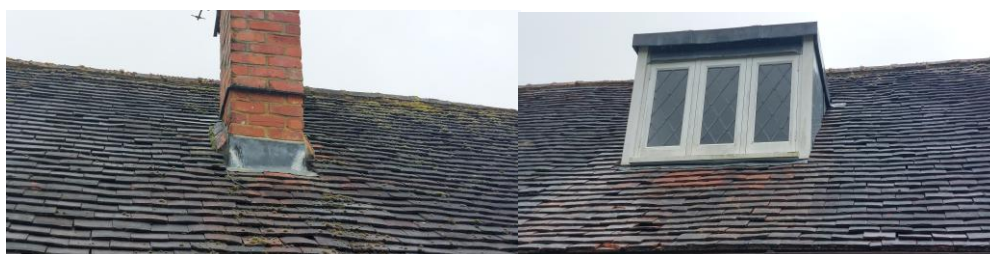
- 3.2.1 There was one building (B01) onsite. There was no internal loft space to access within B01. Externally, there were missing pieces of tile, gaps between tile and gaps around the flashing throughout the roof space. The north-western elevation included hanging tile. The building was classified as being of moderate bat roost suitability.

*Photographs 01 and 02 – Gaps around flashing along eastern elevation and gaps between tiles / missing tiles along western elevation.*

- 4.1.1 Building B01 has been assessed as offering moderate bat roost suitability due to missing pieces of tile, gaps between tiles and gaps around the flashing. As this building will be impacted during the development, it is not possible to scope out the potential that works could result in the killing or injuring of individual bats and permanent loss of the roost which would constitute an offence under the *Conservation of Habitats and Species Regulations (2017) (as amended)* and the *Wildlife and Countryside Act (1981) (as amended)*. Resulting to adverse impacts to bats significant at the **site** level.

- 4.2.1 Building B01 shall require 2no. bat emergence surveys to be undertaken during the optimal survey season of May to September, with at least 50% of visits completed in the peak months of May to August, using night vision aids in time aids in line with current guidance (Collins, 2023). This shall allow the presence or likely absence of a bat roost to be established. Where an active bat roost is found, a European Protected Species Derogation Licence shall be required from Natural England to allow works to progress. Any mitigation measures required as part of any such licence would be determined by the results of the survey work.

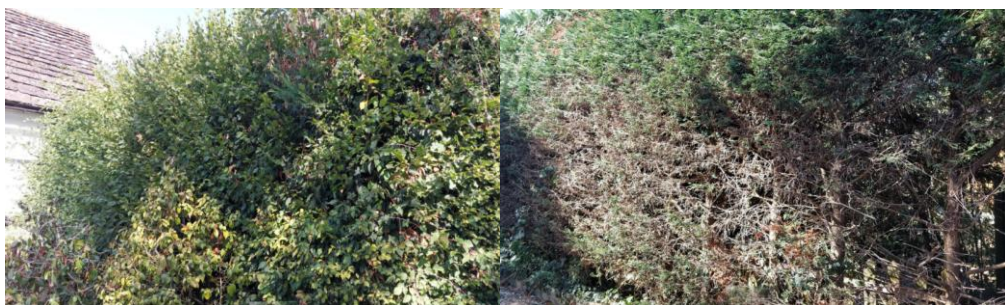
- 4.1.2 The short ornamental hedgerow to the west of the driveway is due to be removed. However, this section of hedgerow is only short in length and provides no connectivity between suitable habitats. All boundary habitat which surrounds the site shall be retained, as such there shall be no adverse impacts upon flightlines or commuting routes.

*Photographs 03 and 04 – Beech and Leylandii hedgerow near entrance of the site.*
