# **Bat Emergence Survey Report**

**Brick Agricultural Building at**

**Thistledown Cottage**

**2<sup>nd</sup> June 2026**

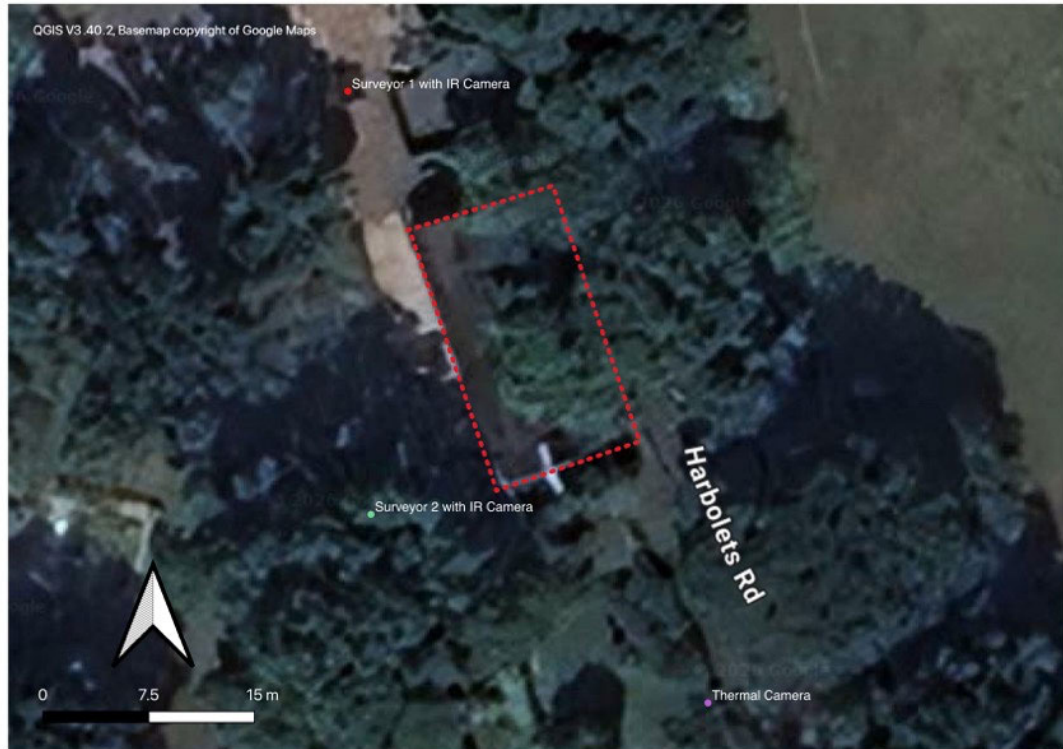
### 3.5 **Figure 2: Surveyor and Camera Positions**

3.4 The night vision observation equipment gave a view of the features of the building surveyed that was not possible with the naked eye, enabling effective observation to continue in the dark. The cameras were installed on tripods, which enabled the surveyor to work normally without having to hold the

camera steady. The Sionyx Aurora IR camera provide a wide angled view which is also recorded and fixed throughout the survey and the Pixfra camera provided a more narrow focused field of view. .

- 3.7 The eastern aspect of the barn building was directly adjacent to the main road, which restricted access to that site for surveyors. However, this aspect was also heavily covered by the adjacent tree and hedge vegetation, which also limited any flight-lines to this face of the building. Therefore, this restriction to sight lines is not considered to have affected the overall conclusions to the survey findings. Additionally, a remote thermal camera was installed to the south east of the building to capture any bat flight/activity heading to this part of the building.

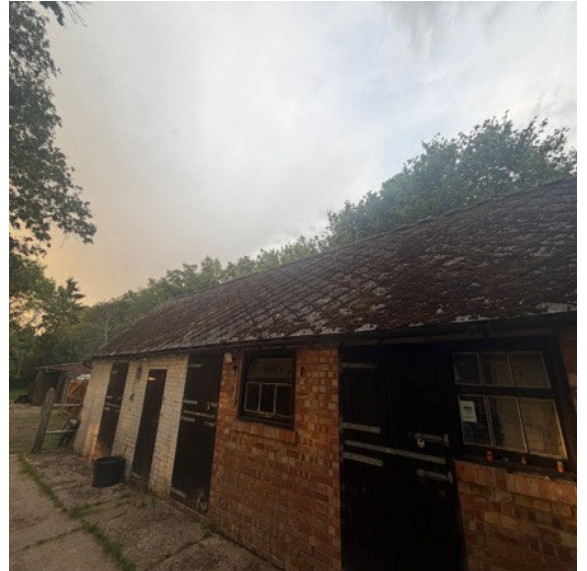
- 4.4 The building was of brick construction with white rendering finish on the southwestern face. The brickwork was single layered and didn't exhibit any cavity within the wall, with the cement pointing in good condition. The bricks were also in good condition, with no gaps or cracks present within the brickwork. The roof was pitched and tiled with slate tiles. These tiles were relatively flat, with limited gaps present. At the gable ends, there were also not any gaps present at the apex joining the brickwork to the eaves of the roof. The ridge tiles were also in good condition, with not any disenable gaps at the joins of the ridge tiles. At the southeastern end of the roof, some of the ridge tiles had a horizontal air vent present, with openings to the southwest and northeast. These ridge tiles provided potential ingress points for any bats.

**Plate 10: Western Face with Ridge Tile Gaps**

- *Structural timbers, particularly ridge beams, purlins, rafters and wall plates, must be inspected visually for roosting bats before cutting or removal;*

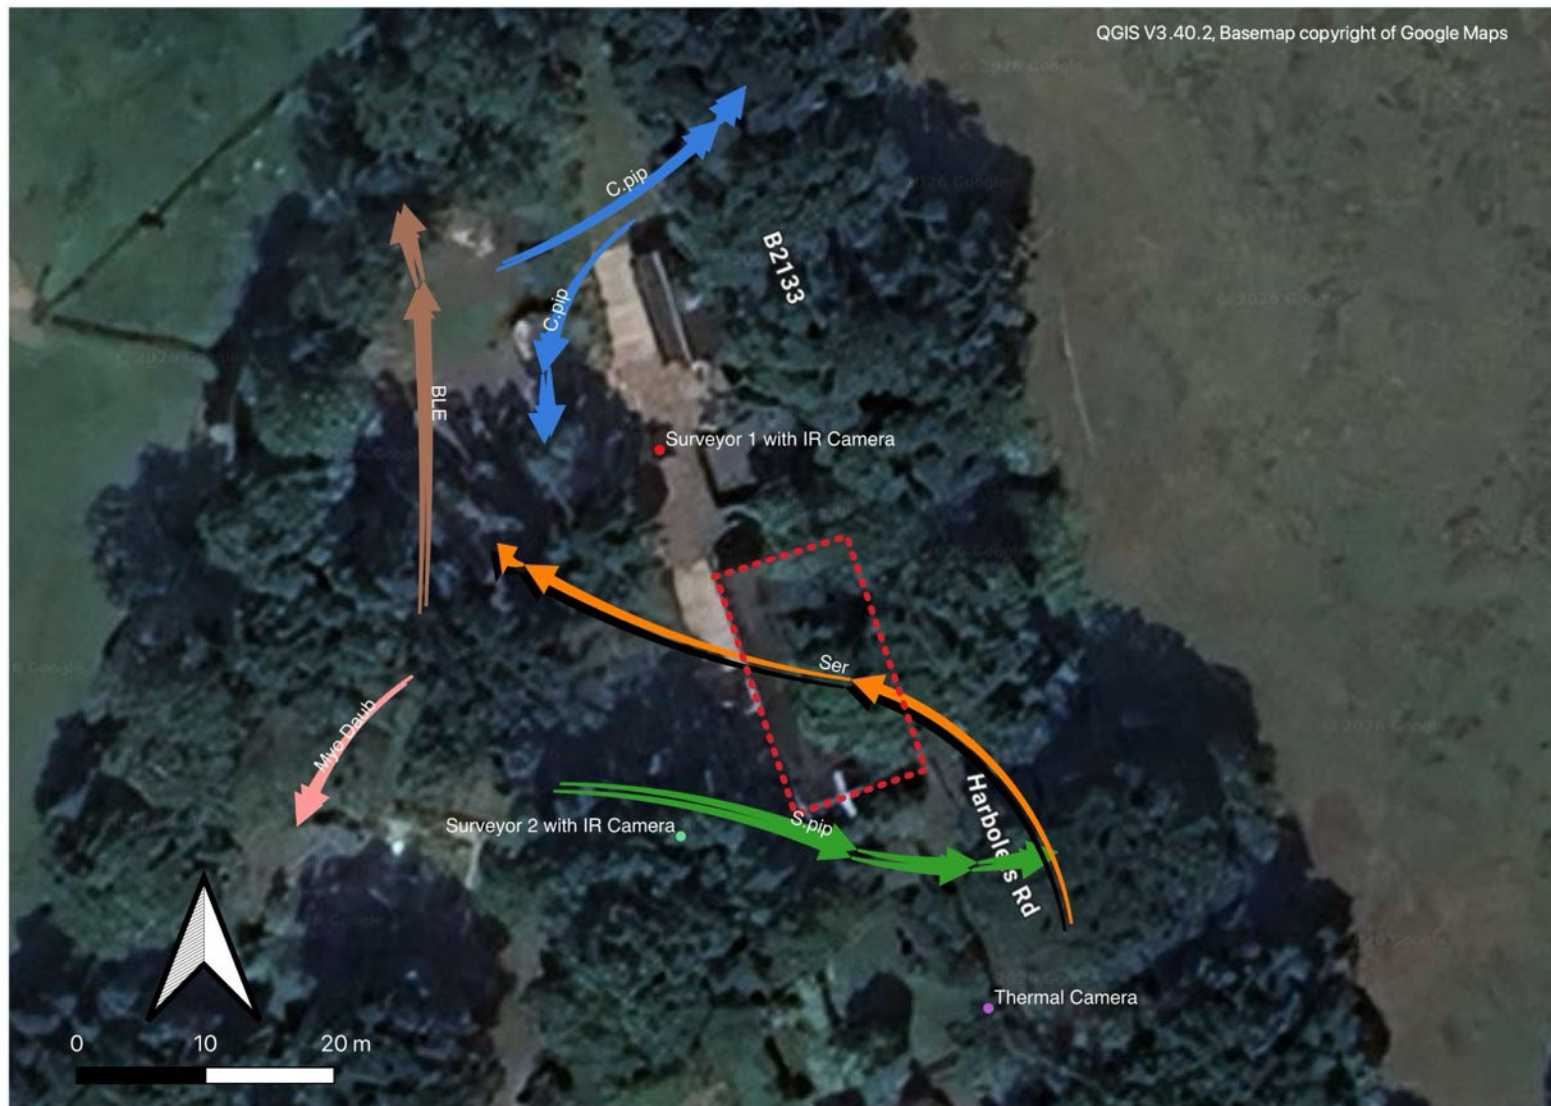
## 8.0 SUMMARY MAP OF BAT ACTIVITY

4.7 Four bat species were recorded and observed, during the survey. The first bat recorded was soprano pipistrelle with a brief pass from the south. This was relatively early on in the survey and was potentially an emergence from a local location. Common pipistrelle passes were also observed and recorded, notably to the north with soprano pipistrelle activity also recorded. A single brown long eared and a single Daubenton's bat was also recorded, respectively. No bat emergences from the building were observed.

- 4.9 The bat activity was similar to the previous survey, but with a slightly diminished level. Common pipistrelle were observed and recorded to the north, with a commuting pass of serotine also observed and recorded. Three soprano pipistrelle were observed and recorded flying from the west, over the southern aspect of the building, then heading off to the east. A single brief call of brown long eared bat was also recorded, with this bat not directly observed. No bats were observed emerging from the building.
