## Preliminary Roost Assessment

119 High Street, Steyning, West Sussex BN443RE

This report is prepared to inform a planning application with Horsham District Council. This proposal can be described as "conversion of existing building to four x two-bedroom apartments, including changes to the external fabric"

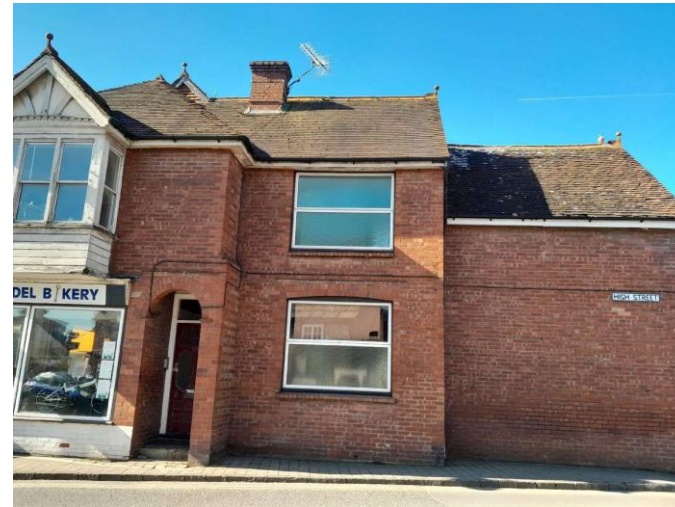
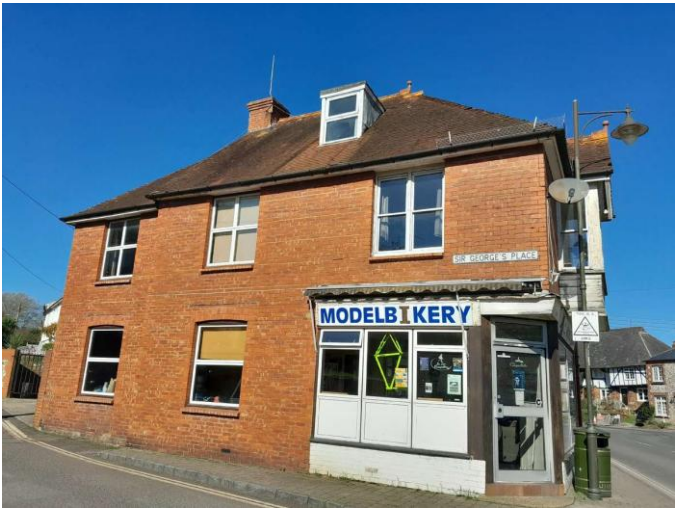
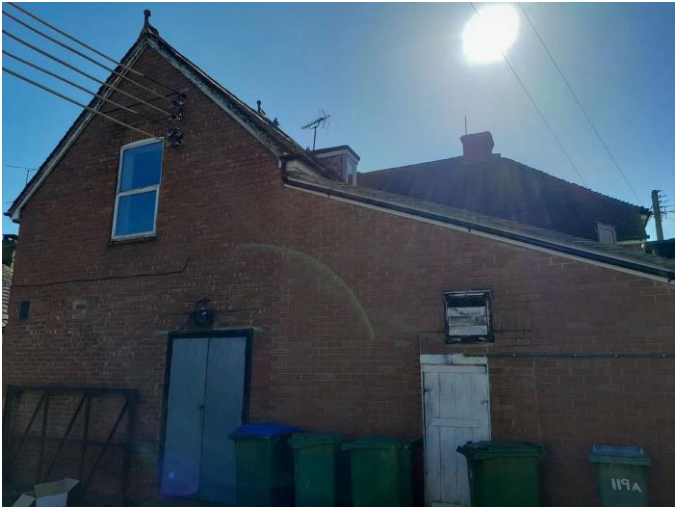
B1 is a two-storey, detached, brick-built building with an occupied flat on the first storey and a residential shop and disused bakery at the ground floor. The building has a complex roof structure, which appears hipped with a dormer window on the south elevation, gabled with catslide roof to the north elevation. The east elevation comprises a cross gable-hip roof with a slightly shorter section of building with pitched roof on the north-most end. See Appendix 4 for further photographs.

In line with Good Practice Guidelines (Collins, J (Ed) 2023), B1 is assessed to have **moderate habitat value** for roosting bats due to a number of suitable roosting features, including gaps under multiple roof tiles and a gap between the soffit and wall.

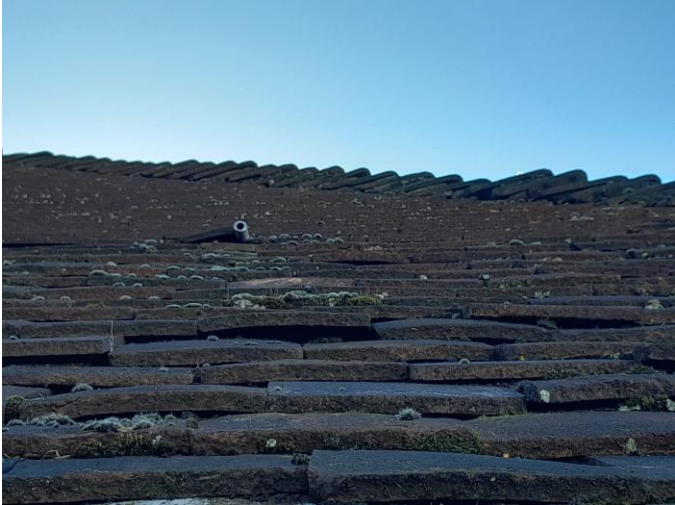
| Feature | Materials | Condition/Suitability | Photographs |
|---|---|---|---|
| Roof | Clay tiles | The roof exhibits frequent defects with multiple gaps present, offering suitable roosting opportunities. | <p><i>Gaps under roof tiles</i></p> |

The proposed development includes impacts to the roof and as such, the works could result in destruction of any bat roosts present within the identified features (gaps under roof tiles and gaps between soffit and wall) and could cause disturbance, death or injury to bats.

Two bat emergence/re-entry surveys will be required on B1, requiring four surveyor positions to provide full coverage of the building's elevations. If bat roosts are confirmed in the building one additional survey may be required to characterise the roost and to inform an EPSL application to Natural England.

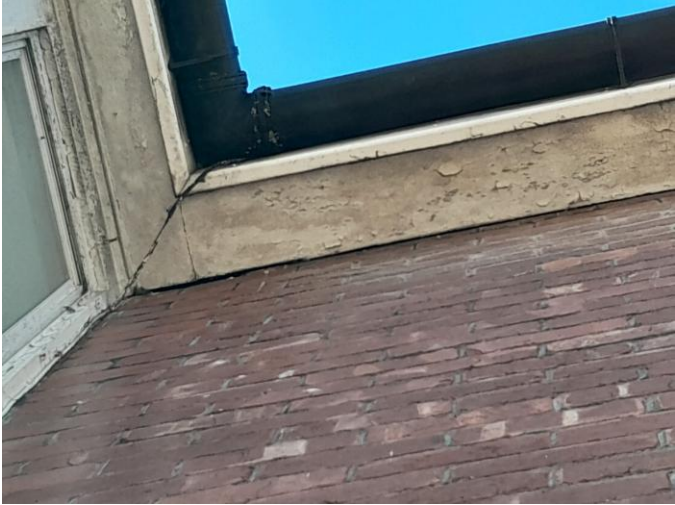
| Feature | Materials | Condition/Suitability | Photographs |
|---|---|---|---|
| Soffit/Fascia | PVC | The PVC eaves and soffits show minor defects with small gaps or wear, potentially offering roosting opportunities. | <p><i>Gap between soffit and wall</i></p> |

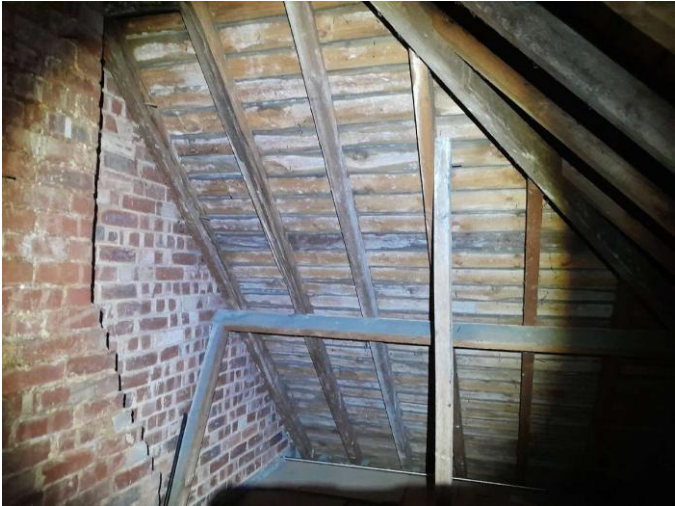
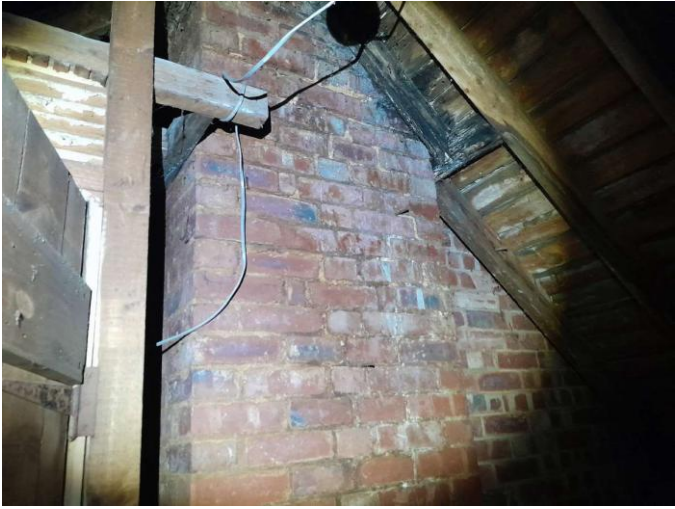
| | Voids | Timber Boards | One internal void was recorded. | <div><p><i>void</i></p><p><i>void</i></p></div> |
