# OAKLANDS STUD FARM, FOREST GRANGE, WEST SUSSEX, RH13 6HX

Landscape and Visual Impact Assessment (LVIA) Appendix I Viewpoints I to 5 hla 678 R02

By N Harper BA DipLA CMLI  
June 2026

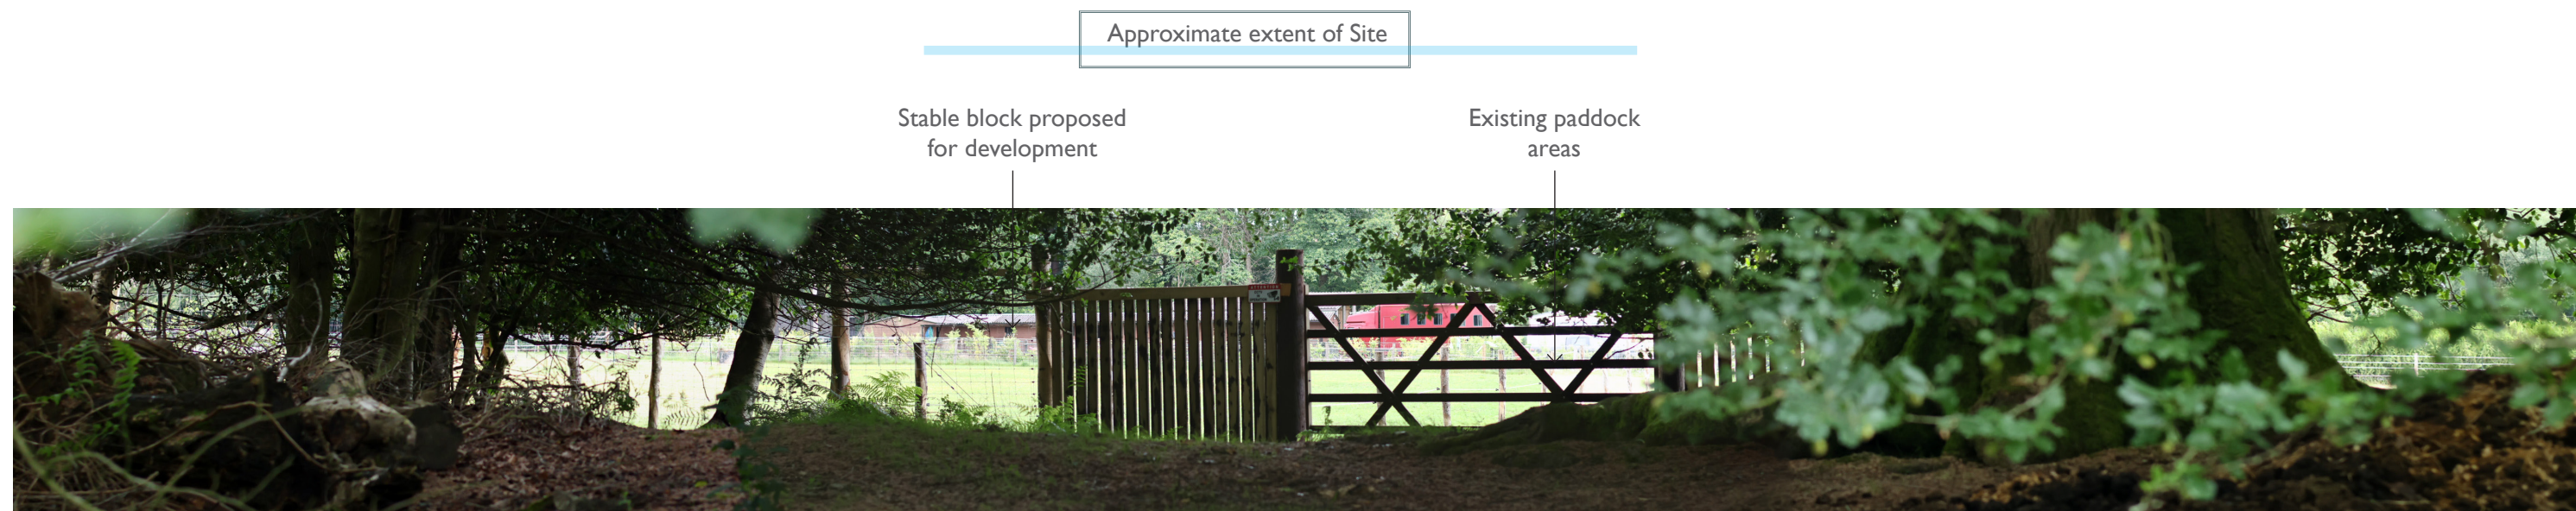
**Figure 2 Viewpoint I**

2.1.1 Location: From a managed path on accessible land located within a private area of woodland approximately 110m north west of the stables.  
GPS ref: 50.07398 N, 0.27095 W.

2.1.3 Existing Views Description: This is a filtered and framed view that partially sees the stable block, parked vehicles and the enclosing post and wire fencing. The pole barn is entirely screened.

2.1.7 During Construction Magnitude of Impact: **Negligible Adverse** (The construction would be a barely discernible change).

2.1.8 On Completion, Magnitude of Impact: **Negligible Adverse** (The development would be a barely discernible change).

2.1.10 Mitigation: Mitigation is not required although planting on the paddock side of the woodland would strengthen the woodland edge and screen views in long term.

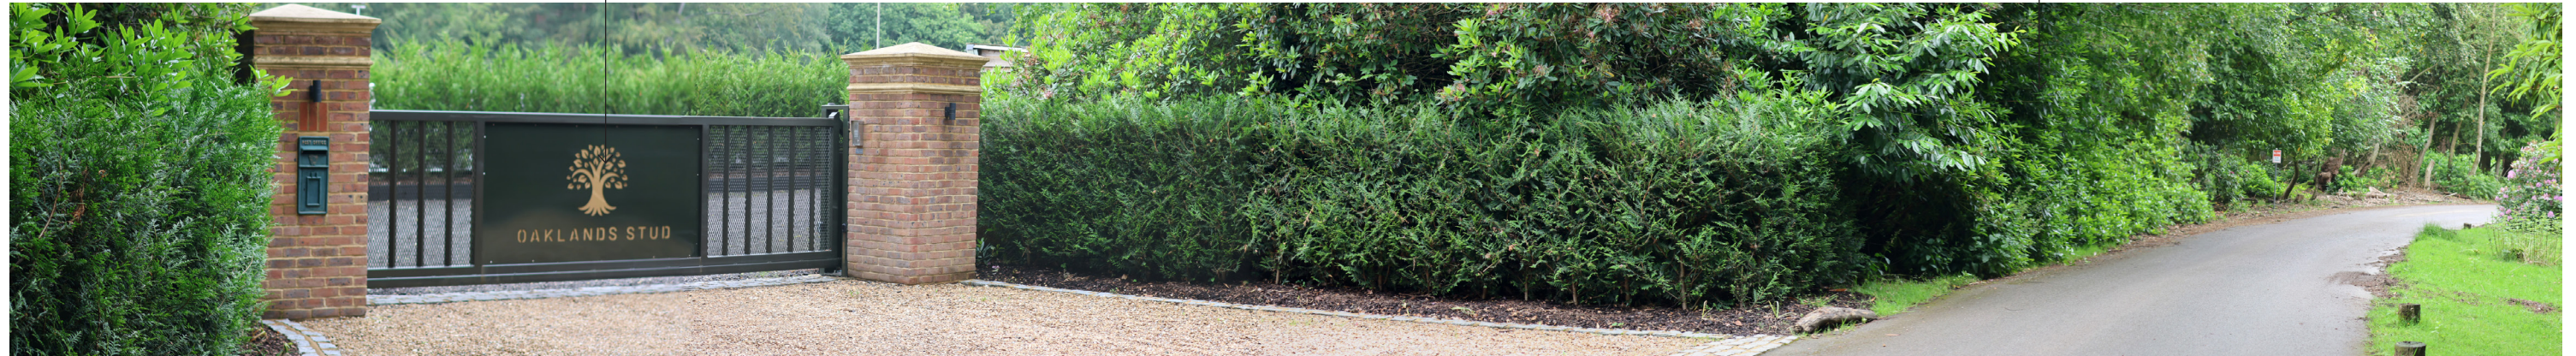
**Figure 5 Viewpoint 4**

Main gates to Oaklands Stud and development area

Main development area screened by intervening vegetation

2.4.1 Location: From private road that gives access to the Site and directly opposite the entrance gates, located approximately 100m south west of the stables.  
GPS ref: 51.07409 N, 0.27111 W

2.4.3 Existing Views Description: This is a foreshortened view from a private road that is strongly influenced by the road surface, the gates to the Site and the surrounding mature planting.

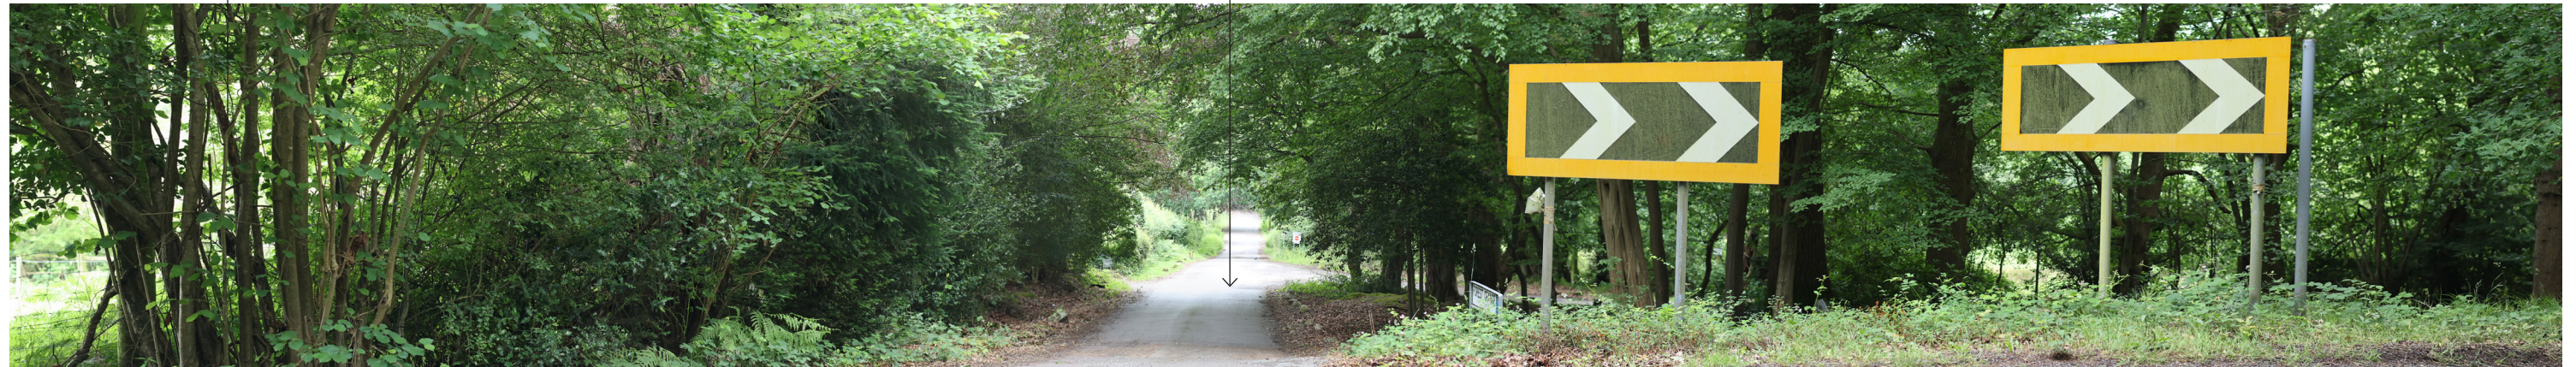
**Figure 6 Viewpoint 5**

Main development area screened  
byond intervening vegetation

Private drive to residential  
estate and Oaklands Stud

2.5.1 Location: From the grass verge on the north side of Forest Road and looking down the private road that gives access to the Site, located approximately 600m north west of the stables.  
GPS ref: 50.07779 N, 0.27668 W.

2.5.3 Existing Views Description: This is an enclosed view from Forest Road that is strongly influenced by the highway and its vehicle movements as well as the surrounding mature woodland planting and the private drive in to the estate. The development area is entirely screened.
