## Preliminary Ecological Appraisal and Roost Assessment

Pinkhurst, Pinkhurst Lane, Slinfold, Horsham, West Sussex, RH13 0QR

This report is prepared to inform a planning application with the Horsham District Council. The proposal is described as: Removal of existing barn / stable structures and erection of a barn for the mixed use of stabling of private horses and the storage of hay / plant and machinery. Creation of a sand school with associated works.

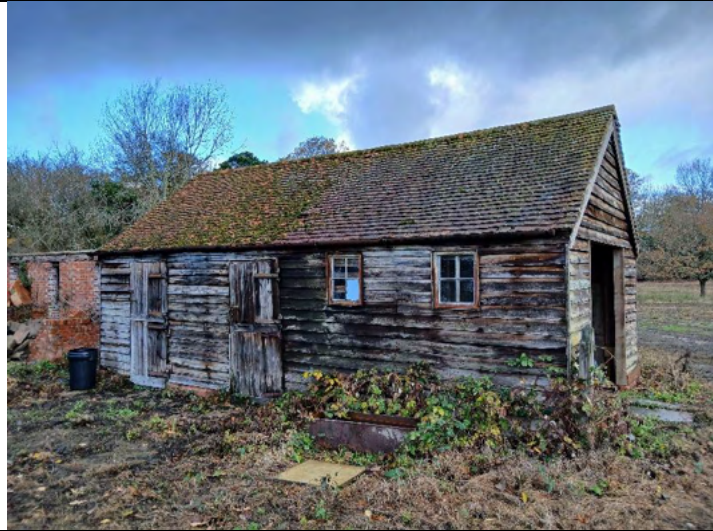
| <b>B4 Building Description</b> | | <b>Photographs</b> |
|---|---|---|
| <p><i>Summary</i></p> <p>B4 is a single storey timber built outbuilding. The walls are timber clad along all elevations. The windows and doors are timber framed. There are timber bargeboards along all elevations. The roof is gable ended with clay tiles. There is one internal void within B4 (see below). No evidence of bats was found on or within B4.</p> <p>The building has <b>low habitat value</b>.</p> | | |

| <p><i>Recommendations</i></p> | <p><b><u>Roosting Habitat [Buildings]</u></b></p> <p>One bat emergence/re-entry surveys is required on B4 and B5 during the active bat season (May – September) to confirm presence/likely-absence of bats roosting in or on the building. These survey visits should be completed during the optimal survey period mid-May to August inclusive.</p> <p>Three surveyors are required to provide full coverage of the building's elevations to look for emerging/re-entering bats. Surveyors will be equipped with infrared cameras to see where any specific roost locations are located.</p> <p>If a bat is seen emerging from the building on the survey visit, an additional two bat emergence/re-entry surveys will be required. If any bat roosts are confirmed from this survey schedule, a bat license would be required to demolish the buildings as it would involve the destruction</p> |

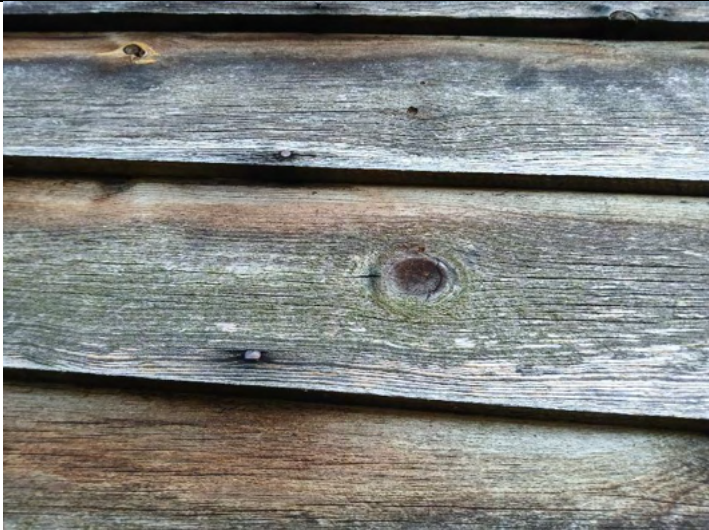
| Timber clad walls | <p><b>Condition/Description</b></p> <p>Generally in good condition with tightly sealed timber boards.</p> <p><b>Suitability/Access/Evidence of Bats</b></p> <p>N/A</p> | |

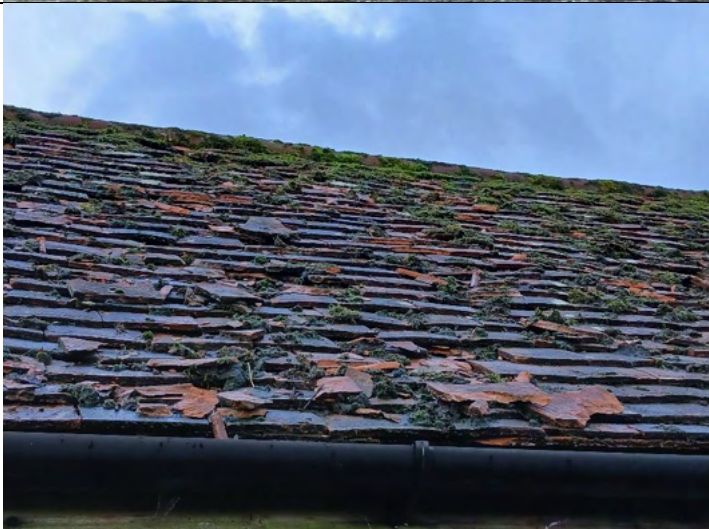
| Clay tiles | <p><b>Condition/Description</b></p> <p>Multiple slipped and broken tiles.</p> <p><b>Suitability/Access/Evidence of Bats</b></p> <p>Provides opportunities for crevice dwelling species.</p> | |

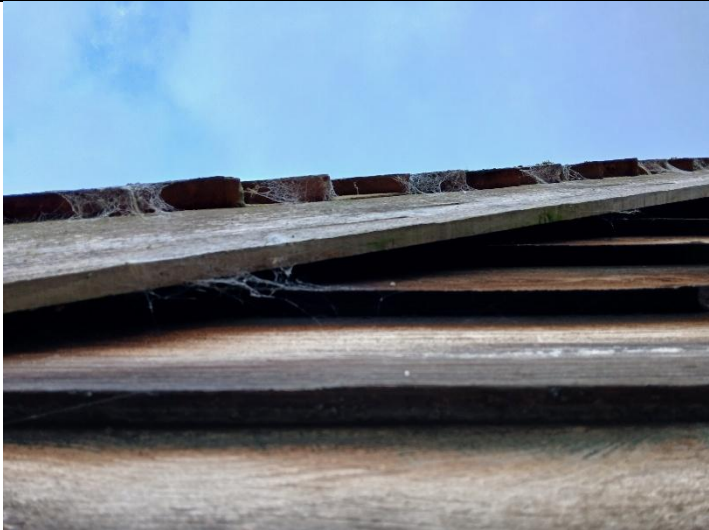
| Timber<br>bargeboards | <p><b>Condition/Description</b></p> <p>Linear bargeboard gap along the eastern and western elevations.</p> <p><b>Suitability/Access/Evidence of Bats</b></p> <p>Provides opportunities for crevice dwelling species.</p> | |

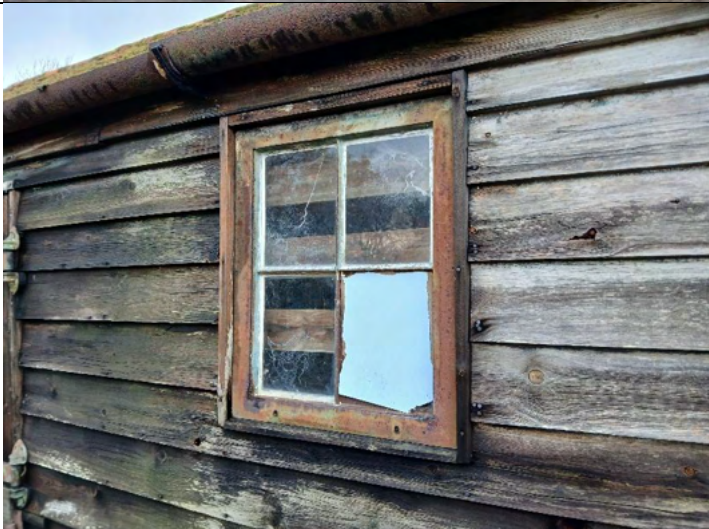
| Timber framed<br>window/doors | <p><b>Condition/Description</b></p> <p>Tightly sealed.</p> <p><b>Suitability/Access/Evidence of Bats</b></p> <p>N/A</p> | |

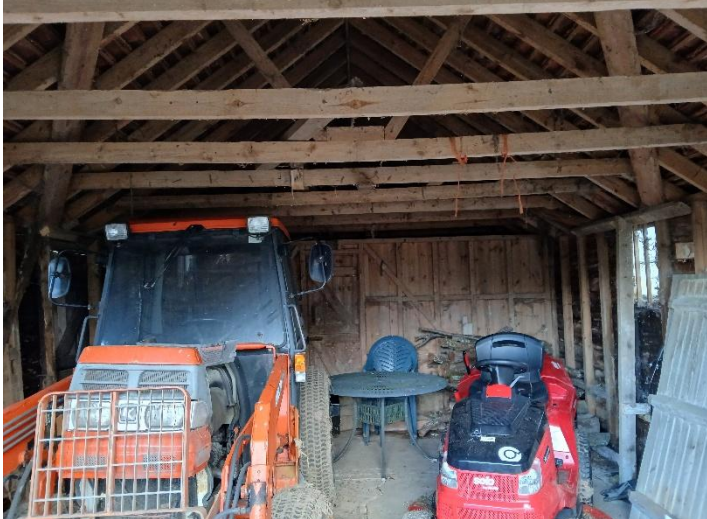
| Internal voids | <p><b>Condition/Description</b></p> <p>There is an internal void within B4. The void is used for the storage of garden equipment. Its roof is unlined. The building is supported by timber beams.</p> <p><b>Suitability/Access/Evidence of Bats</b></p> <p>No evidence of bats was found within B4. There are several ingress points into the void via slipped tiles, however no suitable roosting features were identified within B4. The ingress of large volumes of light further limits the suitability for roosting bats.</p> | |

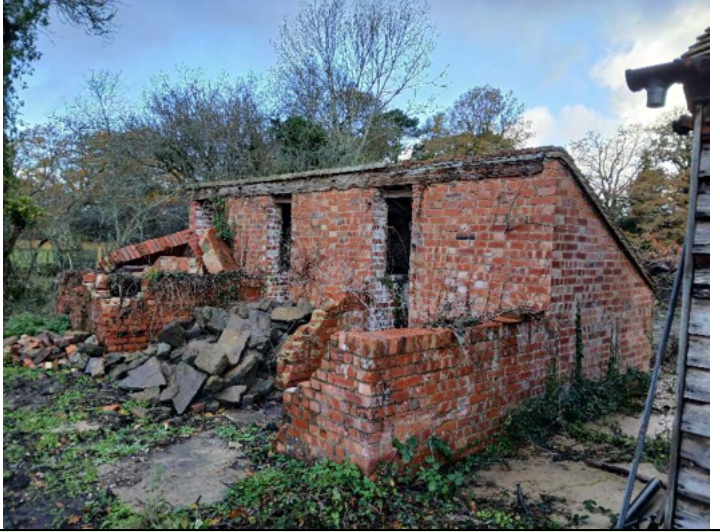
| <p><i>Summary</i></p> <p>B5 is a single storey brick built outbuilding. The walls are unrendered along all elevations. The roof is gable ended with clay tiles. There is one internal void within B5 (see below). No evidence of bats was found on or within B5.</p> <p>The building has <b>low habitat value</b>.</p> | | |

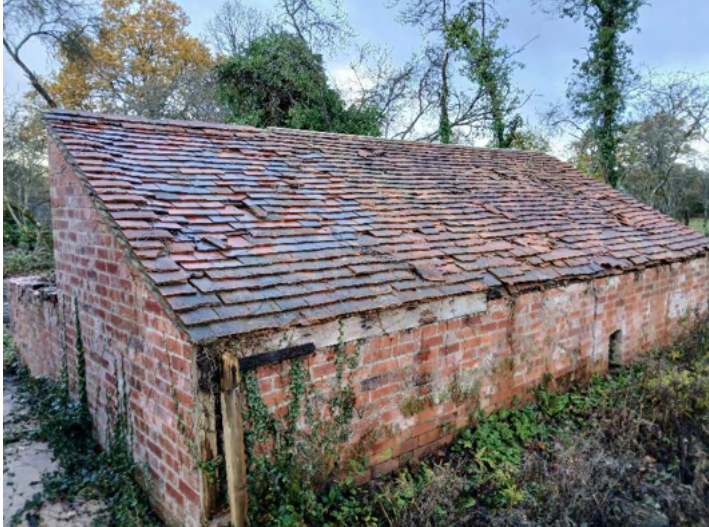
| Clay tiles | <p><b>Condition/Description</b></p> <p>Multiple slipped and broken tiles.</p> <p><b>Suitability/Access/Evidence of Bats</b></p> <p>Provides opportunities for crevice dwelling species.</p> | A photograph showing the exterior of a brick building with a gabled roof covered in clay tiles. Some tiles are missing or broken, and the brickwork is weathered and partially covered in ivy. |

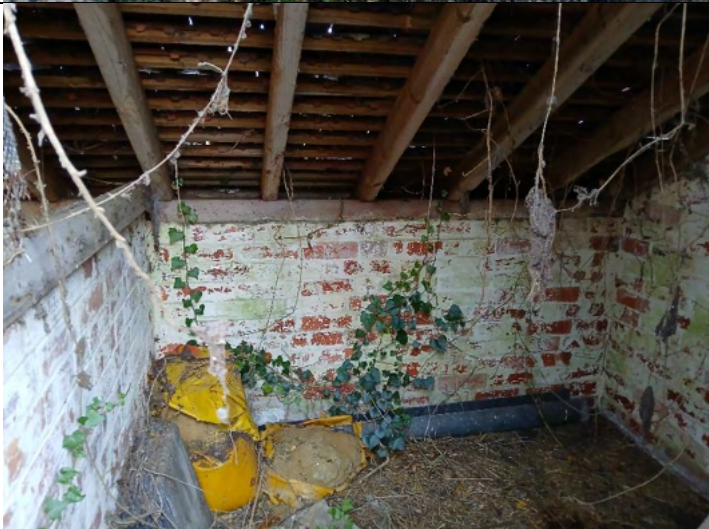
| Internal voids | <p><b>Condition/Description</b></p> <p>There is an internal void within B5. The void acts as an inactive stable building. The roof is unlined and is supported with timber beams.</p> <p><b>Suitability/Access/Evidence of Bats</b></p> <p>No evidence of bats was found within B5. There are several ingress points into the void via slipped tiles and open doors however no suitable roosting features were identified within B5. The ingress of large volumes of light further limits the suitability for roosting bats.</p> | A photograph showing the interior of a void space. The ceiling is supported by a network of wooden timber beams. The walls are made of brick and have peeling white paint. There is some debris and a yellow bag on the floor. |

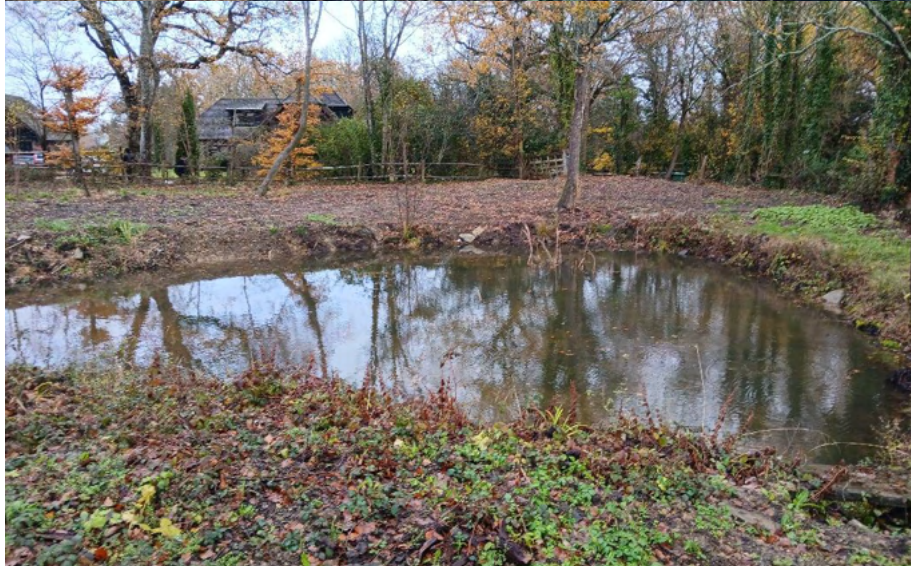
*Figure 30. P1.*

There is one non-priority pond located within the garden. P1 is located to the north of B1 and covers an area of approximately 166m<sup>2</sup>. P1 does not have semi natural habitat surrounding the entirety of the pond. No duckweed or filamentous algae was observed within the pond. P1 is further described in the amphibian section below.

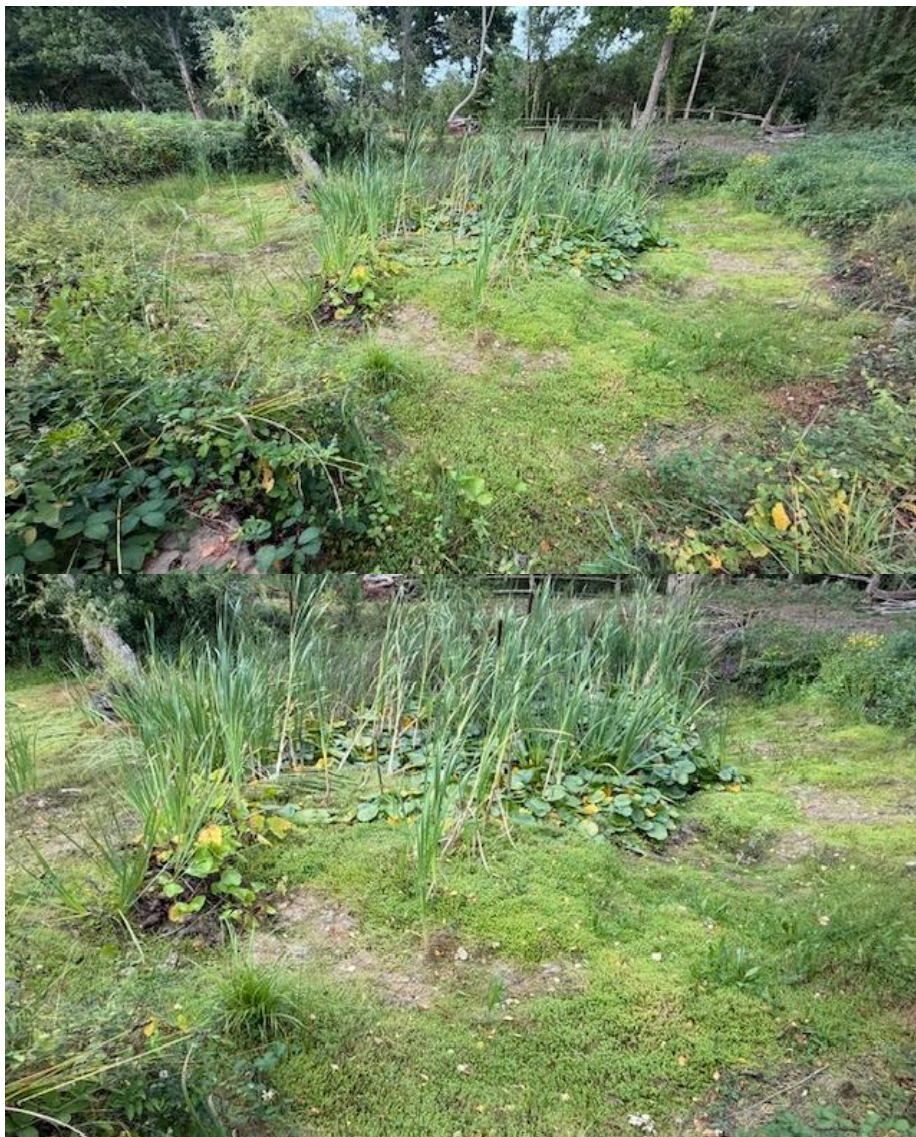
| <i>Foreseen Impacts</i> | <p>When georeferencing the proposed development plans over scaled mapping of the site, it is noted that the development area is likely to result in the further loss or significant disturbance of 0.1105ha of suitable great crested newt habitat (i.e. vegetated garden). If great crested newts are present within P1, this will constitute a loss of 0.1105ha within 100m of a potential breeding pond. When completing the rapid risk assessment published by Natural England (Natural England 2015), the proposed development produces an Amber risk score, which states: Offence Likely. <b>However, P1 has been observed by the landowners to dry out fully each summer, resulting in negligible suitability for breeding amphibians, as seen in photos 31-34.</b></p> |

*Figure 31. P1 dried out.*

*Figure 32. P1 dried out.*

| <i>Recommendations</i> | <p>Due to the result of the HSI assessment and the fact that P1 dries out every summer, P1 is deemed to provide negligible opportunities for great crested newts. Owing to the nature of the proposed development and the low potential for impacts to great crested newts, further surveys are considered to be disproportionate. A precautionary working method will be implemented for common amphibians during construction, including the following measures:</p> <ul style="list-style-type: none"> <li>• Vegetation will be maintained at a short sward height (&lt;5cm) to discourage amphibians. The vegetation can then be cleared to ground level and must be maintained at this level for the duration of construction to deter amphibians from the working area.</li> <li>• Any rubble piles will be dismantled by hand and debris and brash will be stored on pallets or removed from the site to prevent amphibians from utilising these areas.</li> <li>• Any excavations will be covered overnight, or a ramp will be installed to enable any trapped animals to escape.</li> <li>• Best practice pollution prevention measures will be implemented to minimise impacts to nearby habitats.</li> <li>• Any chemicals or pollutants used or created by the development should be stored and disposed of correctly according to COSHH regulations.</li> <li>• If any amphibians are found in the working area these should be allowed to disperse of their own accord or, if at immediate risk, should be moved by hand to a sheltered, vegetated area away from disturbance.</li> <li>• In the unlikely event that a great crested newt is identified, works must cease and advice must be sought from a suitably qualified ecologist.</li> </ul> <p><b><u>Suggested Biodiversity Enhancements</u></b></p> <p>The site could be enhanced for amphibians post-development through creation of amphibian hibernacula using rubble and logs from site clearance. Information on how to construct a hibernaculum can be found here: <a href="https://www.wiltshirewildlife.org/hibernaculum">https://www.wiltshirewildlife.org/hibernaculum</a></p> |

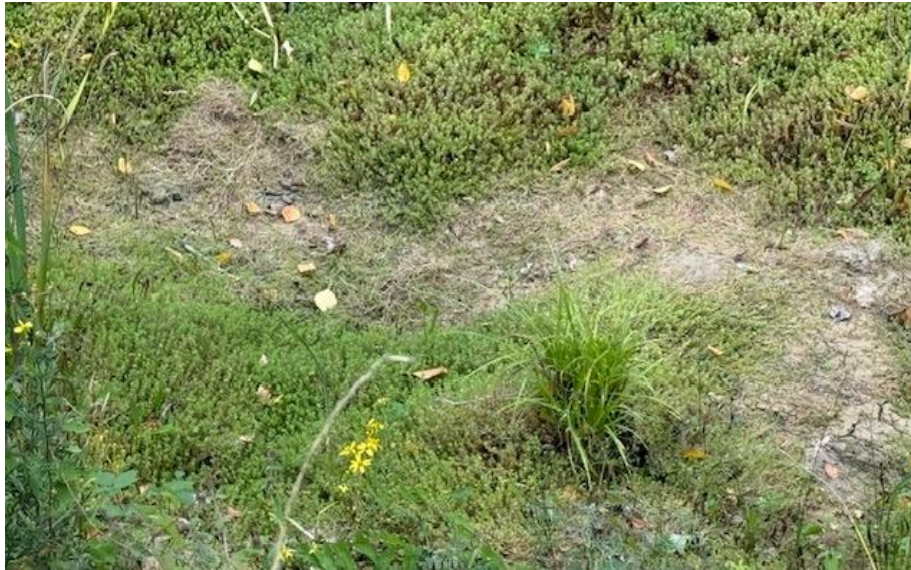
*Figure 33. P1 dried out.*

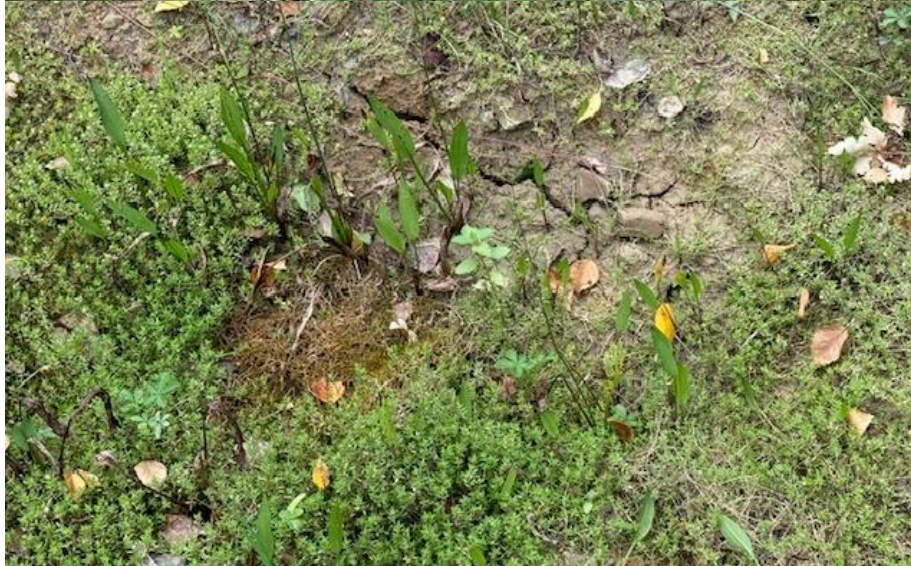
*Figure 34. P1 dried out.*
