## Preliminary Ecological Appraisal and Roost Assessment

Pinkhurst, Pinkhurst Lane, Slinfold, Horsham, West Sussex, RH13 0QR

This report is prepared to inform a planning application with the Horsham District Council. The proposal is described as: Removal of existing barn / stable structures and erection of a barn for the mixed use of stabling of private horses and the storage of hay / plant and machinery. Creation of a sand school with associated works.

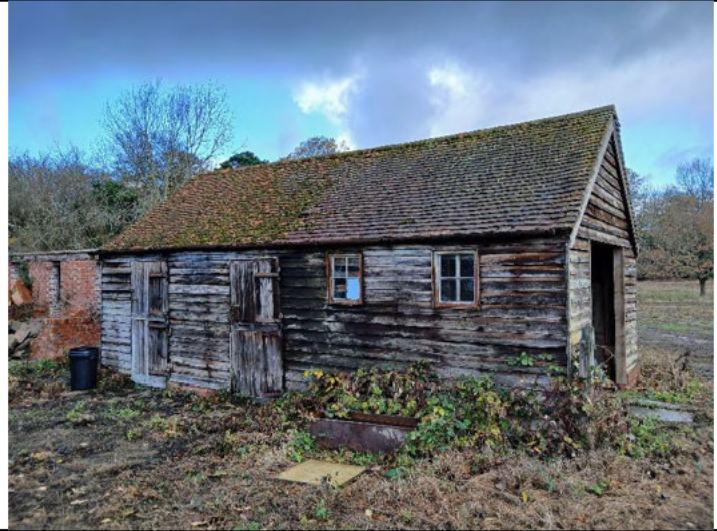
| <b>B4 Building Description</b> | | <b>Photographs</b> |
|---|---|---|
| <p><i>Summary</i></p> <p>B4 is a single storey timber built outbuilding. The walls are timber clad along all elevations. The windows and doors are timber framed. There are timber bargeboards along all elevations. The roof is gable ended with clay tiles. There is one internal void within B4 (see below). No evidence of bats was found on or within B4.</p> <p>The building has <b>low habitat value</b>.</p> | | |

| <p><i>Recommendations</i></p> | <p><b><u>Roosting Habitat [Buildings]</u></b></p> <p>One bat emergence/re-entry surveys is required on B4 and B5 during the active bat season (May – September) to confirm presence/likely-absence of bats roosting in or on the building. These survey visits should be completed during the optimal survey period mid-May to August inclusive.</p> <p>Three surveyors are required to provide full coverage of the building's elevations to look for emerging/re-entering bats. Surveyors will be equipped with infrared cameras to see where any specific roost locations are located.</p> <p>If a bat is seen emerging from the building on the survey visit, an additional two bat emergence/re-entry surveys will be required. If any bat roosts are confirmed from this survey schedule, a bat license would be required to demolish the buildings as it would involve the destruction</p> |

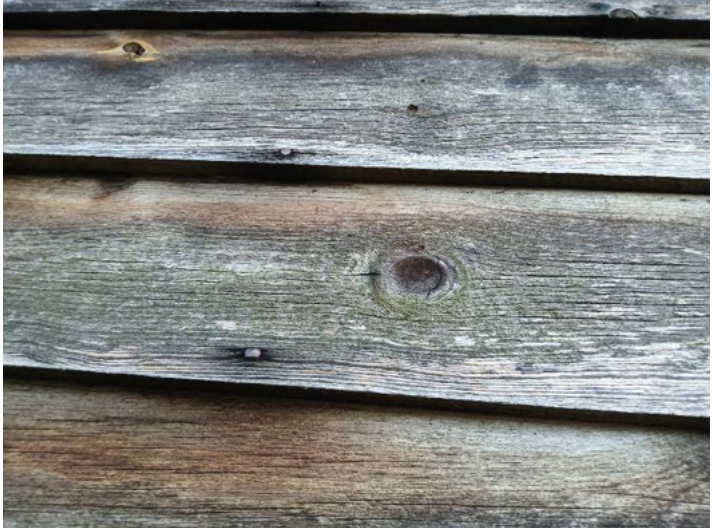
| Timber clad walls | <p><b>Condition/Description</b></p> <p>Generally in good condition with tightly sealed timber boards.</p> <p><b>Suitability/Access/Evidence of Bats</b></p> <p>N/A</p> | |

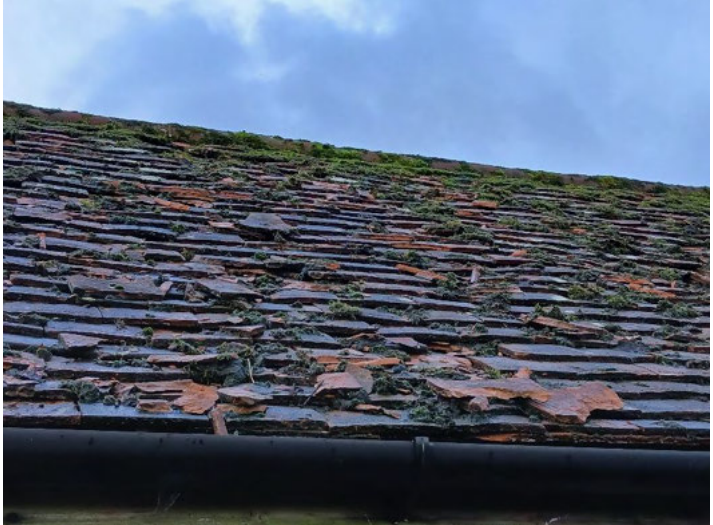
| Clay tiles | <p><b>Condition/Description</b></p> <p>Multiple slipped and broken tiles.</p> <p><b>Suitability/Access/Evidence of Bats</b></p> <p>Provides opportunities for crevice dwelling species.</p> | |

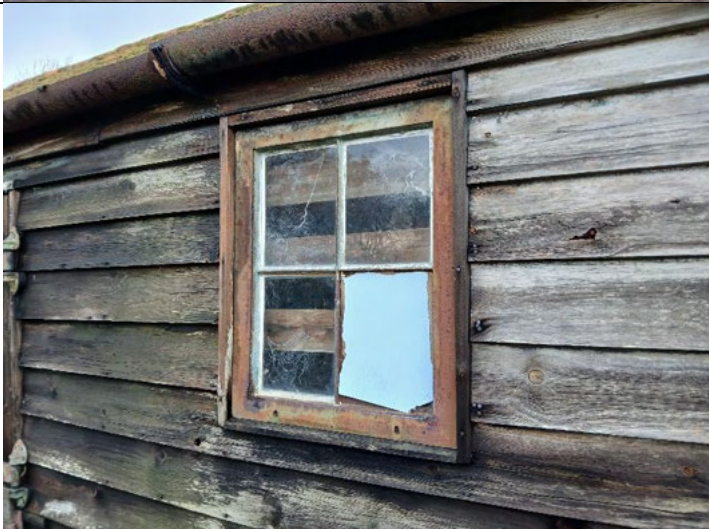
| Timber framed<br>window/doors | <p><b>Condition/Description</b></p> <p>Tightly sealed.</p> <p><b>Suitability/Access/Evidence of Bats</b></p> <p>N/A</p> | |

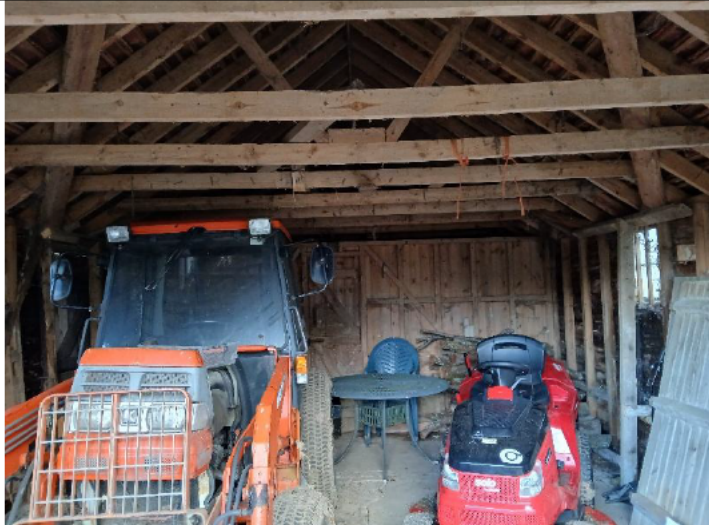
| Internal voids | <p><b>Condition/Description</b></p> <p>There is an internal void within B4. The void is used for the storage of garden equipment. Its roof is unlined. The building is supported by timber beams.</p> <p><b>Suitability/Access/Evidence of Bats</b></p> <p>No evidence of bats was found within B4. There are several ingress points into the void via slipped tiles, however no suitable roosting features were identified within B4. The ingress of large volumes of light further limits the suitability for roosting bats.</p> | A photograph showing the interior of a wooden building with a high, vaulted roof supported by numerous timber beams. An orange tractor is parked on the left, and a red lawnmower is parked on the right. The floor is concrete, and there is some debris and a blue plastic chair in the background. |

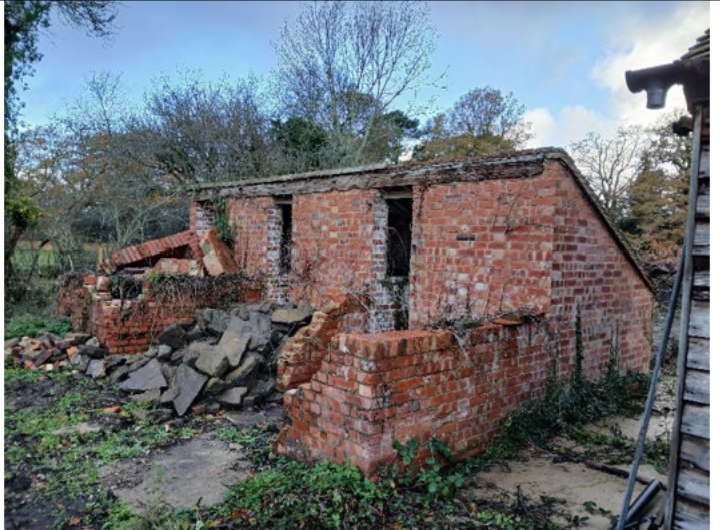
| <p><i>Summary</i></p> <p>B5 is a single storey brick built outbuilding. The walls are unrendered along all elevations. The roof is gable ended with clay tiles. There is one internal void within B5 (see below). No evidence of bats was found on or within B5.</p> <p>The building has <b>low habitat value</b>.</p> | | |

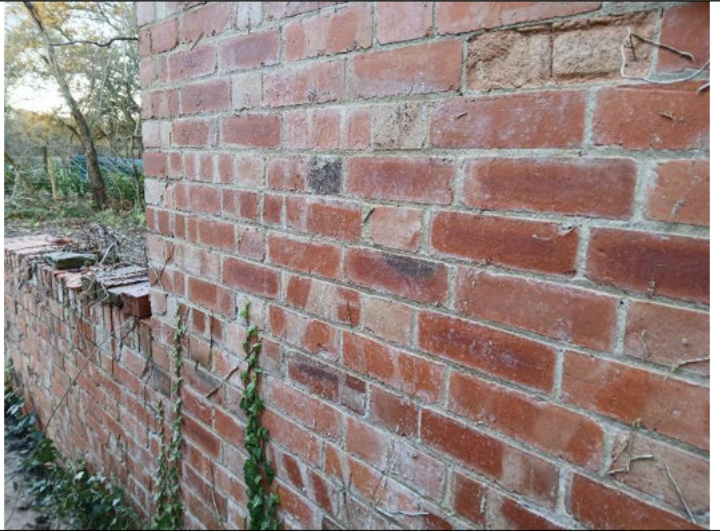
| <p><i>Summary</i></p> <p>B5 is a single storey brick built outbuilding. The walls are unrendered along all elevations. The roof is gable ended with clay tiles. There is one internal void within B5 (see below). No evidence of bats was found on or within B5.</p> <p>The building has <b>low habitat value</b>.</p> | | |
|---|---|---|
| Brick built walls | <p><b>Condition/Description</b></p> <p>No cracks or gaps.</p> <p><b>Suitability/Access/Evidence of Bats</b></p> <p>N/A</p> | |

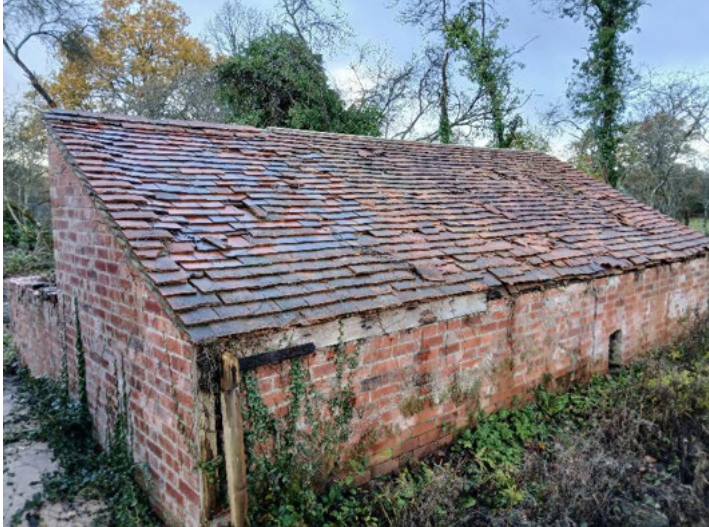
| Clay tiles | <p><b>Condition/Description</b></p> <p>Multiple slipped and broken tiles.</p> <p><b>Suitability/Access/Evidence of Bats</b></p> <p>Provides opportunities for crevice dwelling species.</p> | A photograph showing the exterior of a small, single-story brick building. The roof is covered in reddish-brown clay tiles, many of which appear to be missing or broken. The brickwork is weathered and partially covered in ivy. The building is surrounded by trees and some low-lying vegetation. |

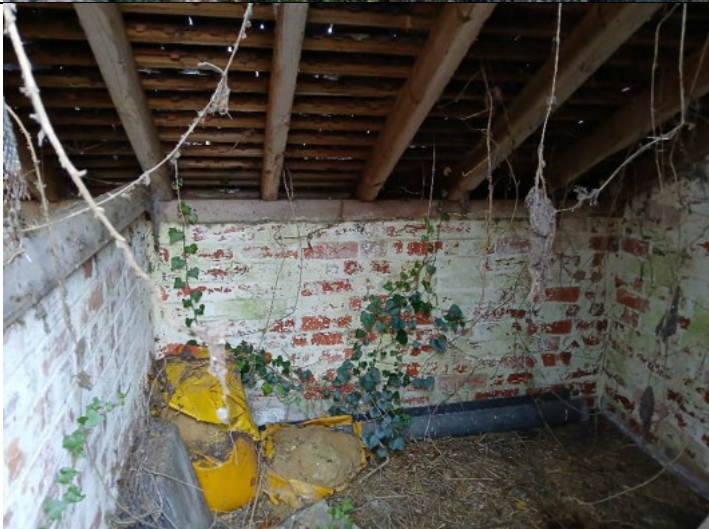
| Internal voids | <p><b>Condition/Description</b></p> <p>There is an internal void within B5. The void acts as an inactive stable building. The roof is unlined and is supported with timber beams.</p> <p><b>Suitability/Access/Evidence of Bats</b></p> <p>No evidence of bats was found within B5. There are several ingress points into the void via slipped tiles and open doors however no suitable roosting features were identified within B5. The ingress of large volumes of light further limits the suitability for roosting bats.</p> | A photograph showing the interior of a void space. The ceiling is supported by a network of dark wooden timber beams. The walls are made of brick and are heavily covered in ivy. The floor is covered with straw or hay. There are some yellow bags or containers visible in the foreground. |

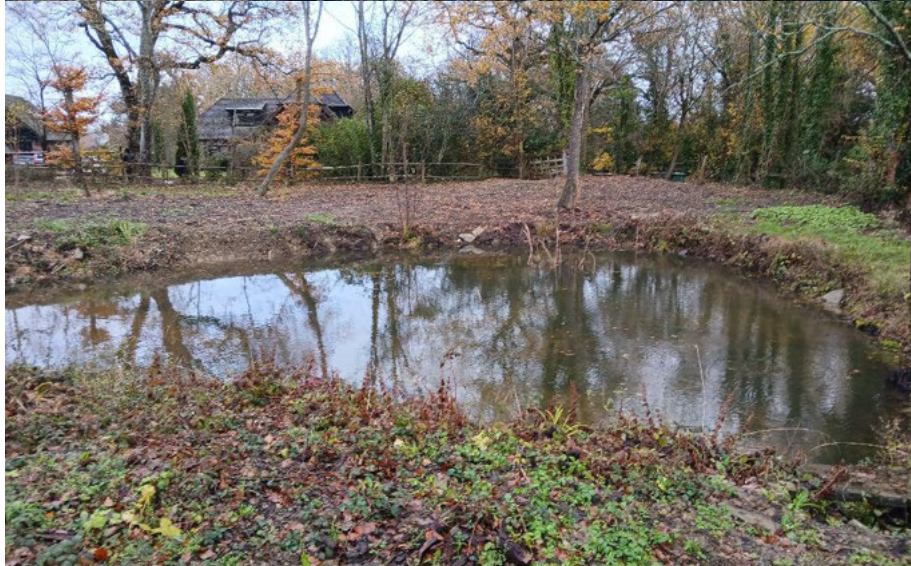
There is one non-priority pond located within the garden. P1 is located to the north of B1 and covers an area of approximately 166m<sup>2</sup>. P1 does not have semi natural habitat surrounding the entirety of the pond. No duckweed or filamentous algae was observed within the pond. P1 is further described in the amphibian section below.

*Figure 30. P1.*

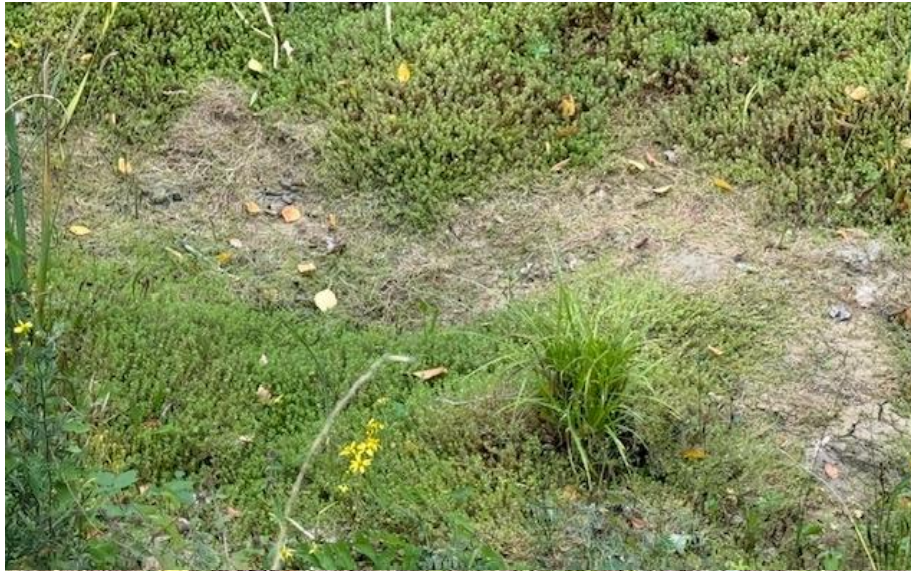
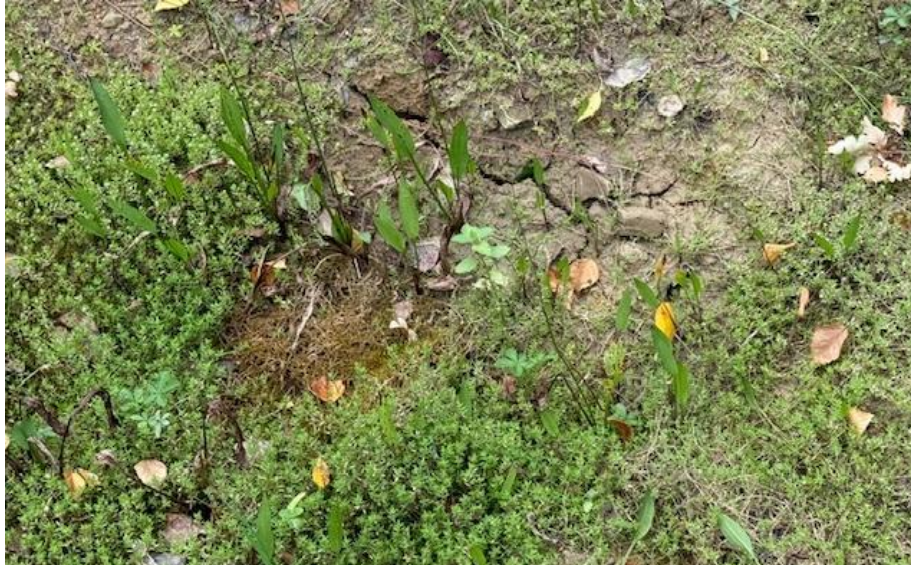
| <i>Foreseen Impacts</i> | <p>When georeferencing the proposed development plans over scaled mapping of the site, it is noted that the development area is likely to result in the further loss or significant disturbance of 0.1105ha of suitable great crested newt habitat (i.e. vegetated garden). If great crested newts are present within P1, this will constitute a loss of 0.1105ha within 100m of a potential breeding pond. When completing the rapid risk assessment published by Natural England (Natural England 2015), the proposed development produces an Amber risk score, which states: Offence Likely. <b>However, P1 has been observed by the landowners to dry out fully each summer, resulting in negligible suitability for breeding amphibians, as seen in photos 31-34.</b></p> |

*Figure 31. P1 dried out.*

*Figure 32. P1 dried out.*

*Figure 33. P1 dried out.*

*Figure 34. P1 dried out.*

| <i>Recommendations</i> | <p>Due to the result of the HSI assessment and the fact that P1 dries out every summer, P1 is deemed to provide negligible opportunities for great crested newts. Owing to the nature of the proposed development and the low potential for impacts to great crested newts, further surveys are considered to be disproportionate. A precautionary working method will be implemented for common amphibians during construction, including the following measures:</p> <ul style="list-style-type: none"> <li>• Vegetation will be maintained at a short sward height (&lt;5cm) to discourage amphibians. The vegetation can then be cleared to ground level and must be maintained at this level for the duration of construction to deter amphibians from the working area.</li> <li>• Any rubble piles will be dismantled by hand and debris and brash will be stored on pallets or removed from the site to prevent amphibians from utilising these areas.</li> <li>• Any excavations will be covered overnight, or a ramp will be installed to enable any trapped animals to escape.</li> <li>• Best practice pollution prevention measures will be implemented to minimise impacts to nearby habitats.</li> <li>• Any chemicals or pollutants used or created by the development should be stored and disposed of correctly according to COSHH regulations.</li> <li>• If any amphibians are found in the working area these should be allowed to disperse of their own accord or, if at immediate risk, should be moved by hand to a sheltered, vegetated area away from disturbance.</li> <li>• In the unlikely event that a great crested newt is identified, works must cease and advice must be sought from a suitably qualified ecologist.</li> </ul> <p><u>Suggested Biodiversity Enhancements</u></p> <p>The site could be enhanced for amphibians post-development through creation of amphibian hibernacula using rubble and logs from site clearance. Information on how to construct a hibernaculum can be found here: <a href="https://www.wiltshirewildlife.org/hibernaculum">https://www.wiltshirewildlife.org/hibernaculum</a></p> |
