# **Land North of East Street, Rusper**

**Ground Investigation Report**

| ISSUE RECORD | | | | | |
|---|---|---|---|---|---|
| Report Reference: 2509007.001.01 | | | | | |

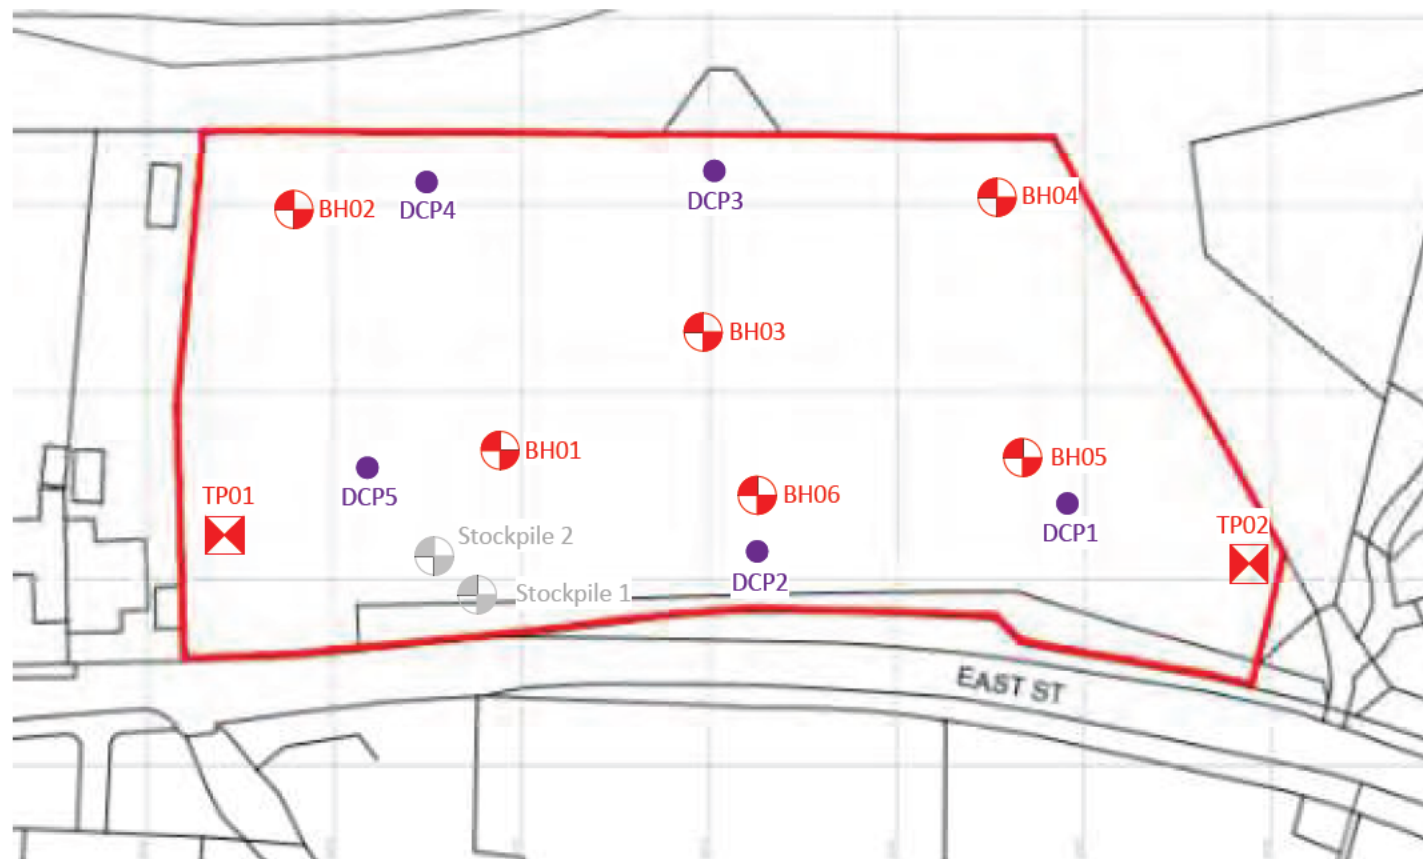
3.3.2 Exploratory hole locations are presented on Figure 3 and detailed descriptions of encountered ground conditions are shown on exploratory hole logs presented in Appendix C.

4.1.1 The fieldwork was undertaken between 16<sup>th</sup> and 17<sup>th</sup> October 2025. The depths of the exploratory holes, descriptions of strata encountered and comments on the groundwater conditions are summarised below while detailed descriptions are shown on exploratory hole logs presented in Appendix C. The locations of the exploratory holes are shown on Figure 3.

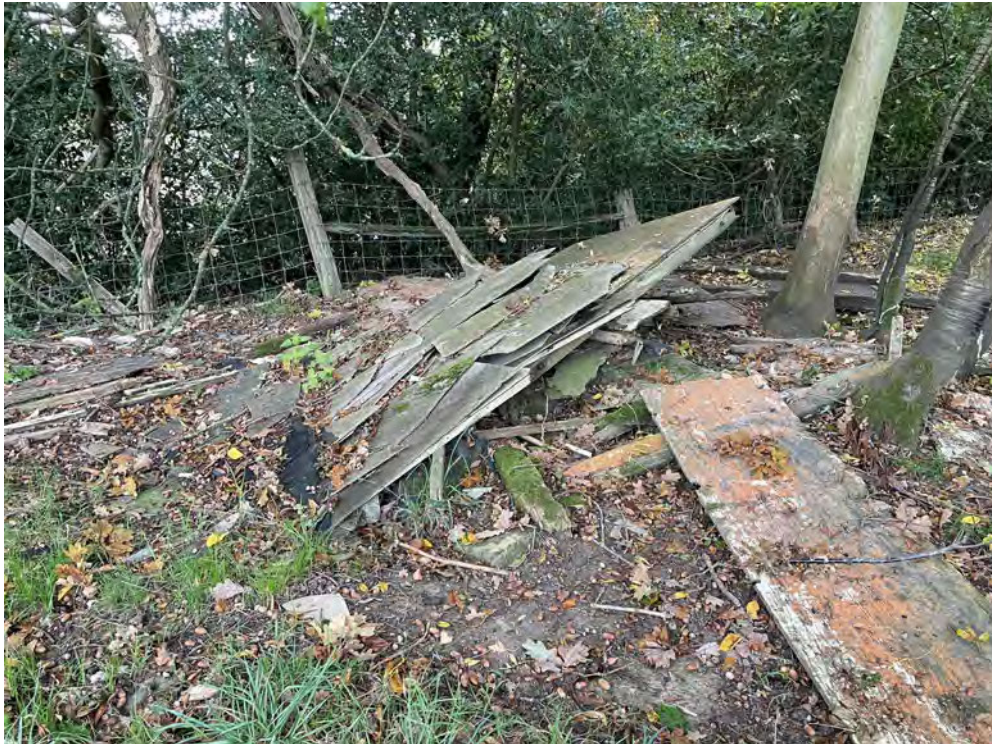
Photograph 1: View of stockpile 1, mainly potential asbestos containing material (old roofing sheets) within the southwestern area of the site.

| Feature | Description |
|---|---|
| <b>Fuel, Hazardous Chemicals and Waste Materials Storage</b> | No evidence of ASTs, USTs, or chemical storage was noted during the site walkover. However, 2No. stockpiles were identified to the southwest along the southern boundary of the site. Stockpile 1 (Photograph 1) consisted of a small pile of potential asbestos containing sheeting. Stockpile 2 (Photograph 2) was measured to be 2m wide by 5m long by 1m high, consisting of limestone brick, red brick, wood, potential asbestos sheeting, tile, ceramics, charcoal, asphalt, slate, glass, rubber roofing, plastic piping, and concrete. |
| <b>Evidence of Potential Contamination</b> | With the exception of the potentially contaminative materials associated with the stockpiles (ACM), no visual or olfactory evidence of contamination was noted on the ground surface during the site reconnaissance. |

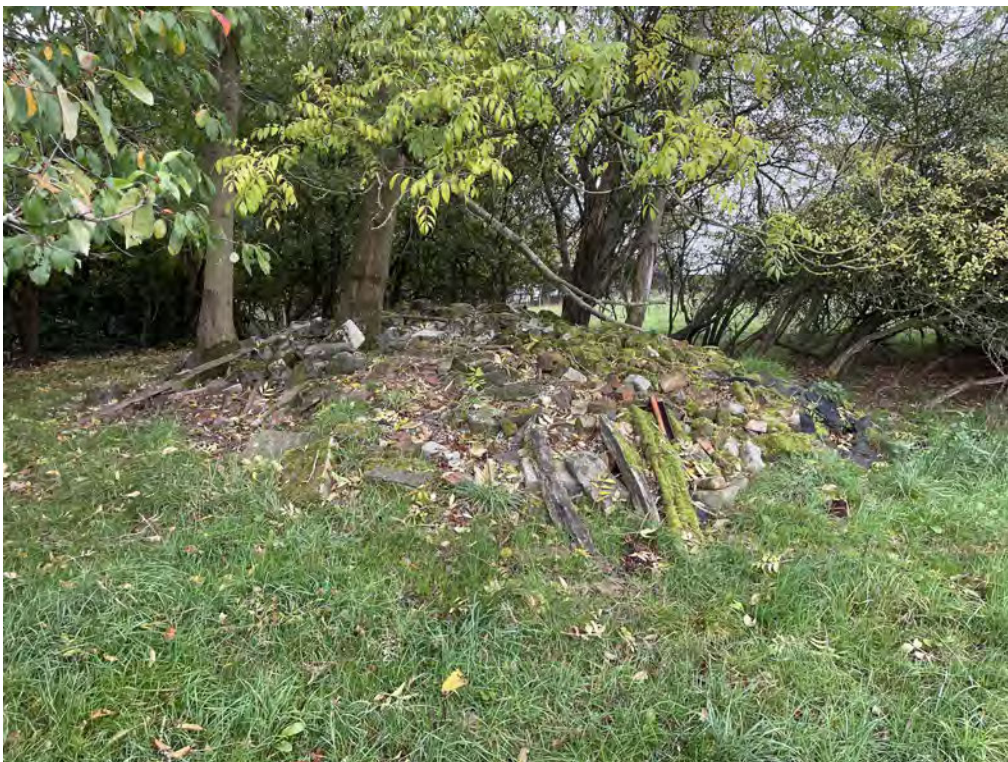
Photograph 2: View of stockpile 2, containing material of limestone brick, red brick, wood, asbestos sheeting, tile, ceramics, charcoal, asphalt, slate, glass, rubber, roofing, plastic piping, and concrete within the southwestern area of the site.

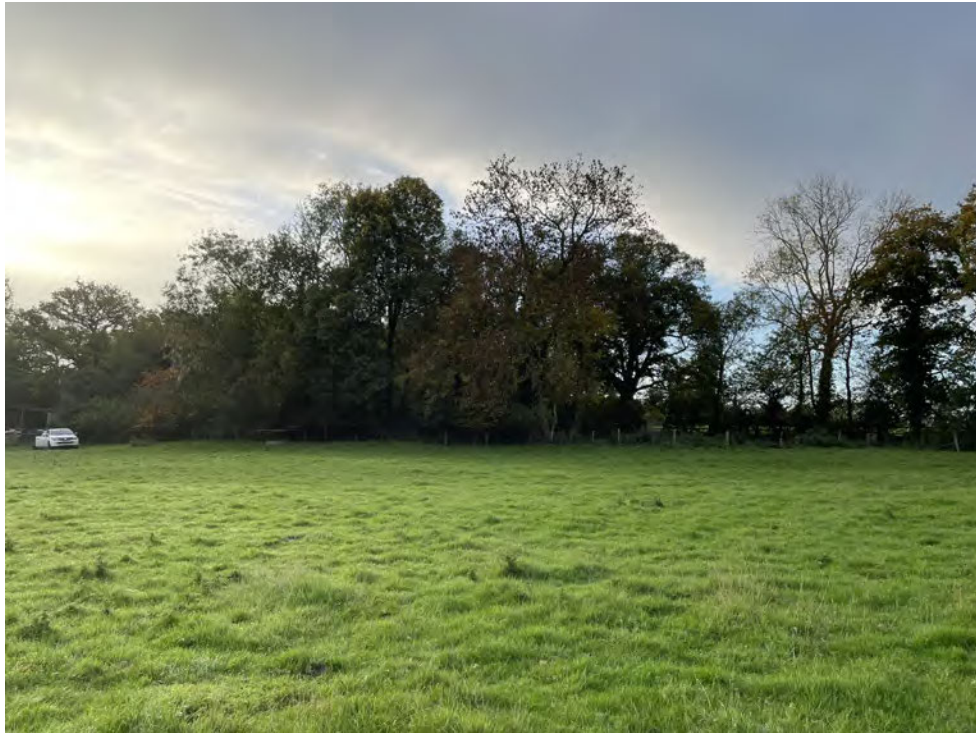
Photograph 5: View of existing soft landscaping and southern site boundary, facing south. Gap in treeline indicates location of felled trees.

| Feature | Description |
|---|---|
| <b>Trees</b> | The northern, eastern and southern boundaries are bordered by mature and semi mature deciduous trees and shrubs (Photographs 3, 4 and 5). Evidence of felled mature trees was noted along the southern boundary, indicated by large tree stumps. |

- 7.5.2 A number of large mature trees were observed along the southern boundary of the site, as well as a small number of mature trees along the northern boundary. Whilst a full desiccation assessment in accordance with the methods outline in BRE Digest 412 'Desiccation in Clay Soils' (1996) has not been undertaken as part of this phase of works, an initial assessment of the potential for desiccation has been completed and the following comments are made with respect to the potential for desiccation to be present in the shallow soils:

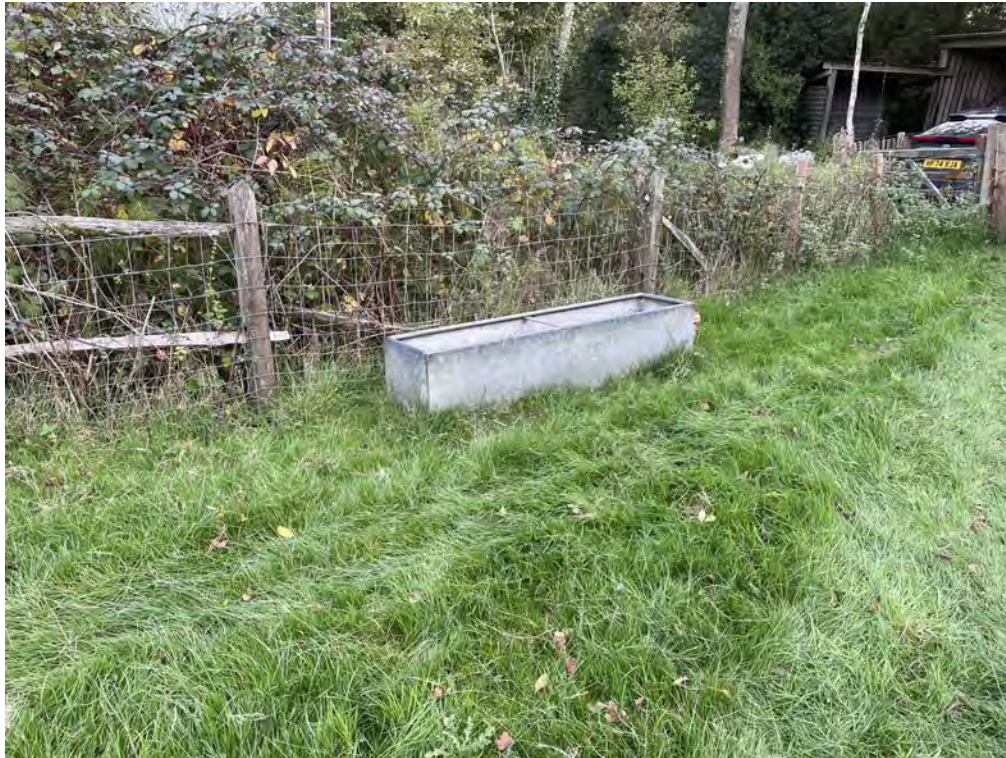
Photograph 7: View of metal feeding trough to the southeastern corner of the site.

| Feature | Description |
|---|---|
| <b>General</b> | 3No. rectangular concrete service covers were noted in an east-west direction to the west of the site. However, no identification markings were found.<br><br>2No. metal feeding trough (Photograph 7) and 1No. circular metal feeder (Photograph 8) were observed to the southeast of the site in proximity to the site entrance. |

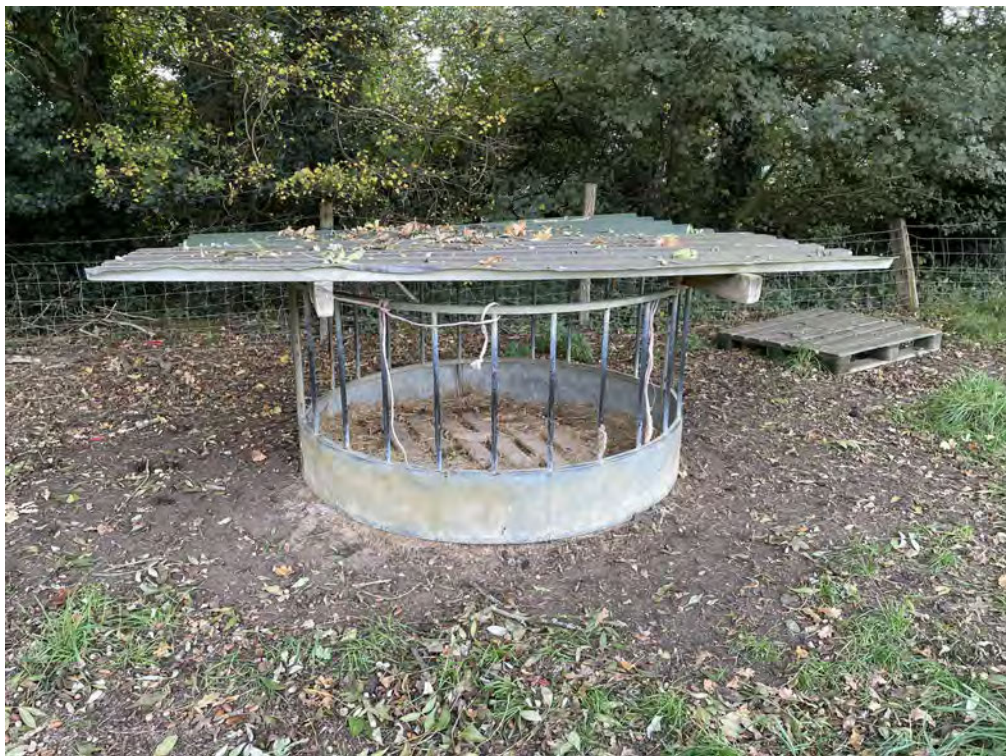
Photograph 8: View of circular feeder to the southeastern area of the site.

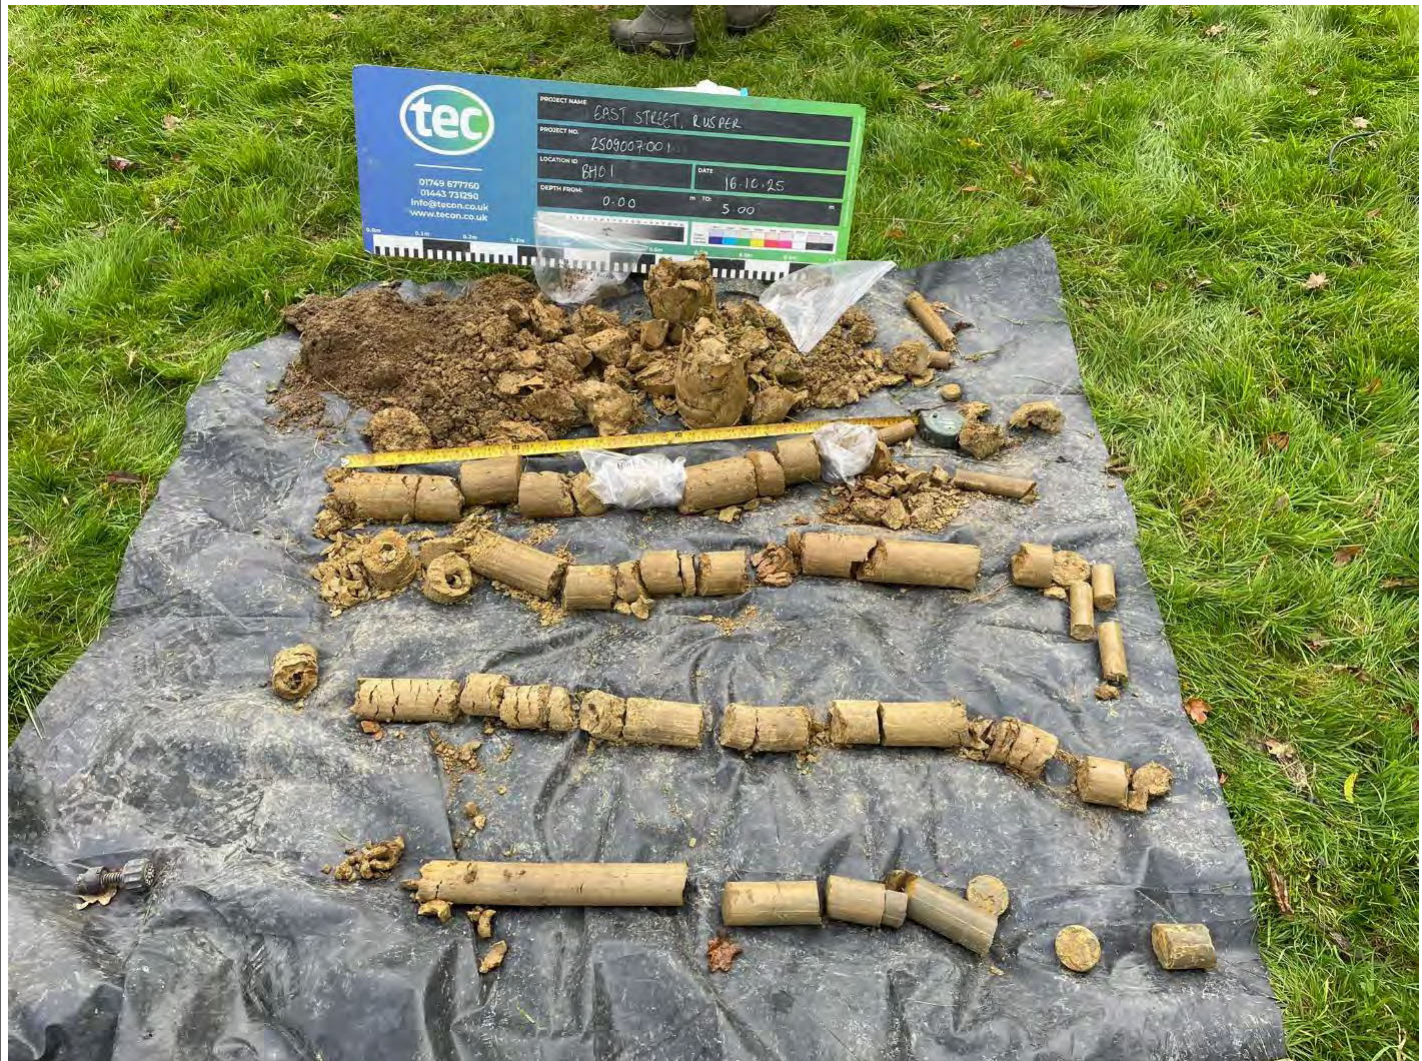
| Remarks<br>Terminated at 5m due to SPT refusal.<br>No groundwater encountered. | Method, Plant, Stability, Dimensions<br>0.00 - 5.00m WLS Archway Lightweight<br>Inclination: 90° | Logger<br>AT |

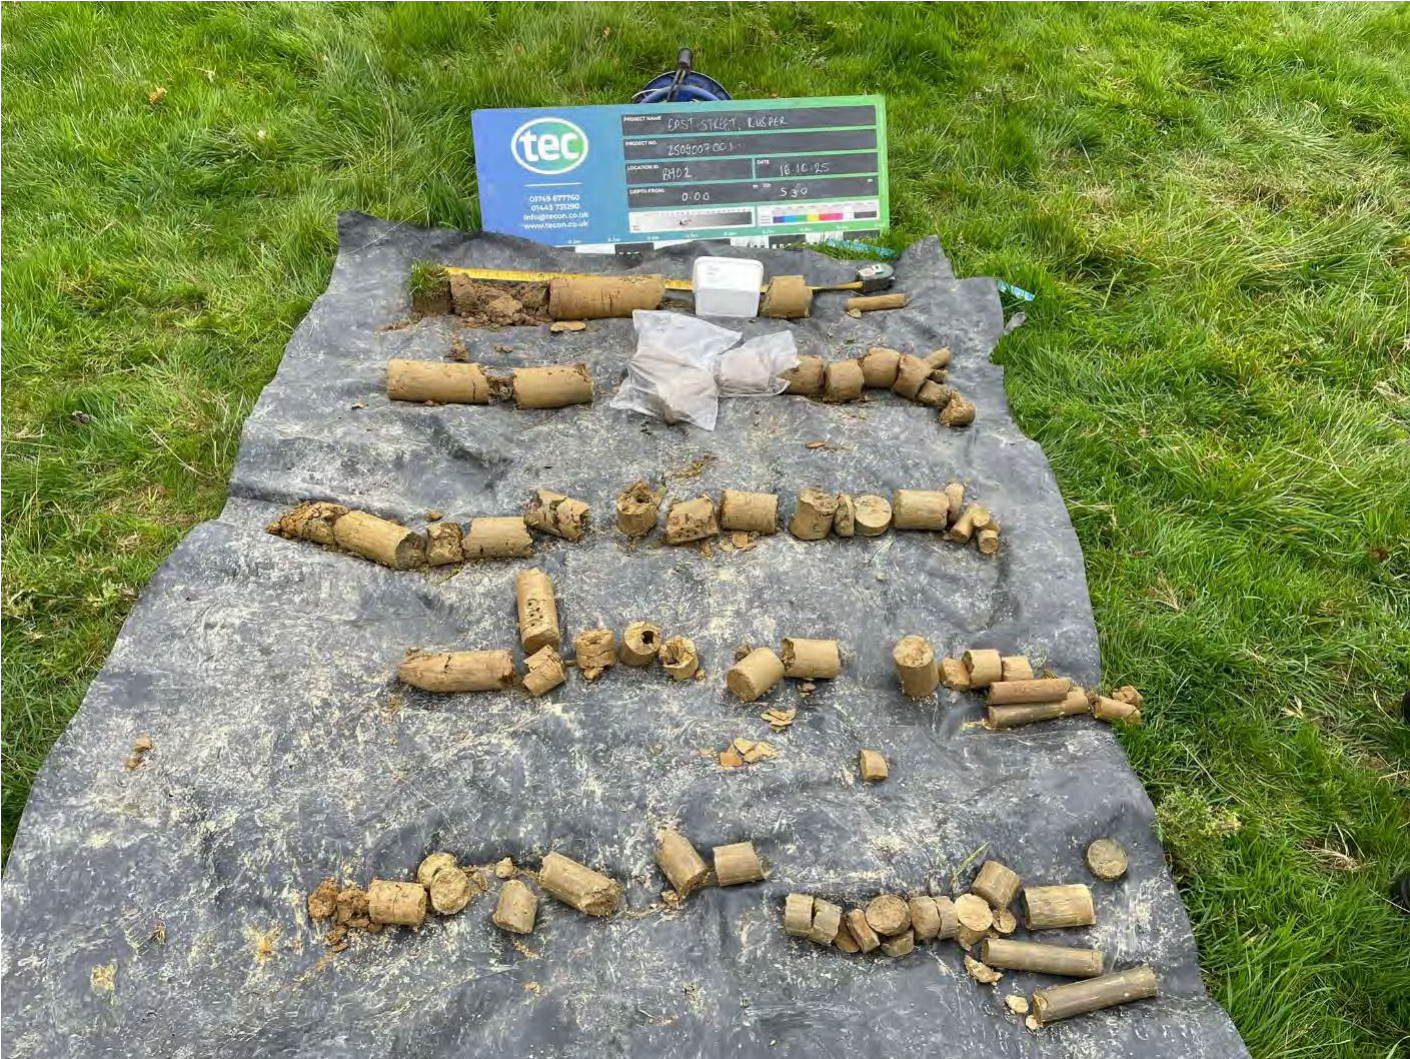
| Remarks<br>Terminated at 5m due to SPT refusal.<br>No groundwater encountered. | Method, Plant, Stability, Dimensions<br>0.00 - 5.00m WLS Archway Lightweight<br>Inclination: 90° | Logger<br>AT |

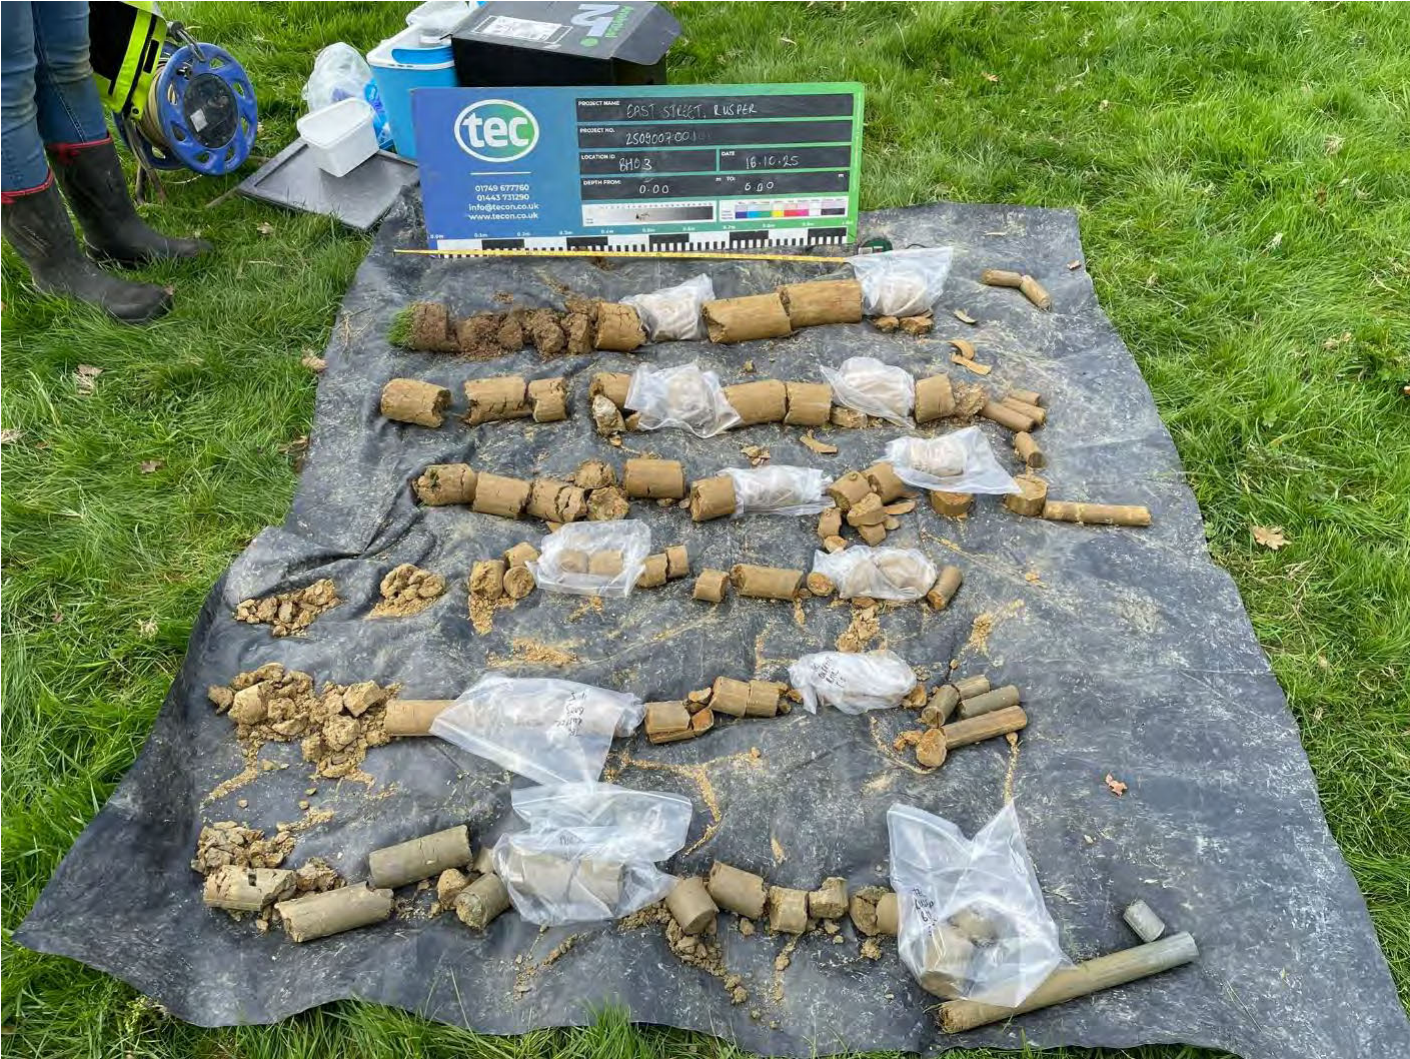
| Remarks<br>No groundwater encountered. | Method, Plant, Stability, Dimensions<br>0.00 - 6.00m WLS Archway Lightweight<br>Inclination: 90° | Logger<br>AT |

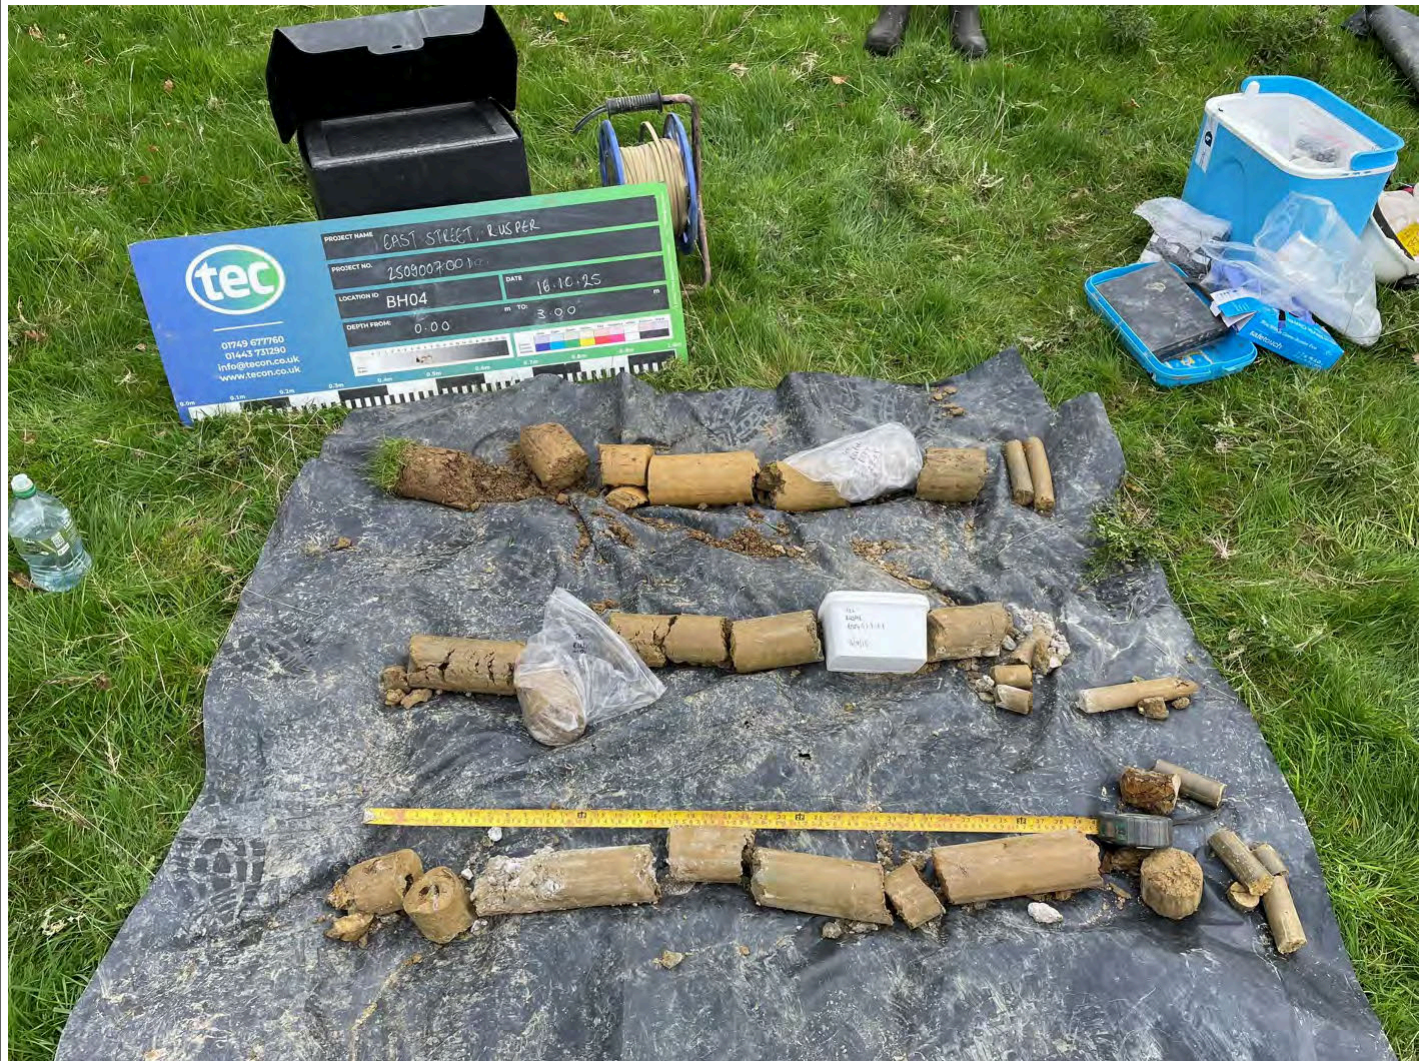
| Remarks<br>Terminated at 3m due to SPT refusal.<br>No groundwater encountered. | Method, Plant, Stability, Dimensions<br>0.00 - 3.00m WLS Archway Lightweight<br>Inclination: 90° | Logger<br>AT |

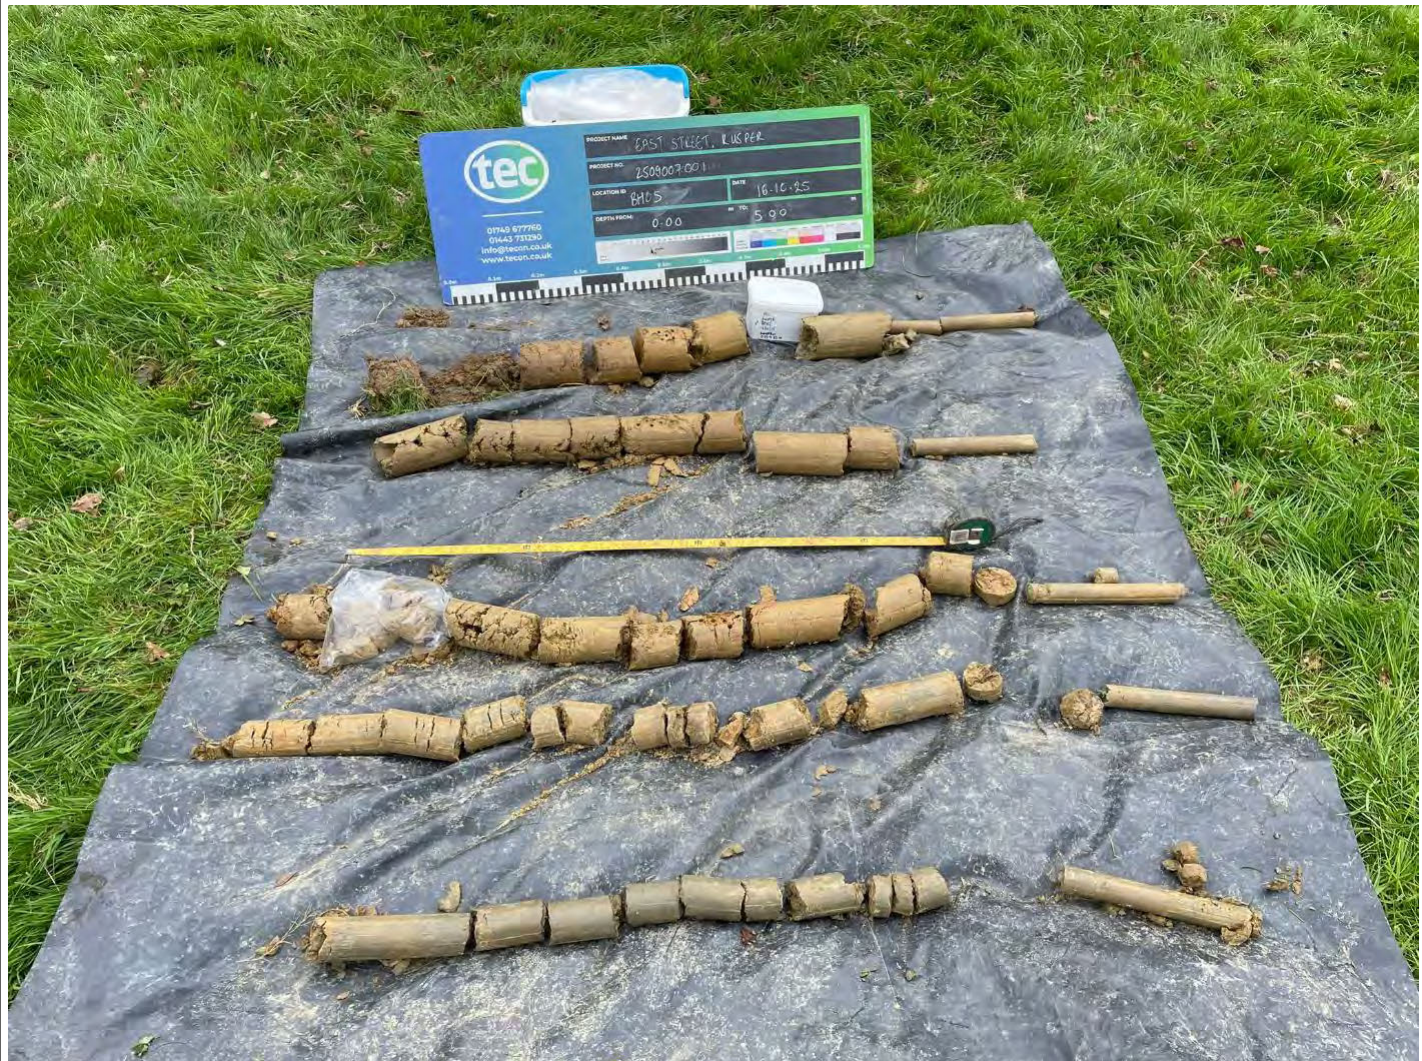
| Remarks<br>No groundwater encountered. | Method, Plant, Stability, Dimensions<br>0.00 - 5.00m WLS Archway Lightweight<br>Inclination: 90° | Logger<br>AT |

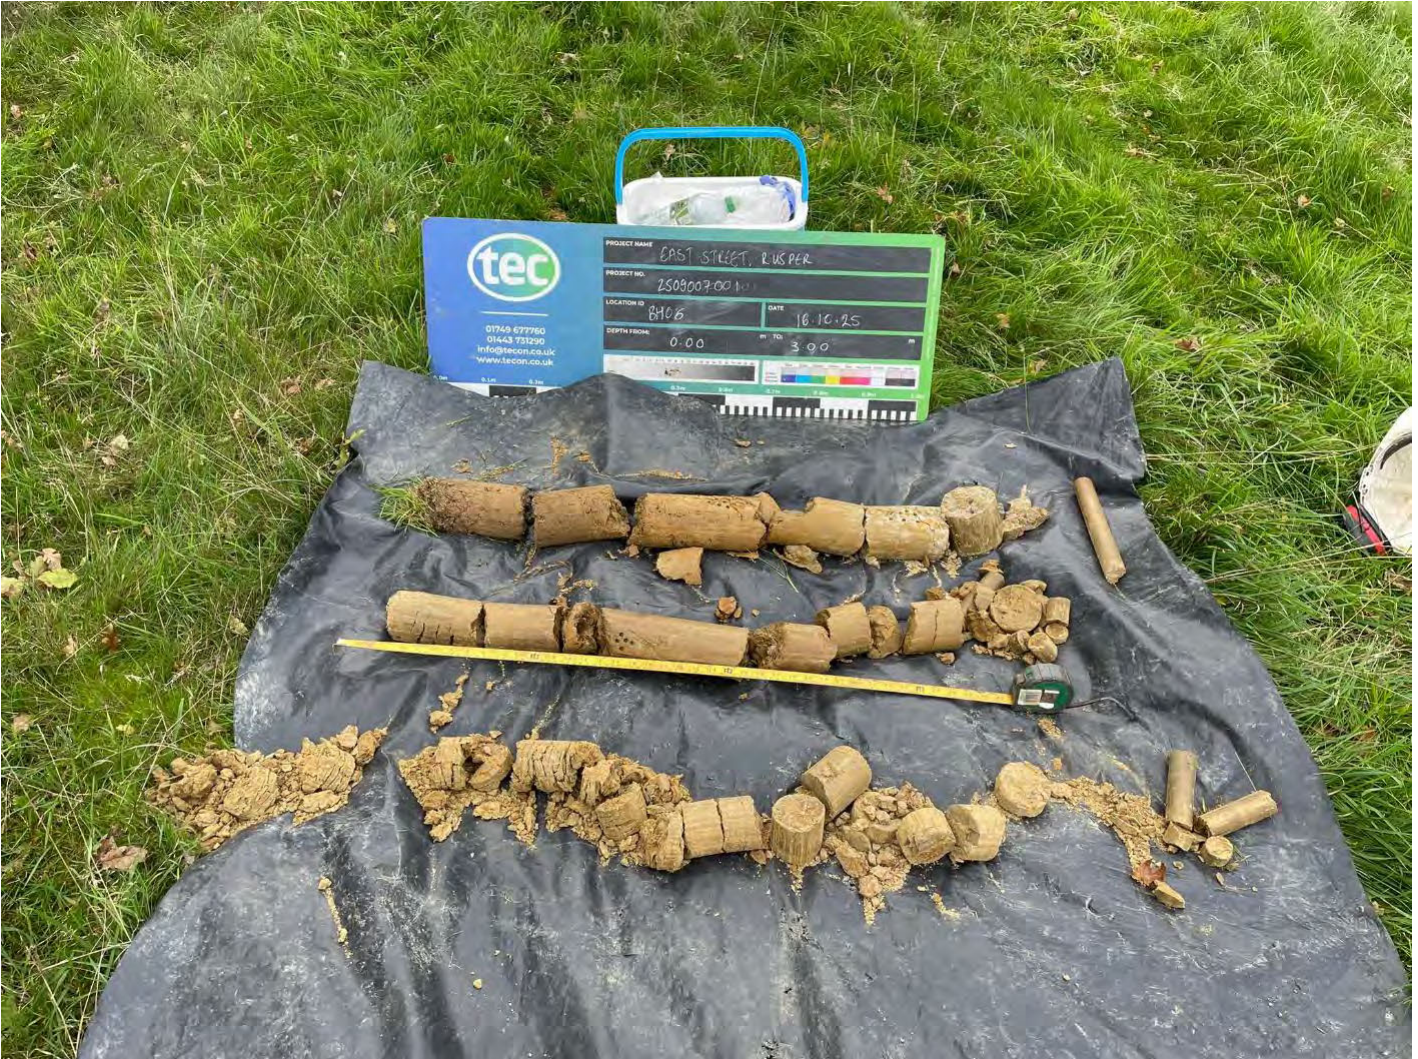
| Remarks<br>Terminated at 3m due to SPT refusal.<br>No groundwater encountered. | Method, Plant, Stability, Dimensions<br>0.00 - 3.00m WLS Archway Lightweight<br>Inclination: 90° | Logger<br>AT |

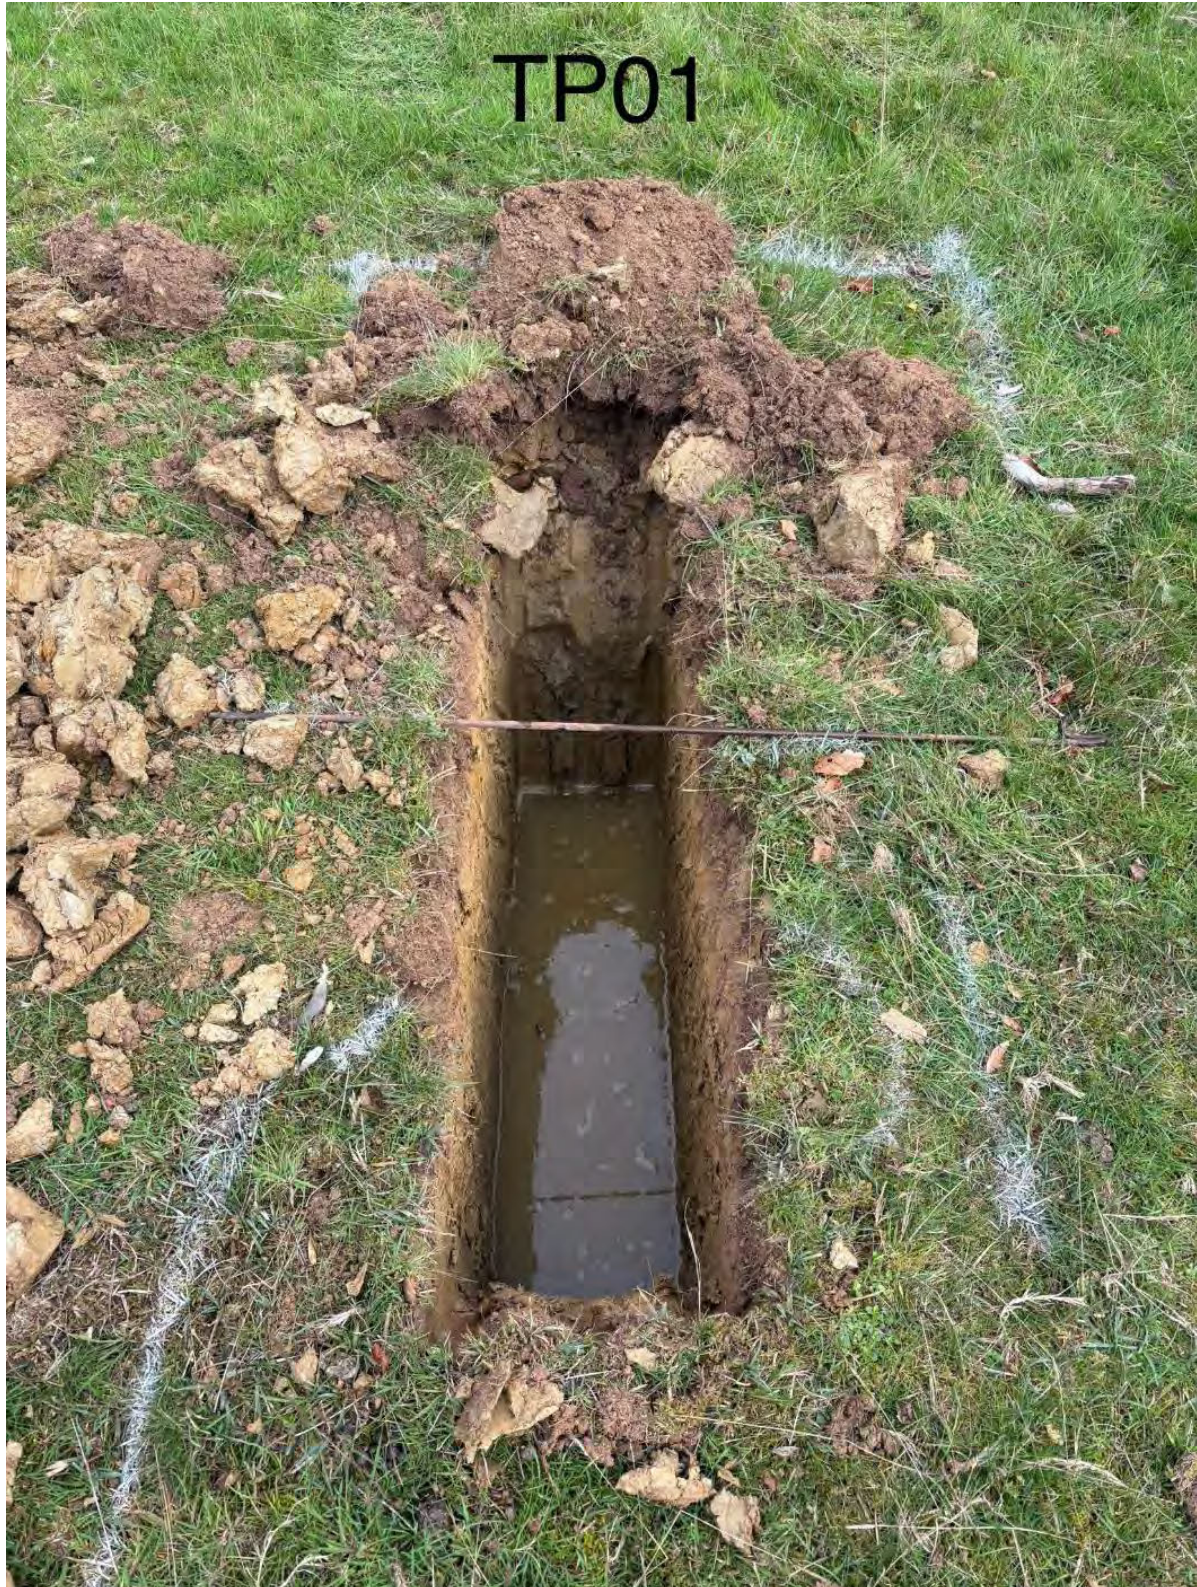
**Remarks**  
Trial pit terminated for soakage testing in accordance with BRE 365.  
No groundwater encountered.

7.12.2 Both soakage tests failed to drain during the test period (i.e. to 75% effective water depth), with marginal a marginal drop in water (maximum 20mm over a 4-hour period) and therefore, the use of soakaways on site is not considered feasible.

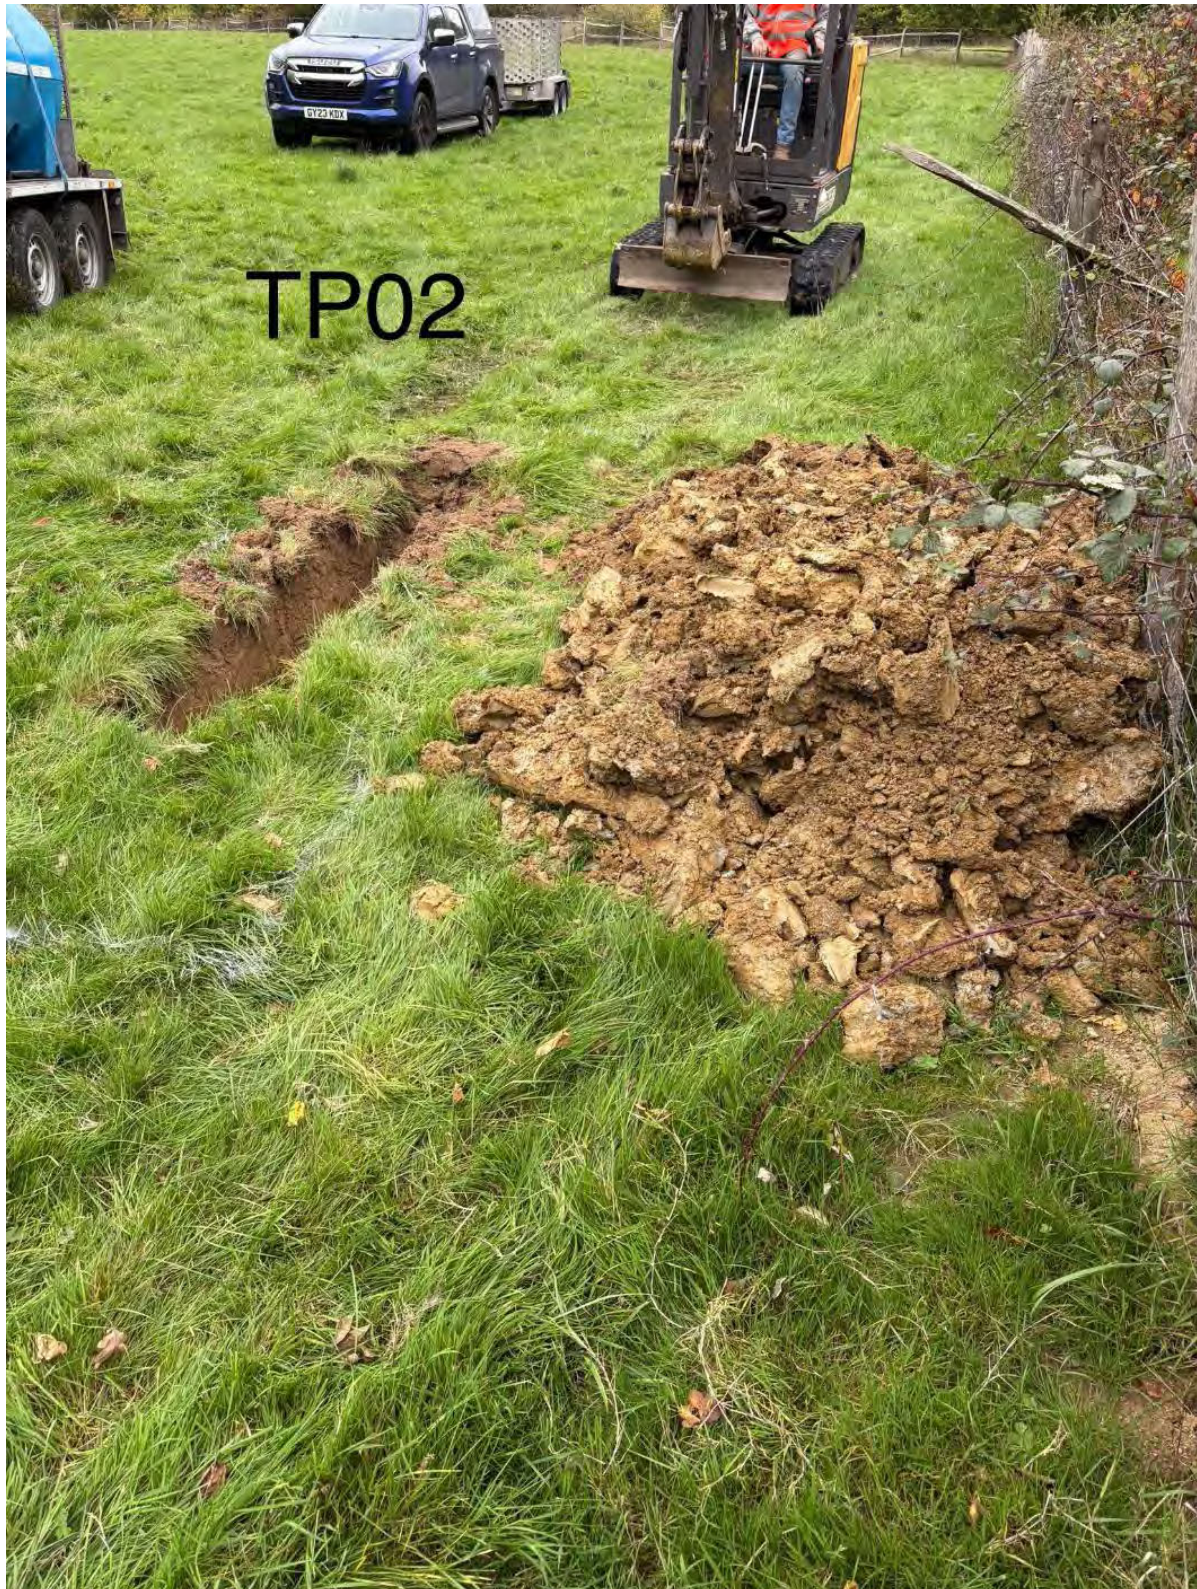
| <b>Remarks</b><br>Trial pit terminated for soakage testing in accordance with BRE 365.<br>No groundwater encountered. | <b>Method, Plant, Stability, Dimensions</b><br>0.00 - 2.00m TP Mini digger<br>Stable<br><div><div><div><div><div></div><div>L = 1.50m</div></div><div><div></div><div>W = 0.30m</div></div></div></div></div> | <b>Logger</b><br>AT |
