# Geo-Environmental Investigation Report

Land at Hornbrook Farm, Brighton Road, Horsham

**Client:** Jaynic Properties Ltd  
**Project:** Land at Hornbrook Farm, Brighton Road, Horsham  
**Title:** Geo-Environmental Investigation Report  
**Report Ref:** 24-1979-P-R2-A  
**Status:** Revision A  
**Date:** 17<sup>th</sup> February 2026

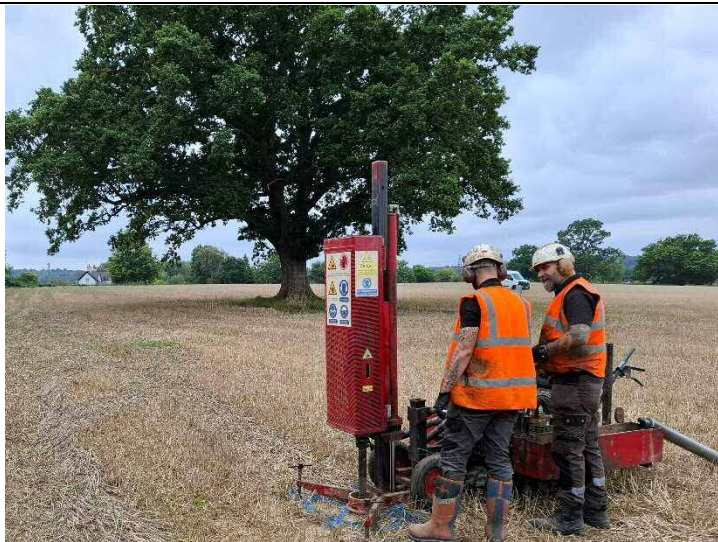
Photograph 1 – A view of a window sampling rig on position.

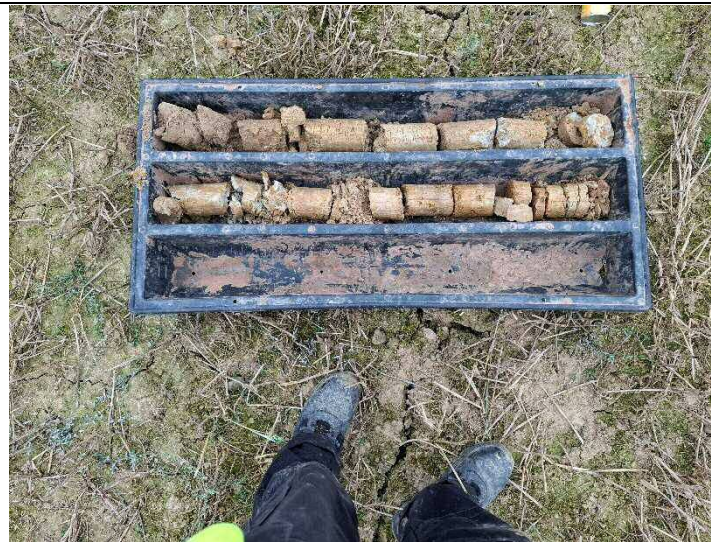
Photograph 2 – A view of an extracted window sample core (WS02).

Groundwater was observed at particularly shallow depths within WS02, between 0.71 and 0.53m bgl during subsequent monitoring phases; however, typically groundwater sat at between 0.99m bgl and 3.40m bgl. Given the presence of shallow groundwater encountered within 2.00m of ground level, dewatering is likely to be required during the earthworks phase and the excavation of foundations. Traditional dewatering techniques, such as sump pumping will likely be required for shallow groundwater ingress. It is recommended that excavations are not left open for prolonged periods.

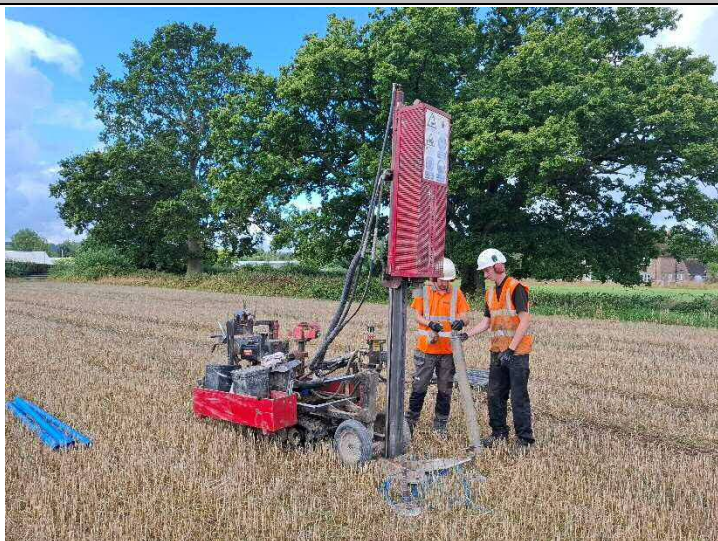
Photograph 3 – A view of a window sampling rig on position.

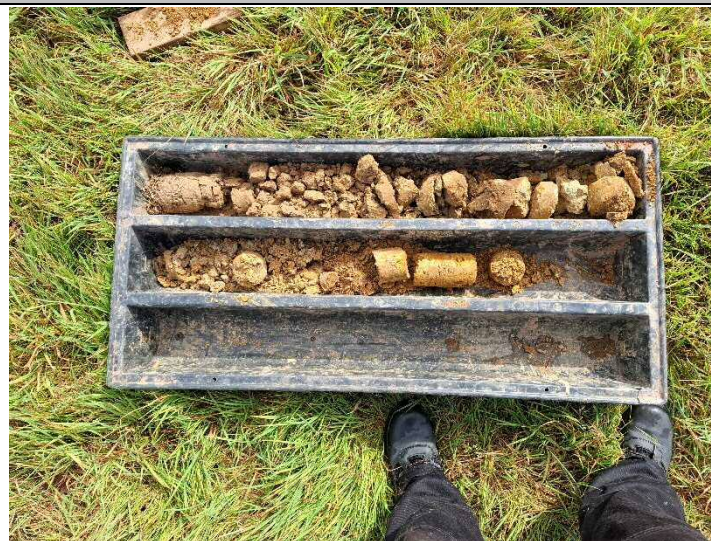
Photograph 4 – A view of an extracted window sample core (WS17).

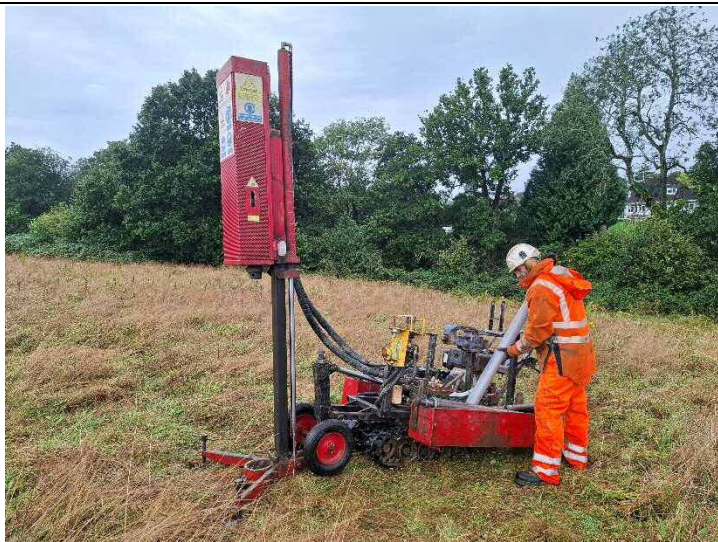
Photograph 5 – A view of a window sampling rig on position.

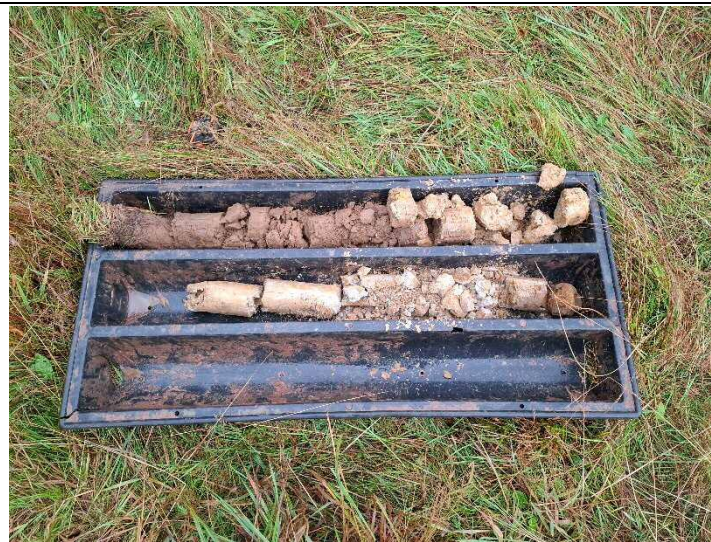
Photograph 6 – A view of an extracted window sample core (WS22)

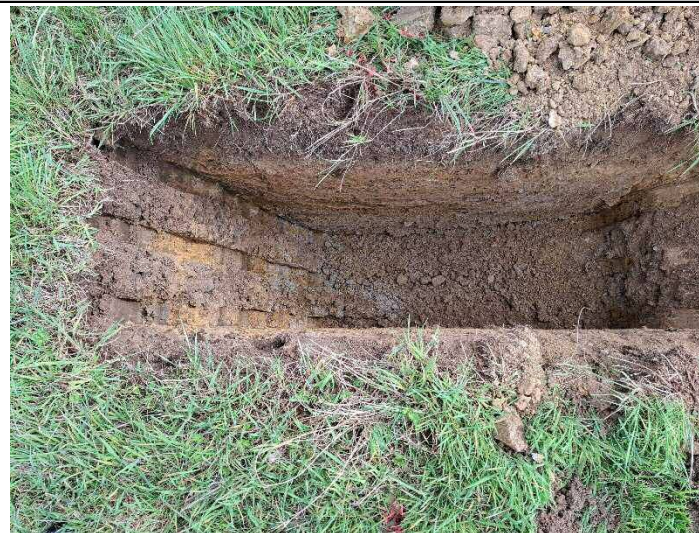
Photograph 8 – A typical view of a trial pit on site with stable sides throughout.

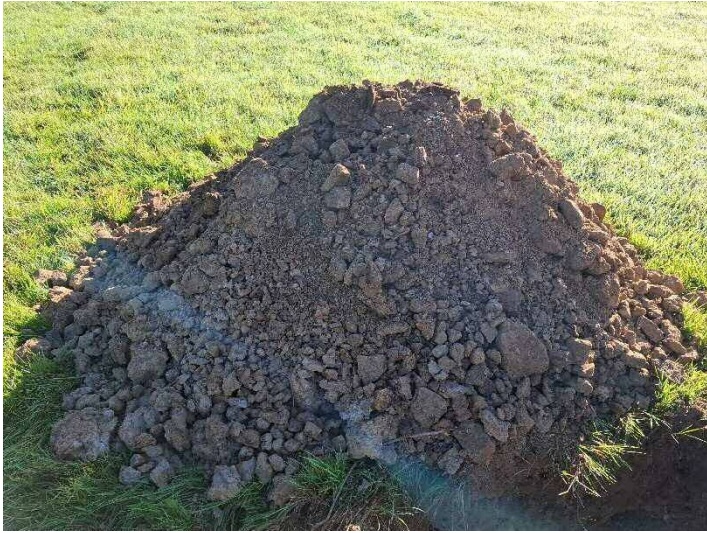
Photograph 9 – A typical view of the trial pit arisings.

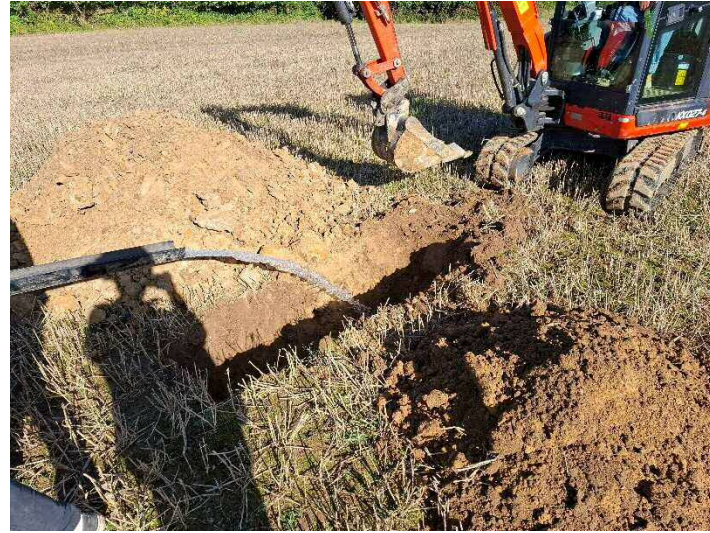
Photograph 10 – A view of a soakaway test being commenced on site.

None of the test locations achieved three repeat tests within a 24-hour period due to the slow infiltration recorded. The tests in TP06 and TP16 failed to pass the 25% effective depth level in their first test.

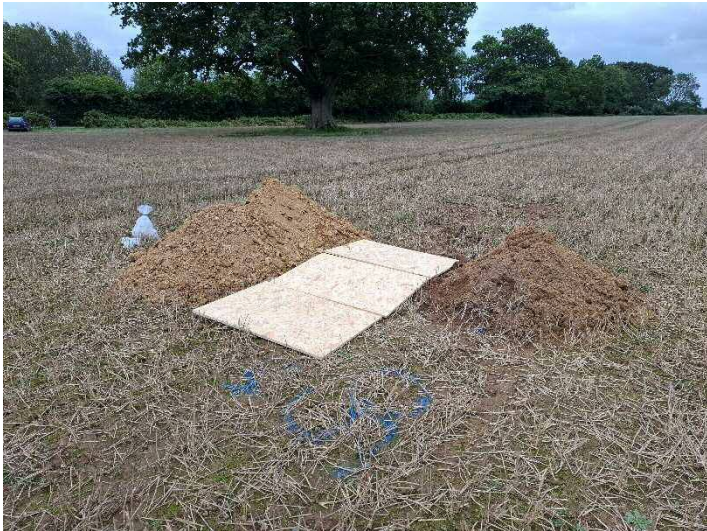
Photograph 11 – A view of a soakaway pit being protected and made safe overnight.

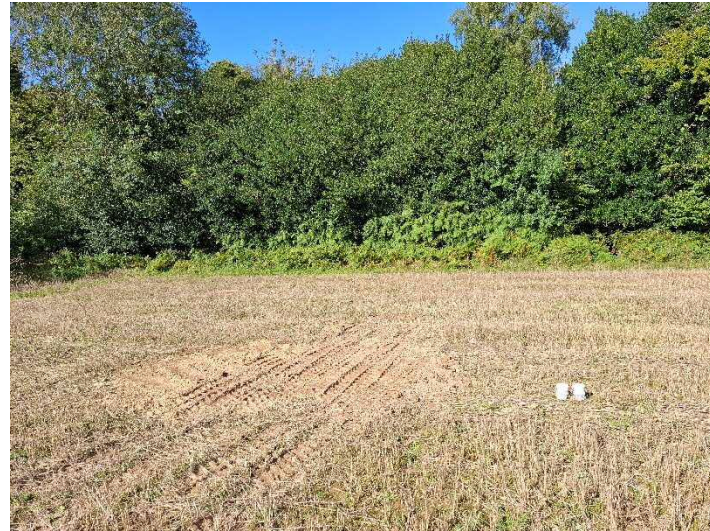
Photograph 12 – A typical view of the trial pit reinstatement.
