## Preliminary Ecological Appraisal and Roost Assessment

Site 1, 1 Hilltop Cottages, The Mount, Ifield, Crawley, West Sussex RH11 0LF

19<sup>th</sup> March 2025

The construction of a residential dwelling with associated landscaping

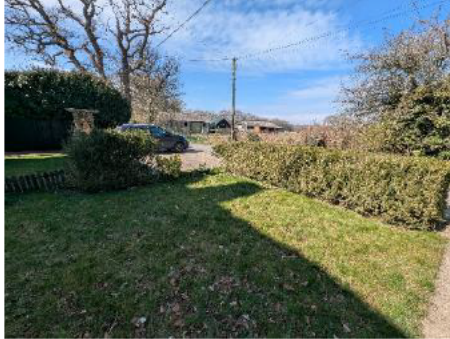
| | <p>It is worth noting the majority of land within this radius comprises of undeveloped grassland and woodland, reducing the likely requirement of EPSL's within this area. This is therefore unlikely to be an accurate representation of the bat population within the area.</p> <p>While no EPSL's have been granted within the area, local knowledge suggests there is a roost present within the adjacent residential dwelling to the west of site, though the species and roost type is unknown.</p> <p>A total of three/one buildings were surveyed to identify their suitability for roosting bats:<br/> B1 is a semi-detached residential dwelling to the west of site.<br/> B2 is a wood cabin to the southeast of site.<br/> B3 is a greenhouse to the northeast of site.</p> |
|---|---|
| Bat foraging and commuting habitat | <p>The scattered trees, hedgerow and flower beds on site provide suitable commuting and foraging habitat for bats (Fig 1). The wider local area comprises predominantly of grassland and woodland, which are well connected to site via a network of hedge and tree lined fields, providing suitable connectivity between the site and more substantial habitat nearby. The site is therefore considered to have <b>moderate</b> suitability for foraging and commuting bats.</p> <p style="text-align: center;"><b>Fig 1</b></p> |

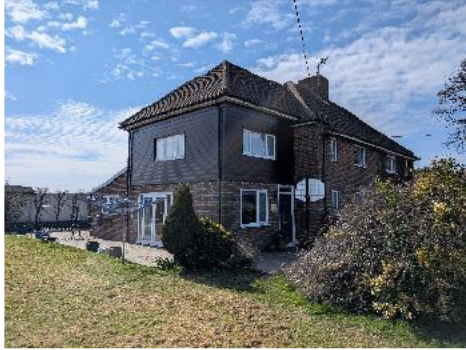
| | <p>It is worth noting the majority of land within this radius comprises of undeveloped grassland and woodland, reducing the likely requirement of EPSL's within this area. This is therefore unlikely to be an accurate representation of the bat population within the area.</p> <p>While no EPSL's have been granted within the area, local knowledge suggests there is a roost present within the adjacent residential dwelling to the west of site, though the species and roost type is unknown.</p> <p>A total of three/one buildings were surveyed to identify their suitability for roosting bats:<br/> B1 is a semi-detached residential dwelling to the west of site.<br/> B2 is a wood cabin to the southeast of site.<br/> B3 is a greenhouse to the northeast of site.</p> |
|---|---|
| B1 - overview | <p>B1 is a semi-detached, hipped residential dwelling with a single-story rear extension (Fig 2). The building is constructed of brick and mortar with areas of timber cladding to the north, east and south. The main roof is clad with clay roof tiles, and the extension with slate roof tiles. There are windows on the north, east and south elevation and skylights on the extension.</p> |

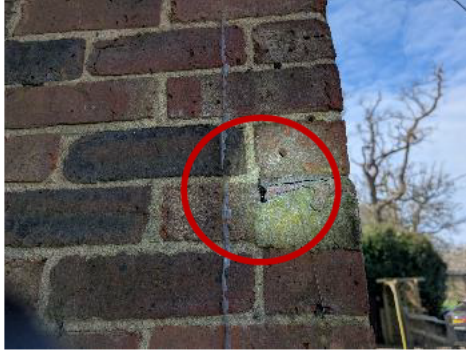
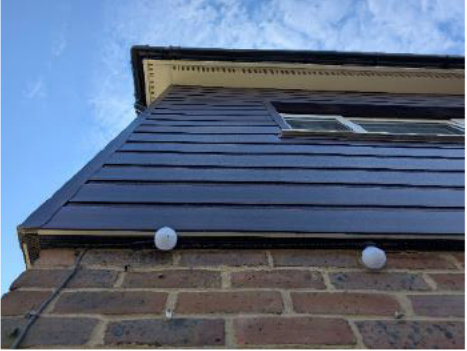
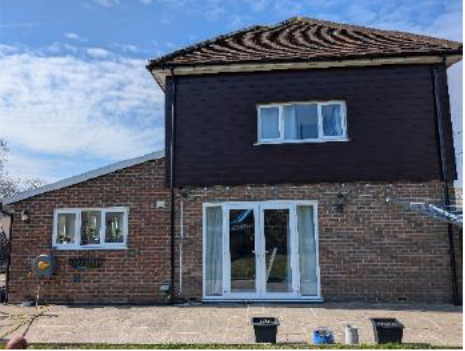
| B1 – exterior | <p>The brick and mortar appears to mostly be in good condition, with one small areas of missing mortar (Fig 3). This could provide a suitable roosting location for crevice dwelling bat species, however, it could be fully inspected from ground level and no bats or evidence of bats was identified. The timber cladding is flush (Fig 4), leaving no gaps. The windows and doors appear to be tightly fitting and in good condition (Fig 5), leaving no gaps.</p> <div style="display: flex; justify-content: space-around; align-items: flex-end;"> <div style="text-align: center;"> <p><b>Fig 3</b></p> </div> <div style="text-align: center;"> <p><b>Fig 4</b></p> </div> <div style="text-align: center;"> <p><b>Fig 5</b></p> </div> </div> <p>Approximately 25% of clay roof tiles are lifted (Fig 6) in addition to a small number of damaged tiles (Fig 7), providing a suitable roosting location for crevice dwelling bat species. The slate tiles on the extension are flush (Fig 8), leaving no gaps.</p> |

| B1 – suitability assessment | <p>B1 has been assessed as having <b>moderate</b> value for roosting bats. The lifted and damaged roof tiles, damaged mortar and gap between the soffit boxes and walls provide suitable roosting features for crevice dwelling bats. In addition, access to the loft void was identified in the form of light ingress and wasps nest, providing access to the loft void for void dwelling bat species and the internal roosting features at the gable ends for crevice dwelling bat species.</p> <p>While droppings were identified within the loft void, due to the small volume this is not considered to be a confirmed roost.</p> | |

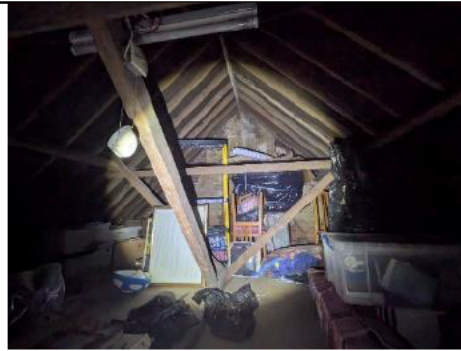
**Fig 11**

| B1 – interior | <p>The loft void within B1 is split into two sections with an area of bitumen felt removed to allow access between the two; V1a is the original loft void above the main section of the dwelling, and V1b is an additional loft void within a two story eastern extension. The void is partially boarded, insulated with mineral wool and lined with bitumen felt (Fig 11). The bitumen felt appears to be in good condition throughout (Fig 12), with no obvious damage or sagging. There are gaps between the brick and mortar and the timber beams at the gable ends (Fig 13), providing a suitable roosting location for crevice dwelling bat species should they gain access.</p> |

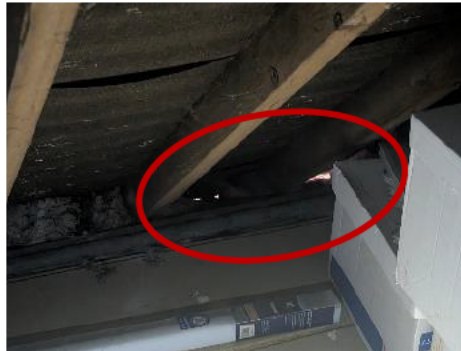
**Fig 14**

Small amounts of light ingress could be seen within V1a at the eaves (Fig 14), and high levels of light ingress could be seen around the full length of the eaves of V1b (Fig 15). Most of the light ingress within V1b can lightly be accounted for by vents present within the soffit boxes, however, given the external gaps between the soffit box and the wall it is likely that access points are still present.

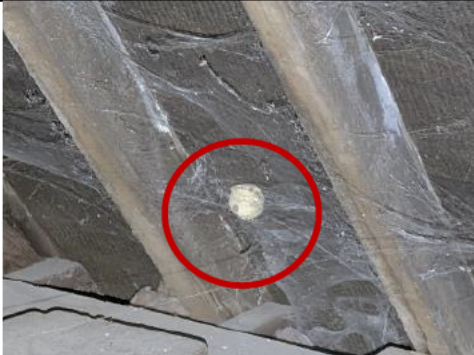
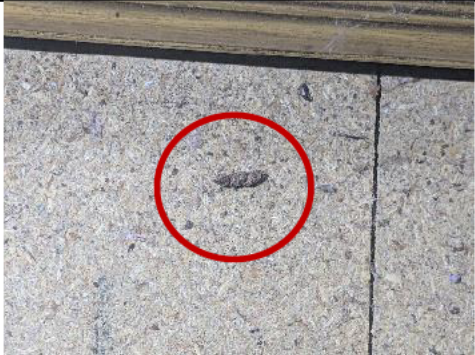
A number of wasps nests were identified within the loft void (Fig 16), demonstrating potential access. In addition, 5 suspected bat droppings were identified within the loft void: one within V1a, two at the gap in the bitumen felt between V1a and V1b and an additional two within V1b (Fig 17). Given the small volume of droppings, this is not considered to be a confirmed roost and is more likely to have been a probing visit.

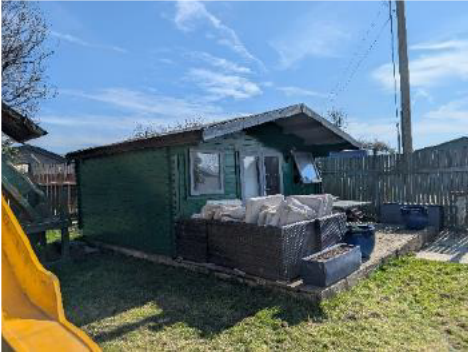
| B2 - overview | <p>B2 is a gabled, timber cabin with overhanging eaves to the west and a bitumen felt roof (Fig 18). There are windows on the western elevation.</p> <p><b>Fig 18</b></p> | |

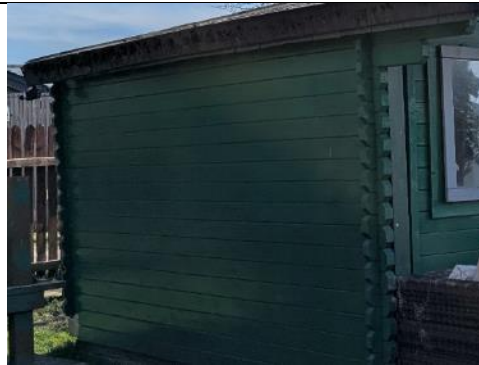
**Fig 19**

| B2 – exterior | <p>The timber walls appear to be tightly fitting and in good condition (Fig 19), leaving no gaps. The windows and doors appear to be tightly fitting and in good condition (Fig 20), leaving no gaps.</p> | |

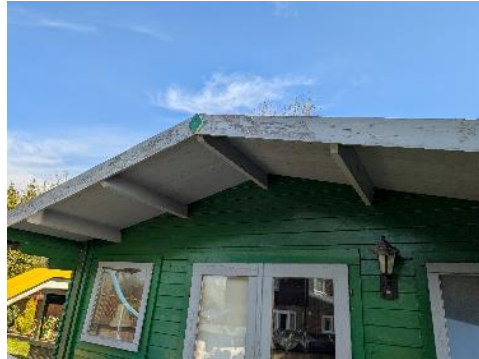
**Fig 21**

The overhanging eaves appear to be in good condition (Fig 21), leaving no gaps. The bitumen felt roof appears to be tightly fitting and in good condition (Fig 22), leaving no gaps.

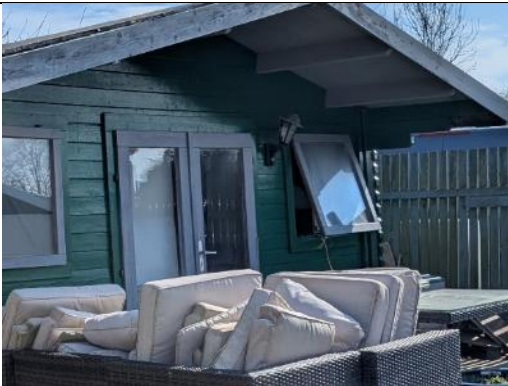
An open window on the western elevation provides access to the interior of B2 (Fig 23). However, due to the windows on the western elevation there are high levels of light throughout, resulting in this being an unsuitable roosting location for void dwelling bat species. No roosting features were identified internally.

| B2 – suitability assessment | B2 has been assessed as having <b>negligible</b> suitability for roosting bats. No features were identified externally, and the interior of B2 is considered unsuitable due to high levels of light. |

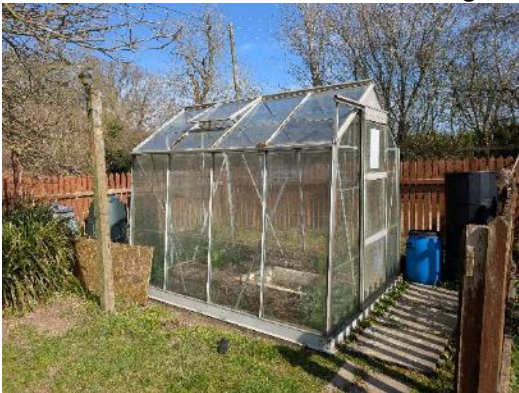
| B3 - summary | <p>B3 is a gabled greenhouse constructed entirely of metal frames and glass panels (Fig 24). Due to the construction of the building with no crevices, highly fluctuating temperatures and a fully lit interior, this is not considered to be a suitable roosting location for bats.</p> <p style="text-align: center;"><b>Fig 24</b></p> |

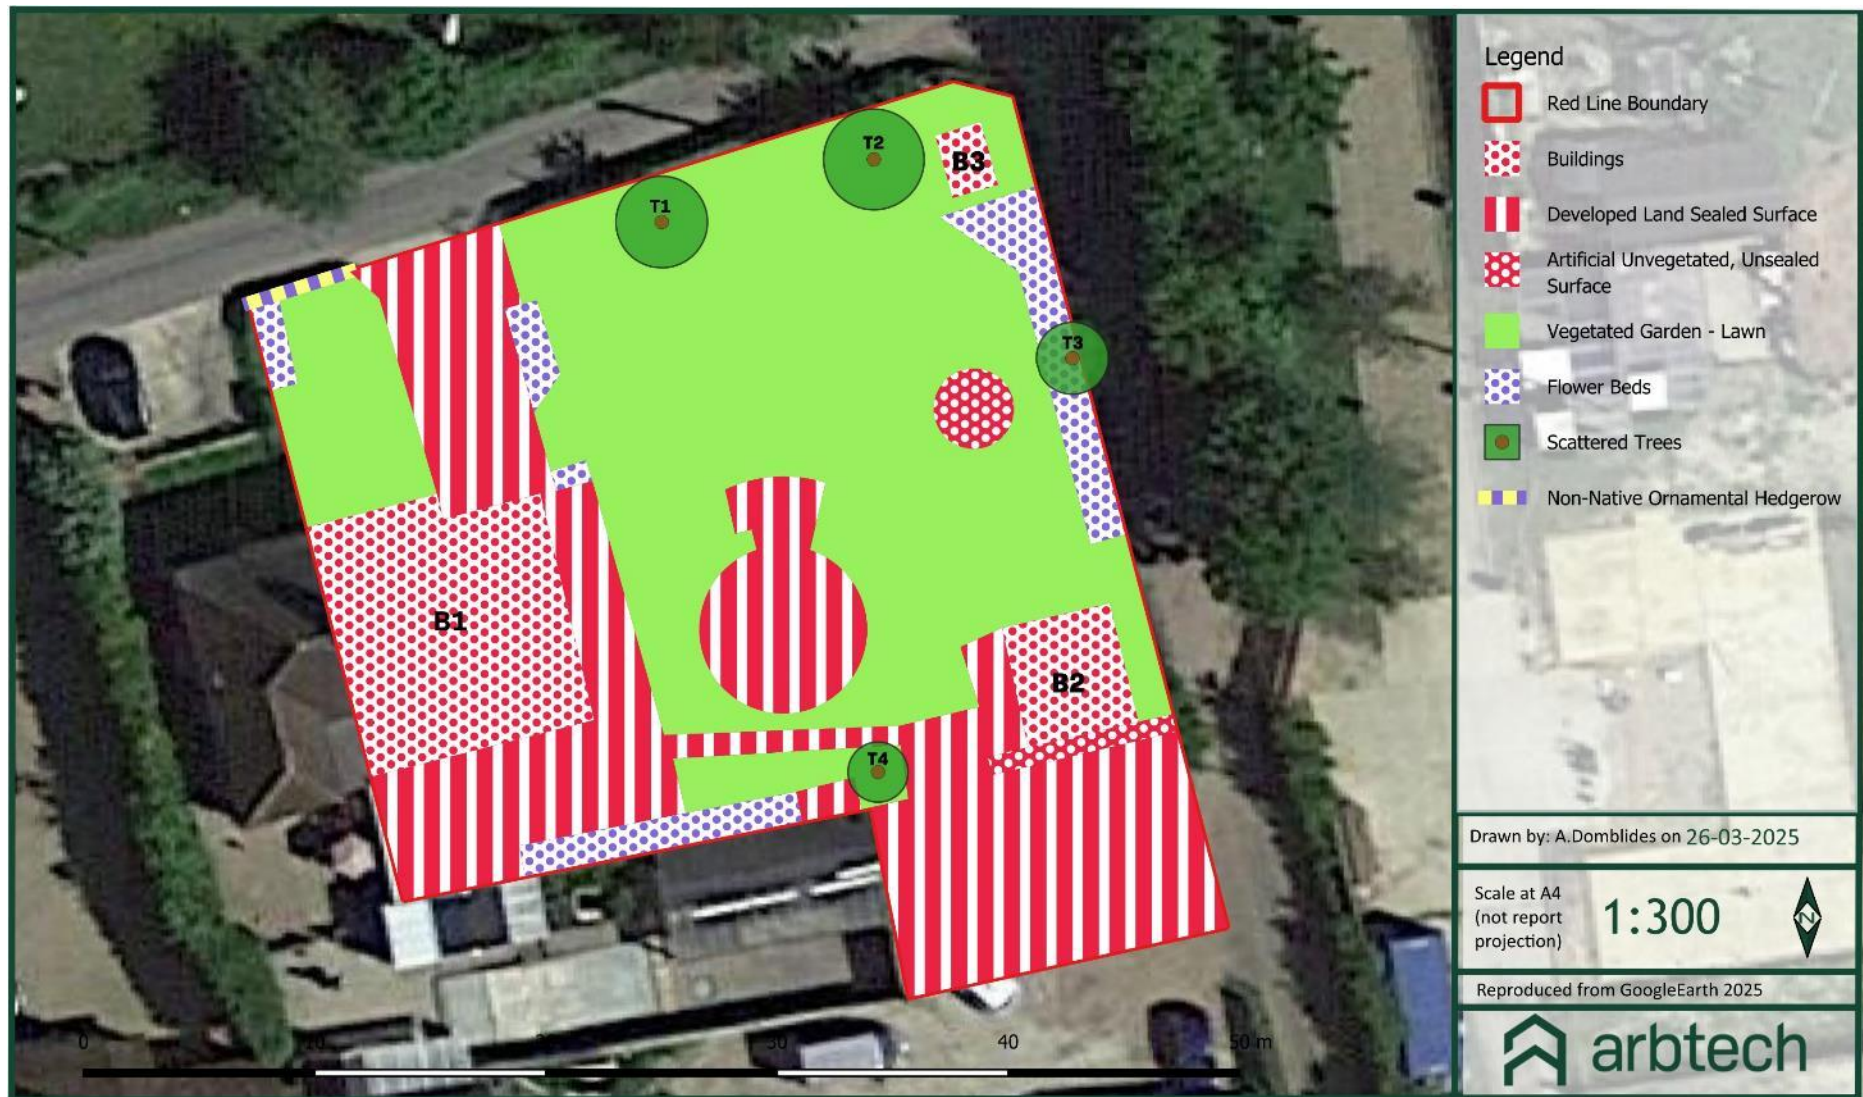
## Appendix 1: Survey/Habitat map

UK Habs Description and Codes:Developed Land: Sealed Surface [u1b]

Artificial unvegetated – unsealed surface [u1c]

Non-native and ornamental hedgerow [h2b]

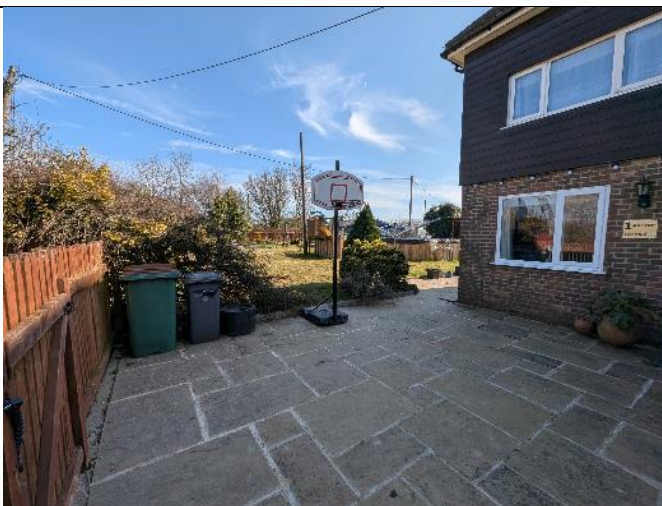
Picture 1: Hardstanding and vegetated garden with scattered shrubs in flower beds to the northwest of site

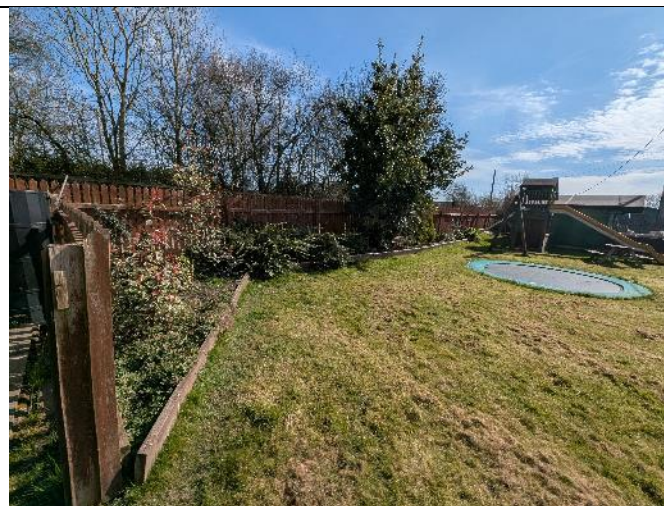
Picture 2: Vegetated garden with scattered shrubs and ground level trampoline to the northeast of site

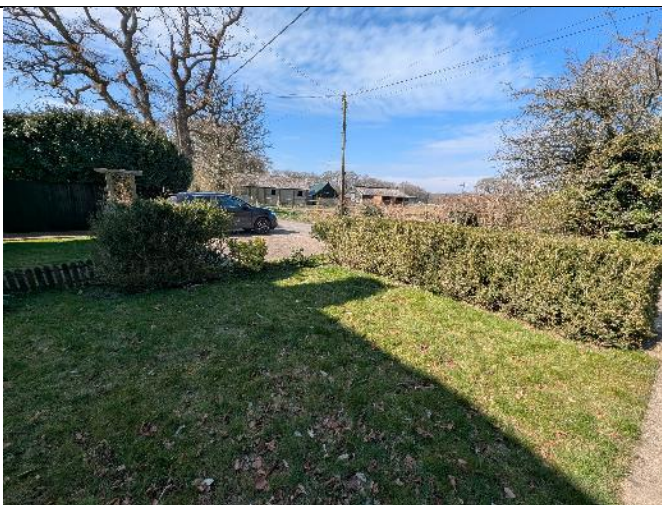
Picture 3: Vegetated garden and ornamental hedgerow with shrubs in flower beds to the northwest of site

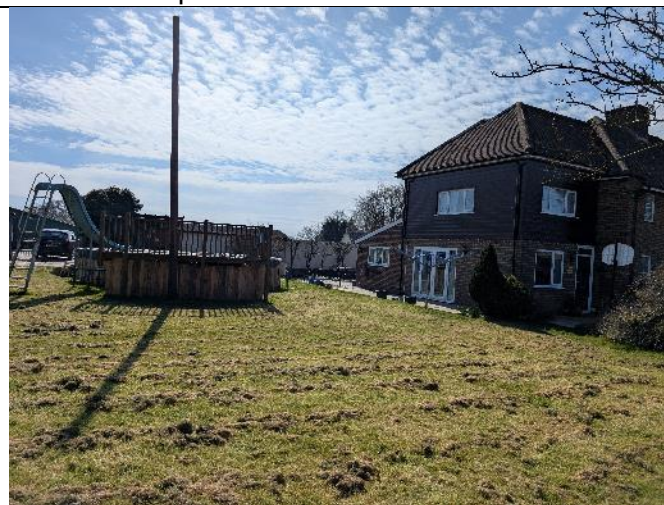
Picture 4: Vegetated garden, B1 and swimming pool in the centre of site

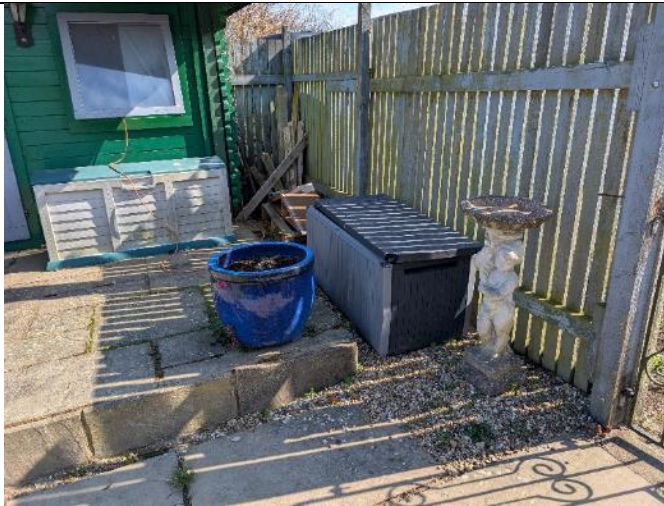
Picture 1: Artificial unsealed surface and hardstanding to the southeast of site

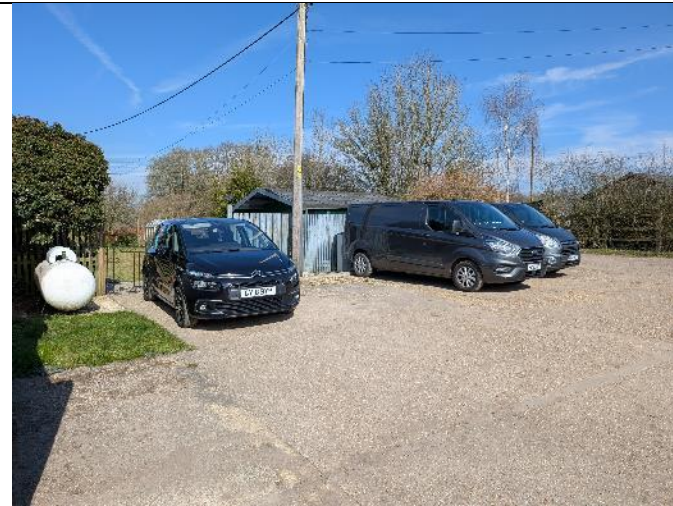
Picture 2: Concrete driveway to the southeast of site
