**Project:**  
New Place Farm, Pulborough

Project Title: **New Place Farm, Pulborough**

## **APPENDIX C – PHOTOGRAPHIC RECORD**

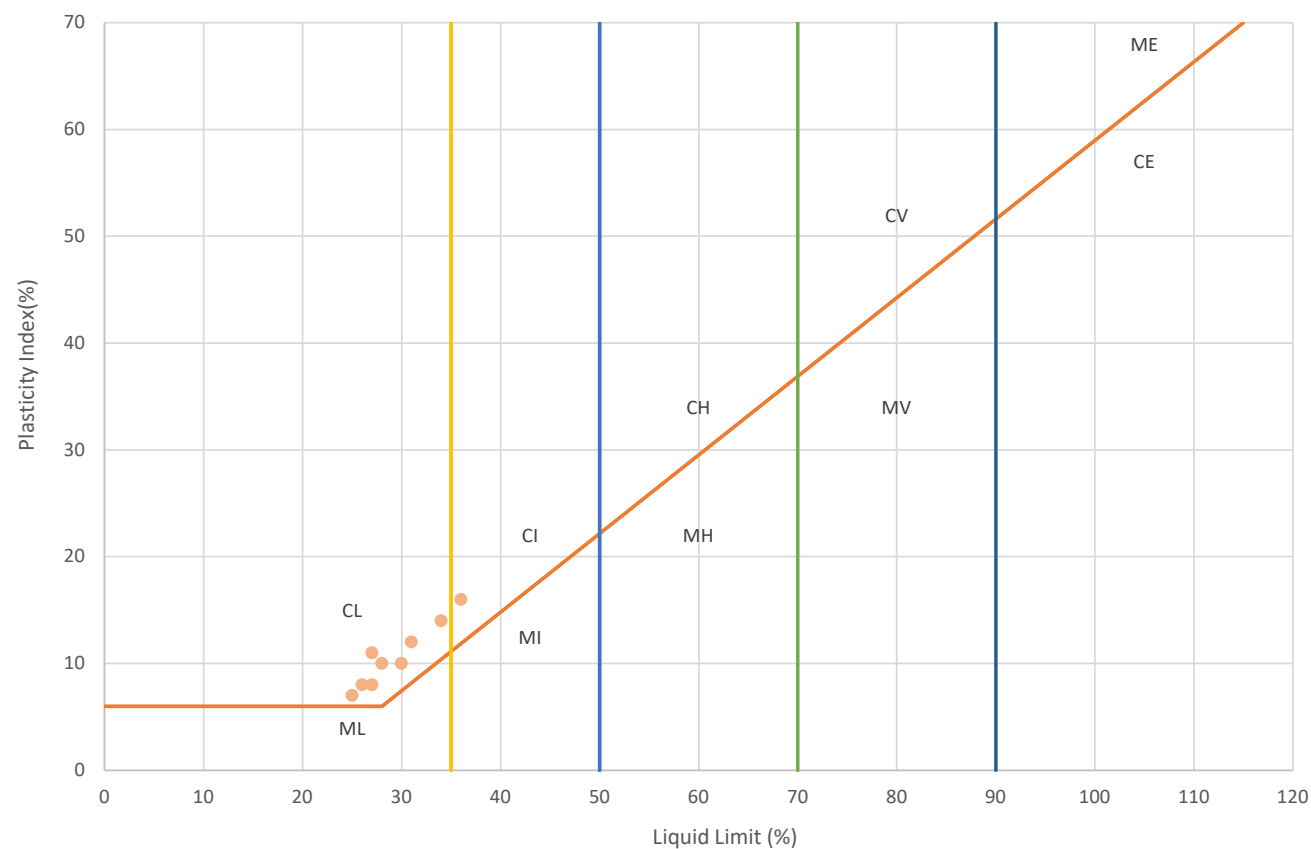
Figure 1: Atterberg Limits A-Line Plot from **LEAP** 2024 and 2025 investigations

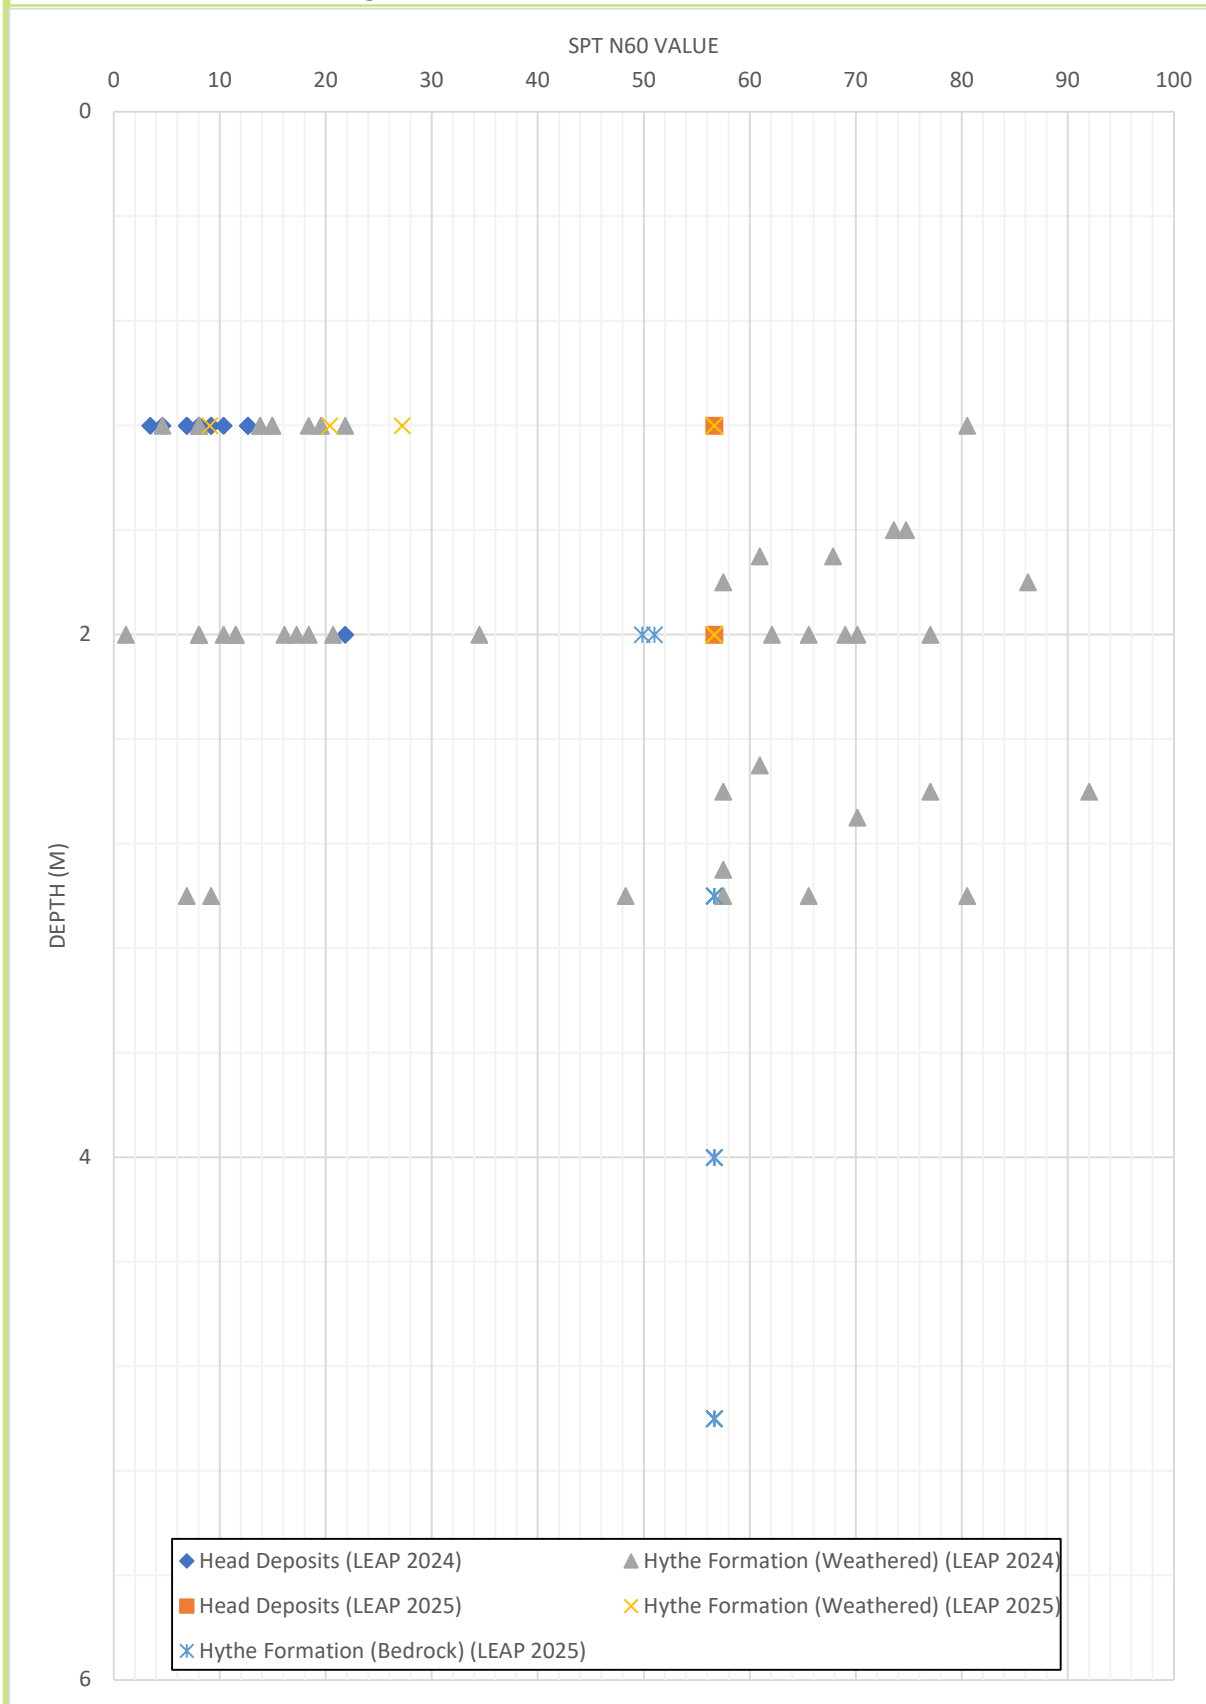
**Figure 2: Plot of SPT N<sub>60</sub> Value v. Depth**

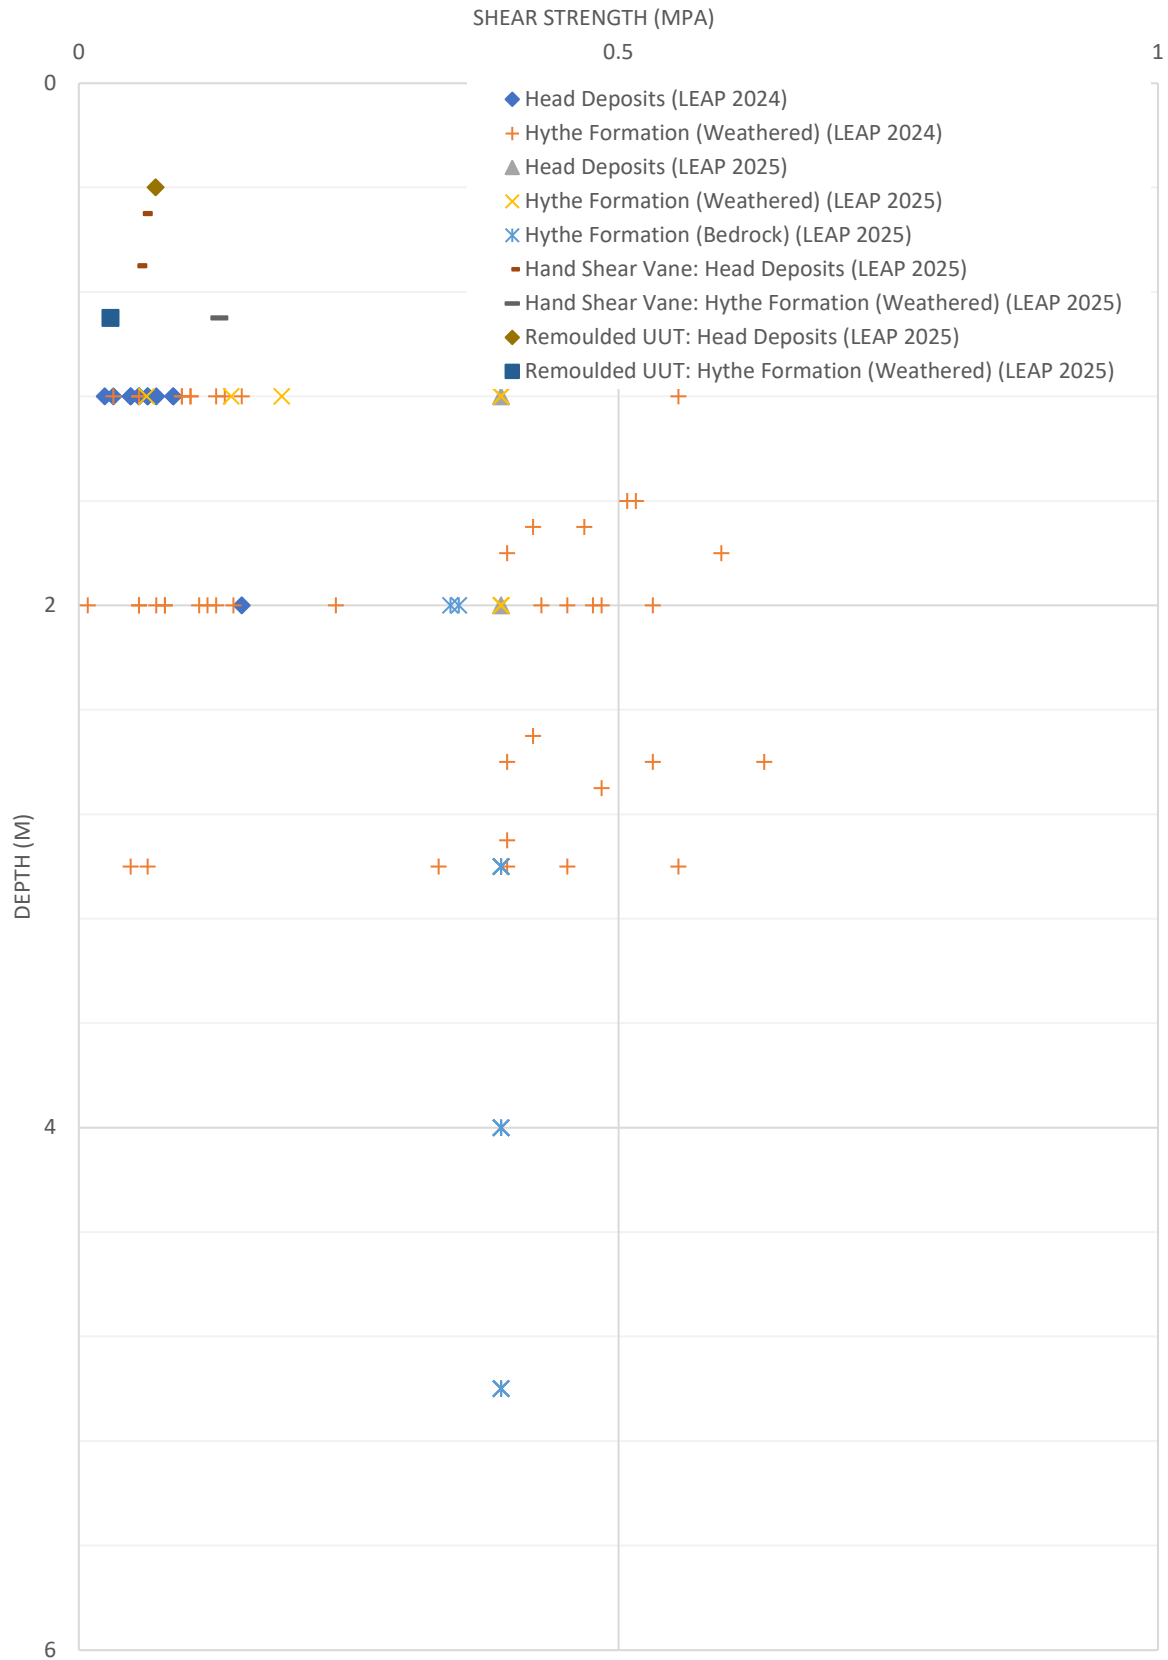
**Figure 3: Plot of Shear Strength v. Depth**

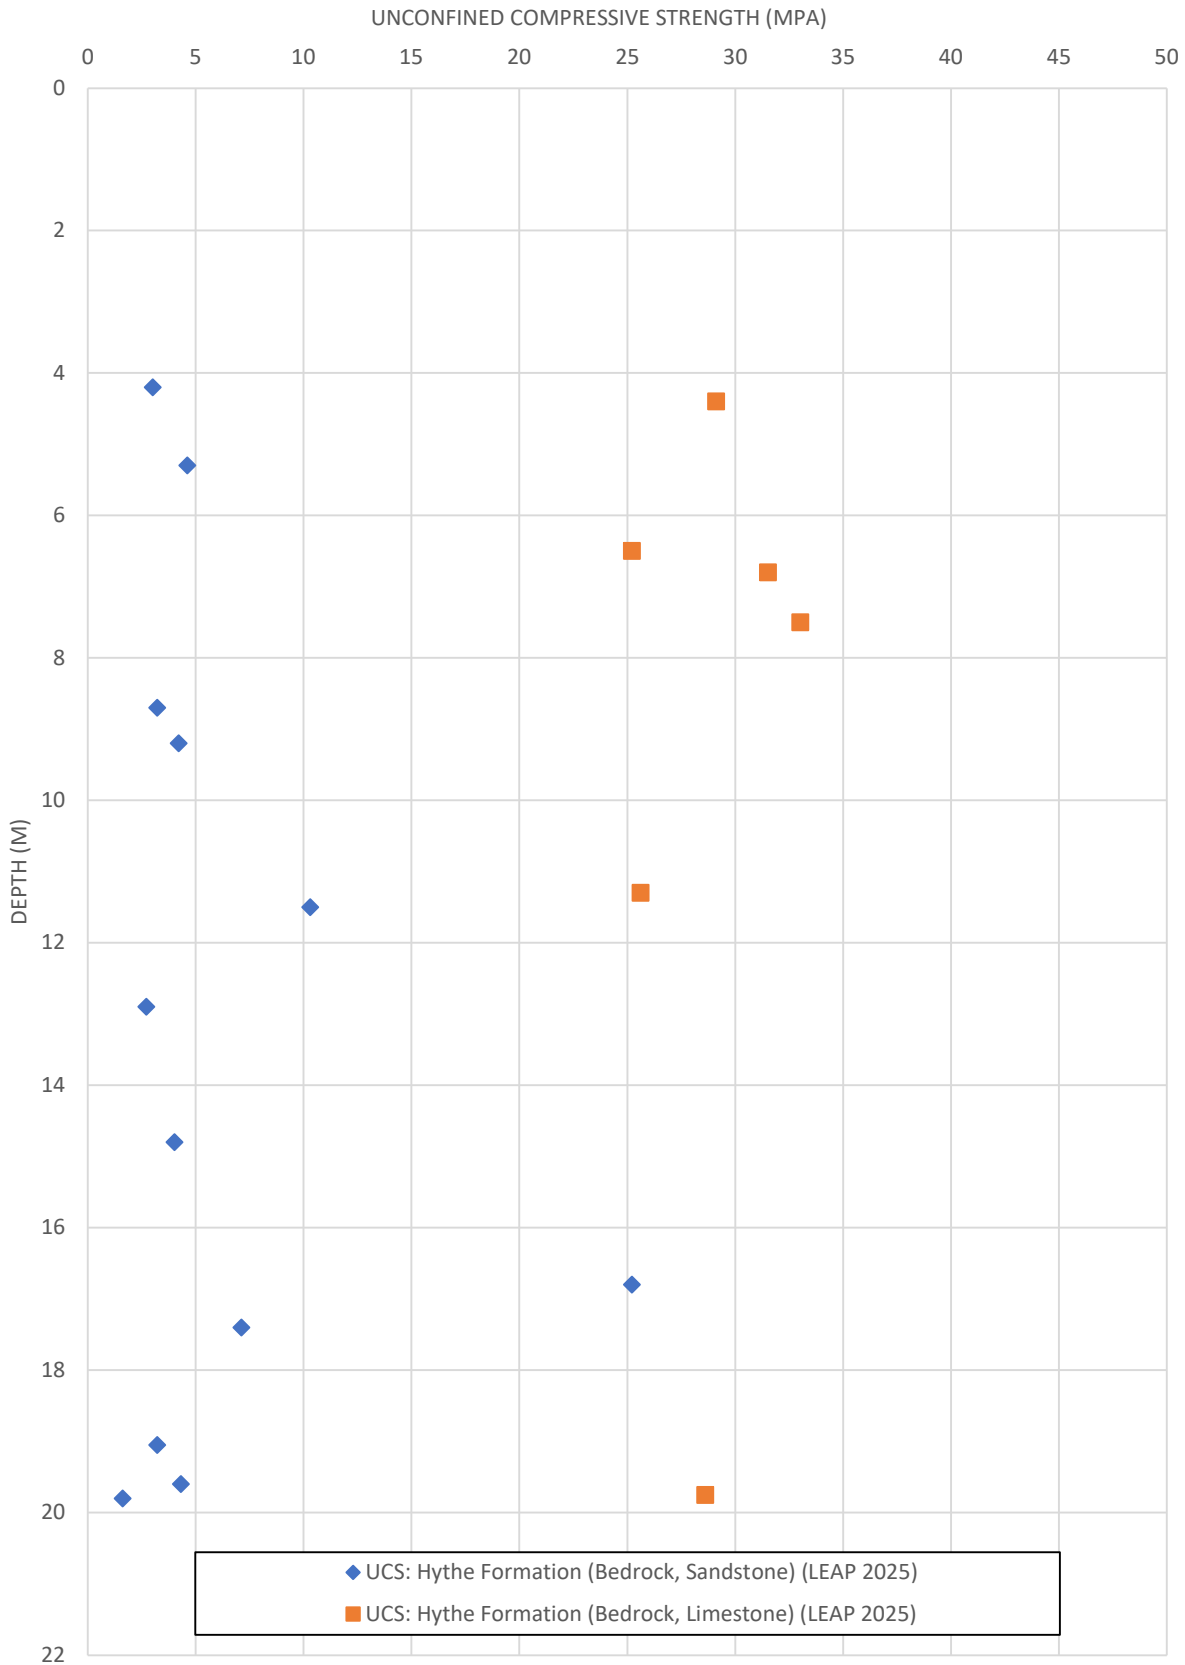
**Figure 4: Plot of UCS v. Depth**

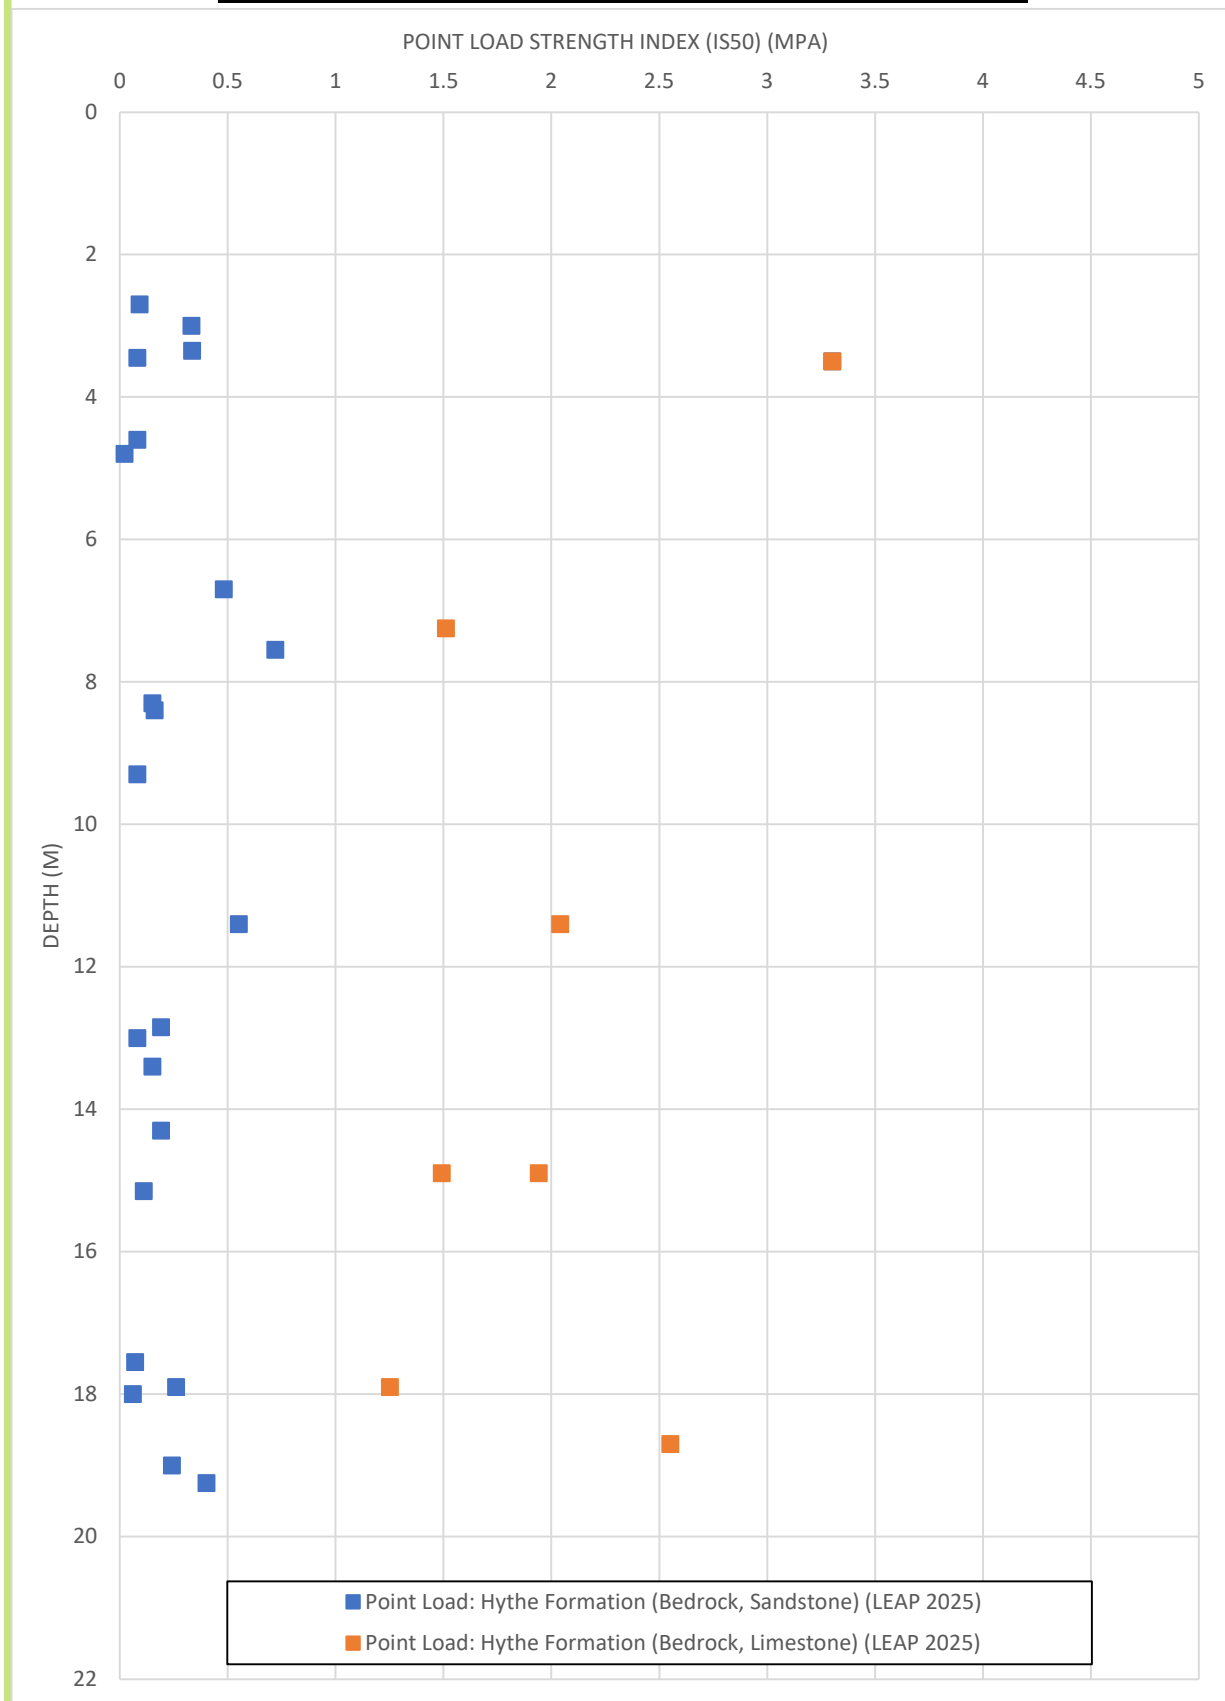
**Figure 5: Plot of Point Load Strength Index (Is50) v. Depth**

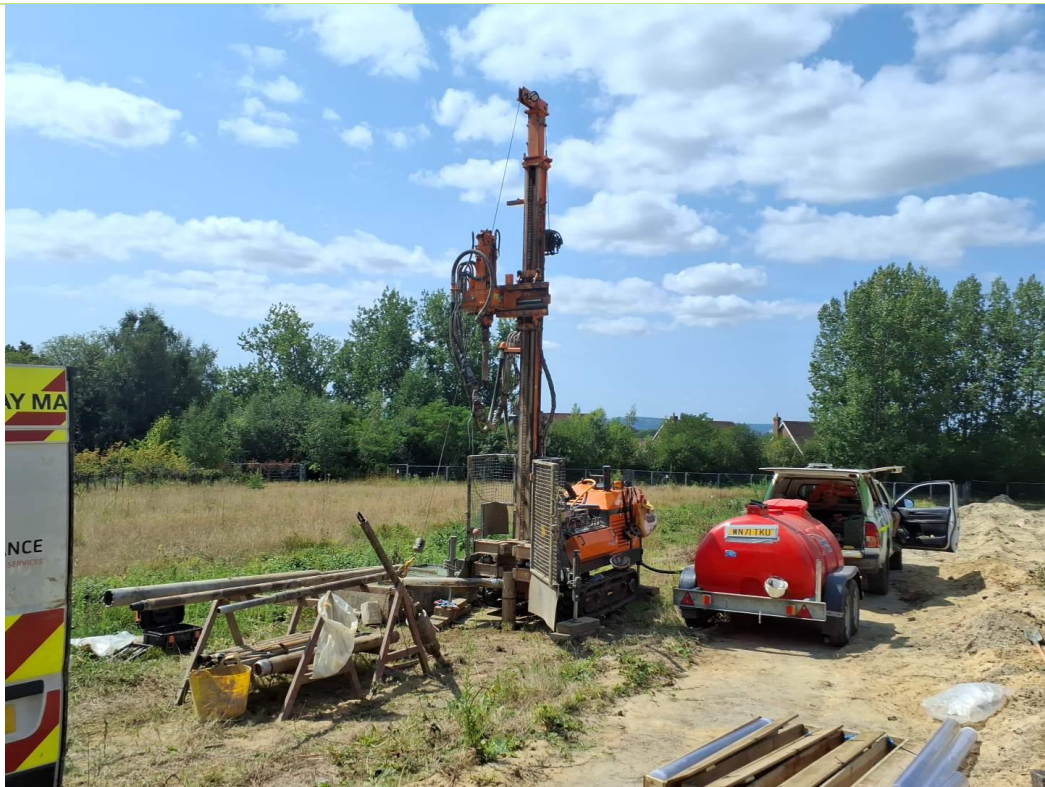
Plate 10 – Overview of drilling rotary core borehole BH401.

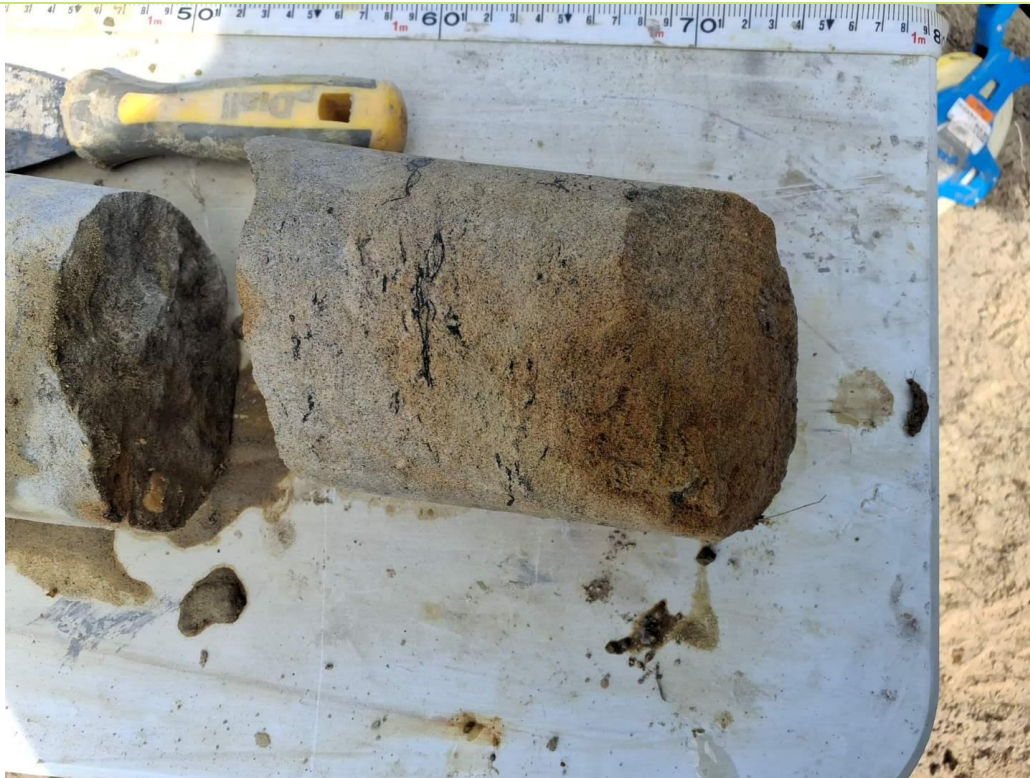
Plate 11 – Medium strong limestone from the Hythe Formation recovered from BH401.

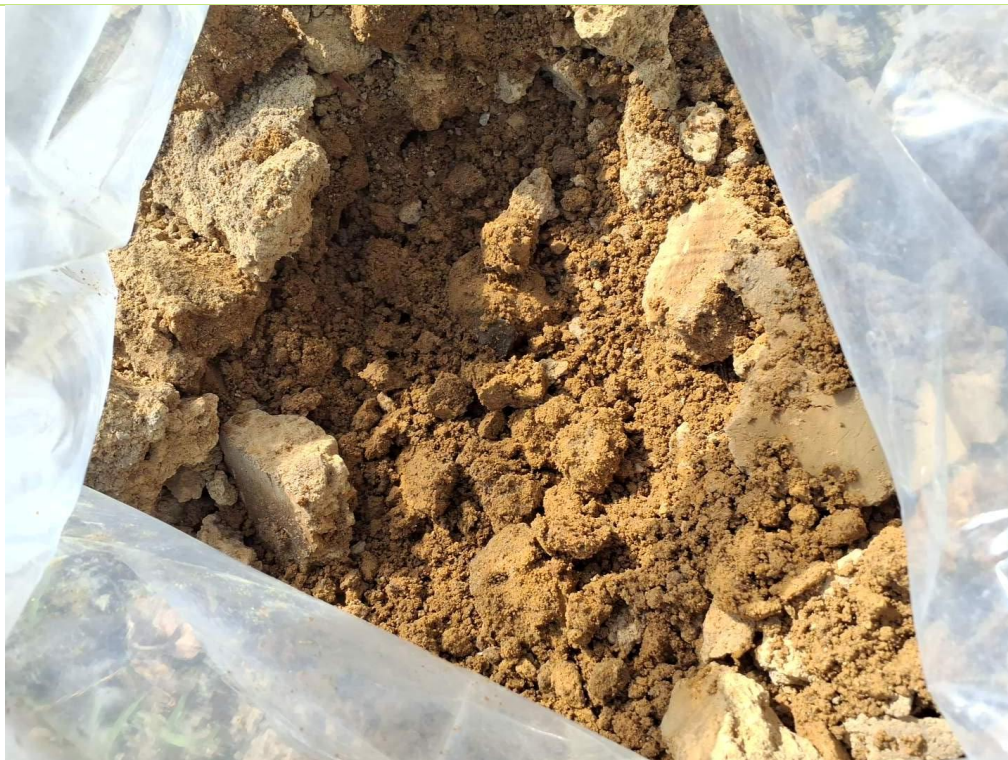
Plate 14 – Overview of slightly gravelly, silty sand of the weathered Hythe Formation from BH401.

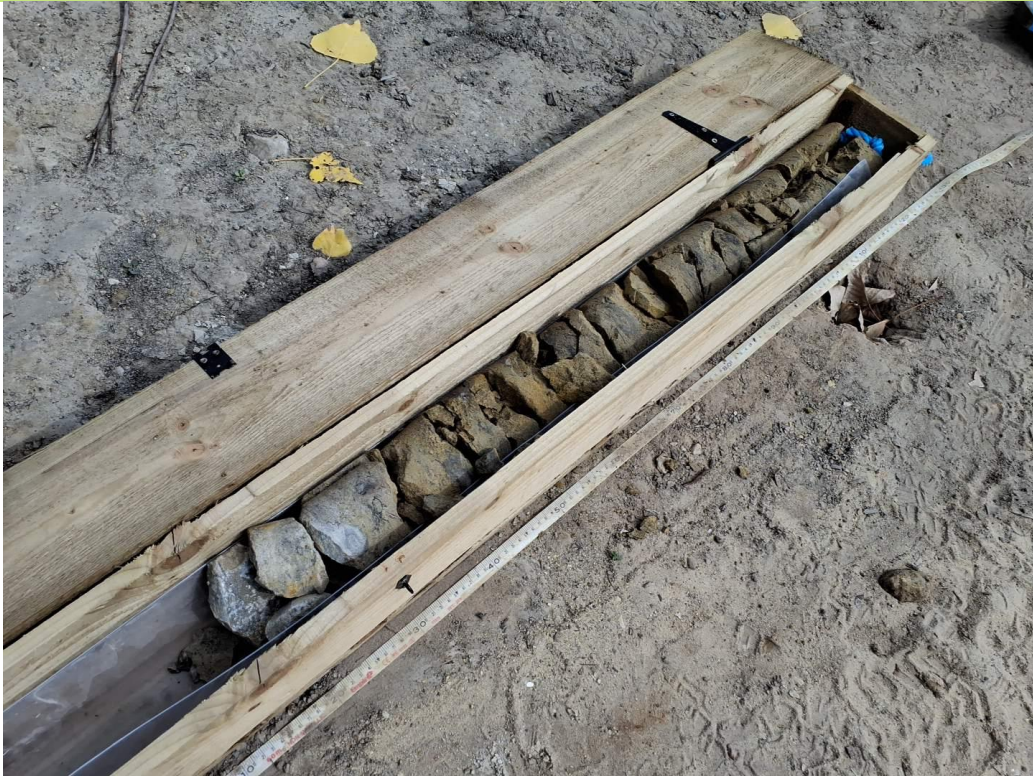
Plate 15 – Overview of interbedded limestone and sandstone in BH402

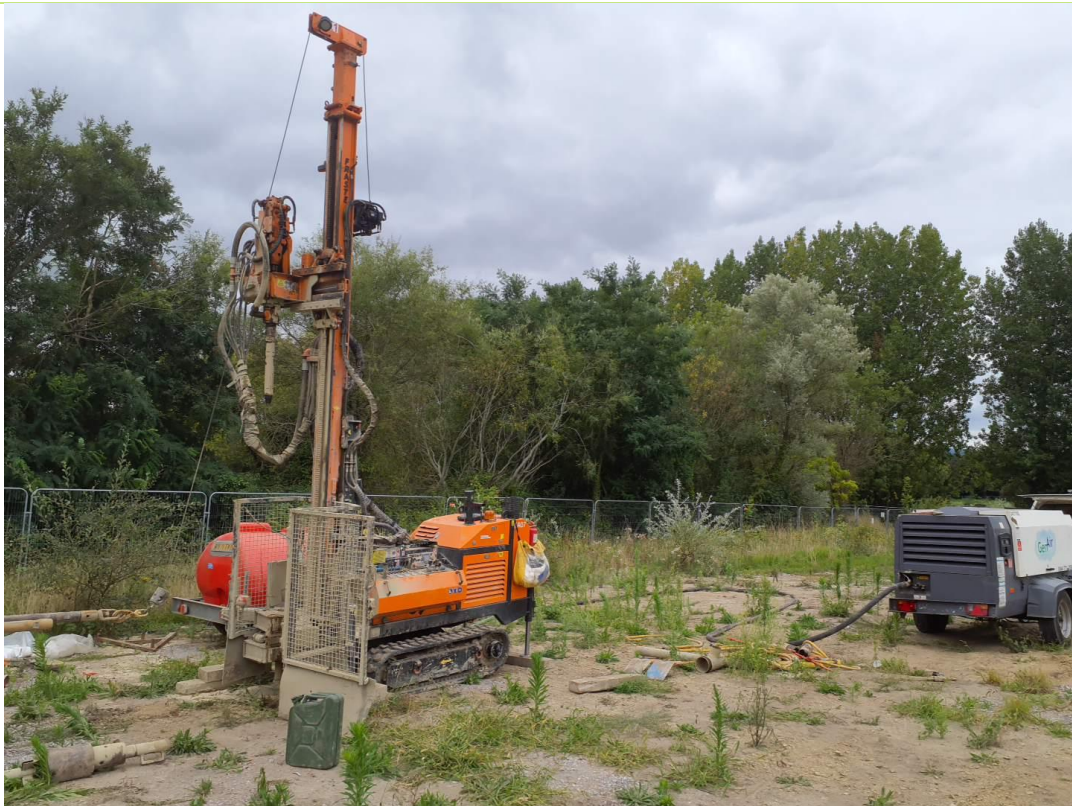
Plate 16 – Overview of BH404 being drilled using compressor.

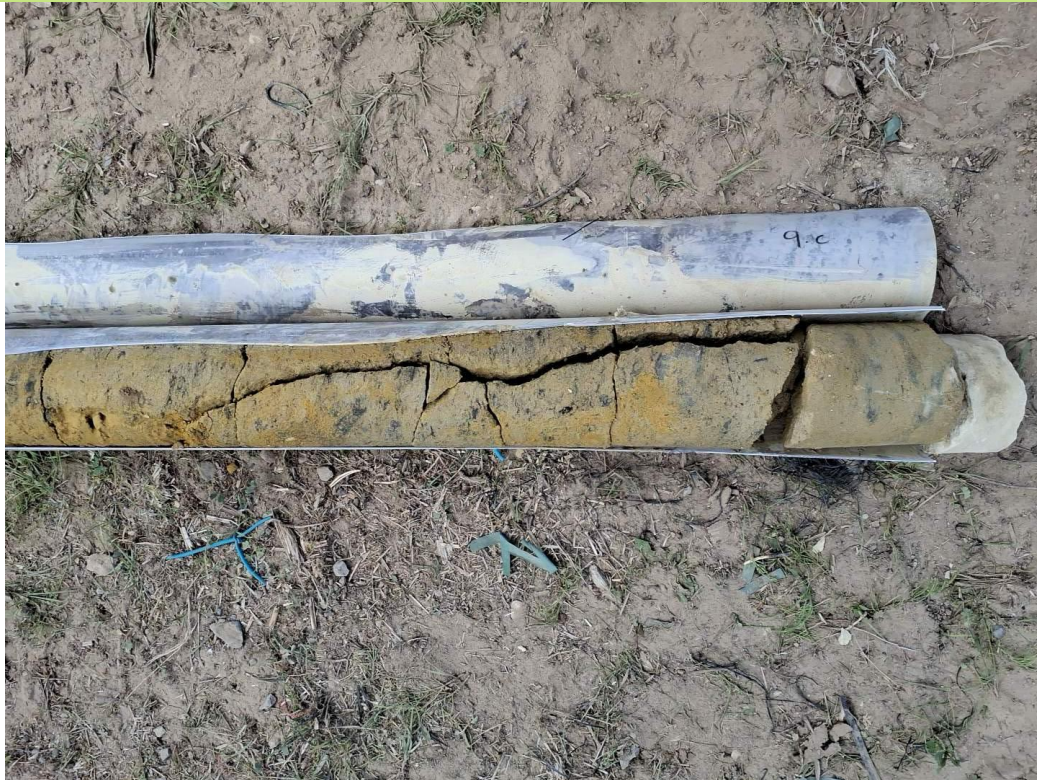
Plate 17 - Overview of sub-horizontal fracture in BH405

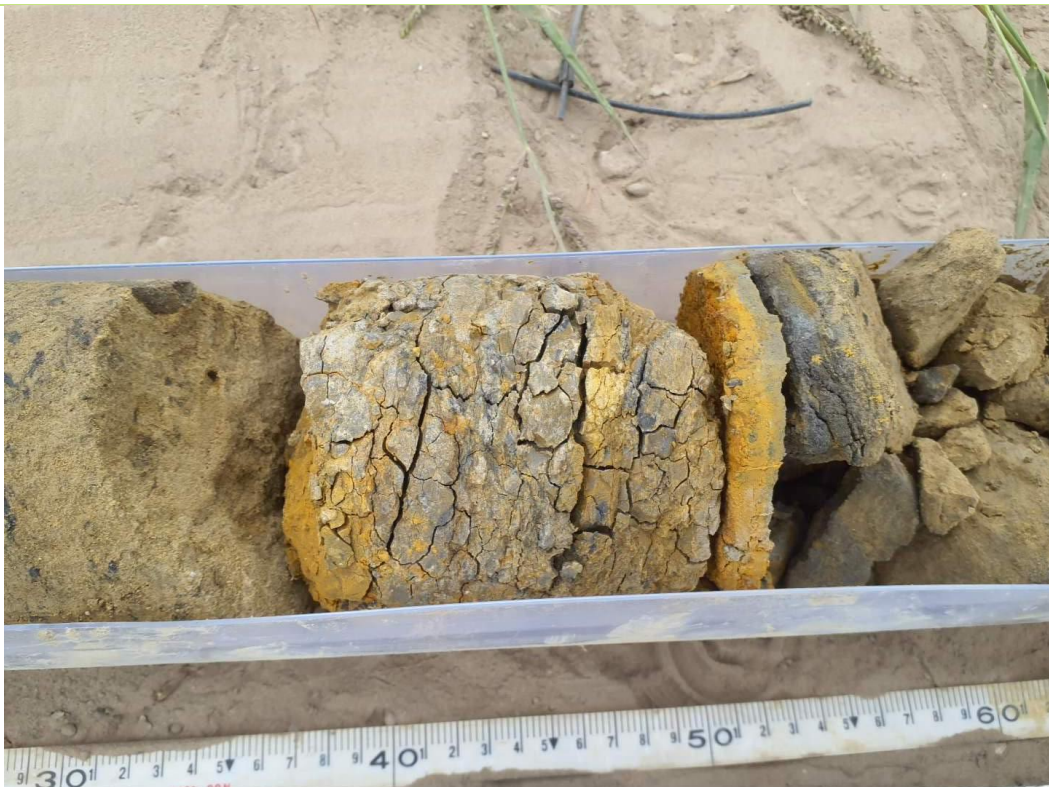
Plate 18 – Overview of horizon of dessicated clay within unweathered Hythe Formation in BH406

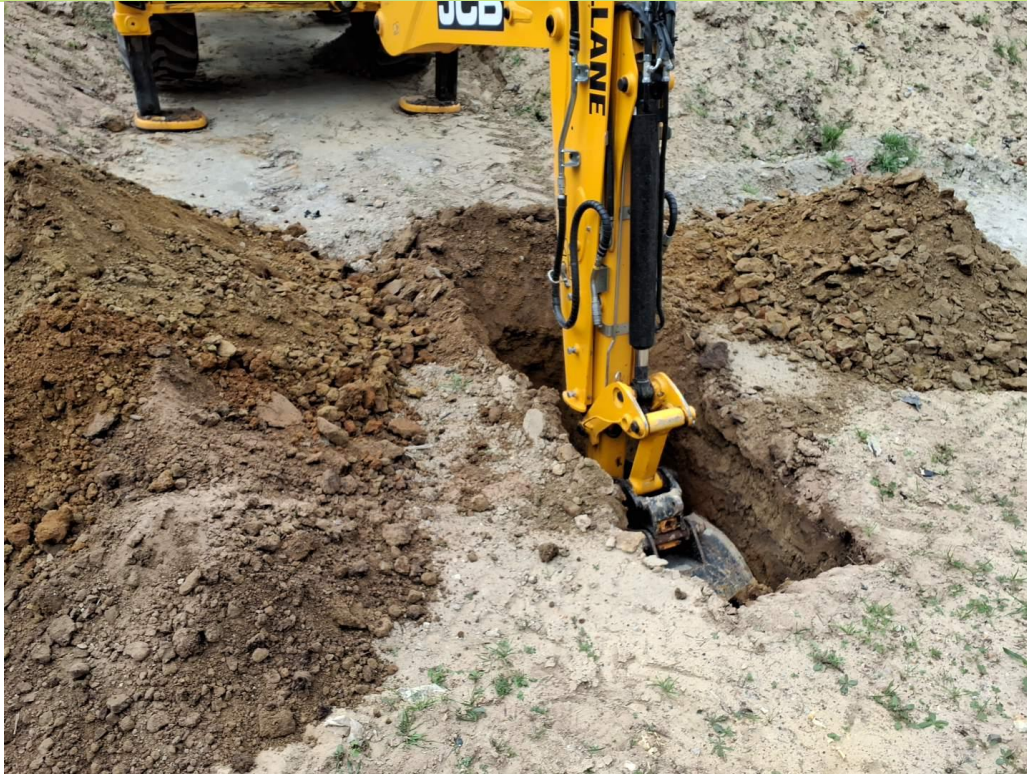
Plate 19 – Overview of trial pitting TP401 with JCB 3CX.

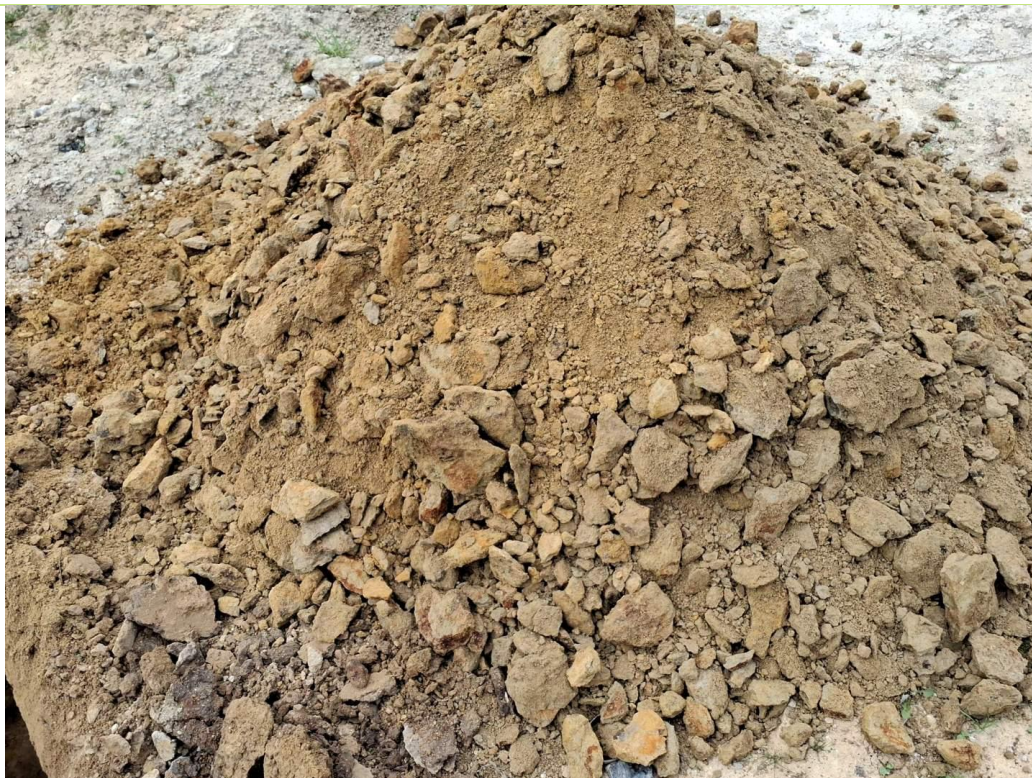
Plate 20 – Overview of Hythe Formation arisings from TP401

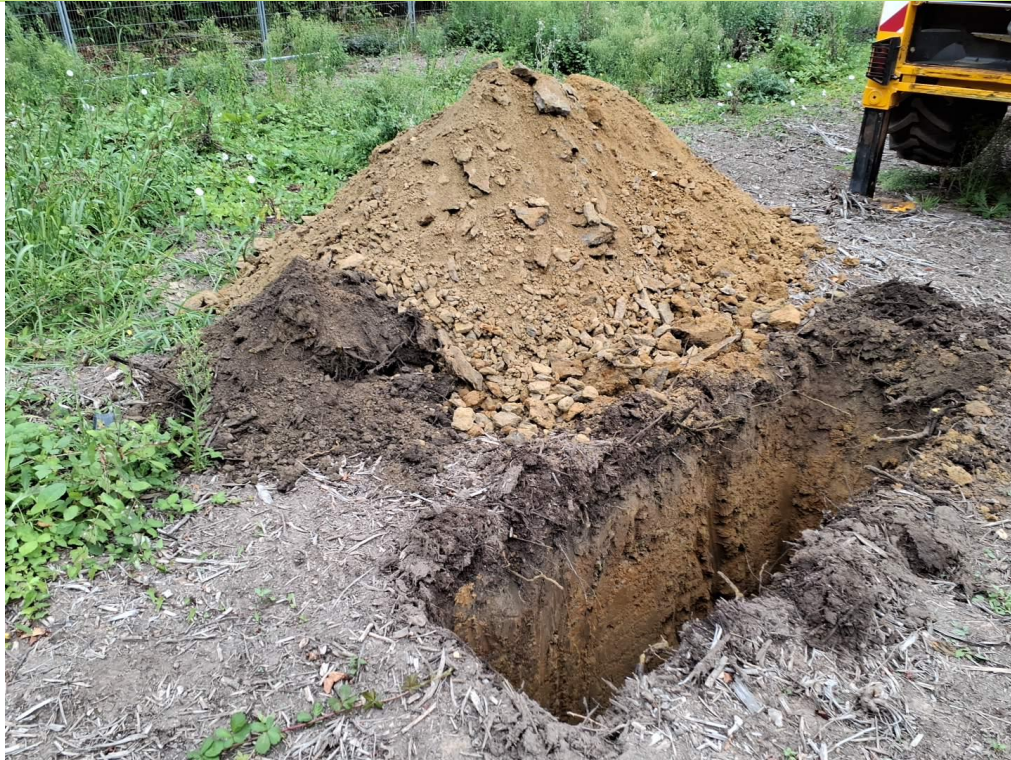
Plate 21 – Overview of topsoil and Hythe Formation from TP402

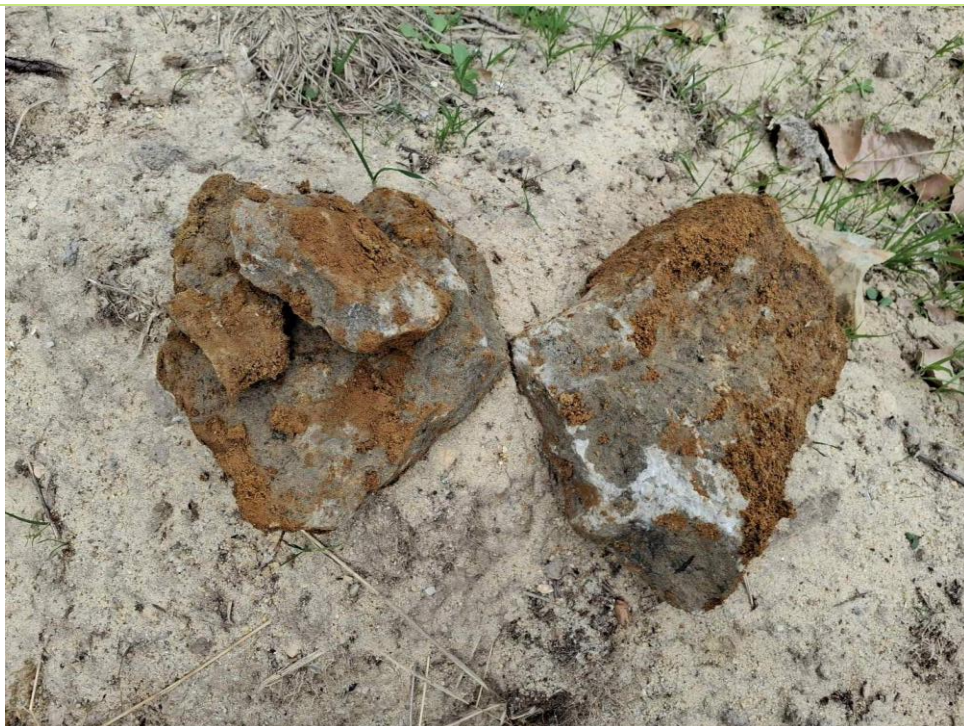
Plate 22 – Limestone gravels from TP409

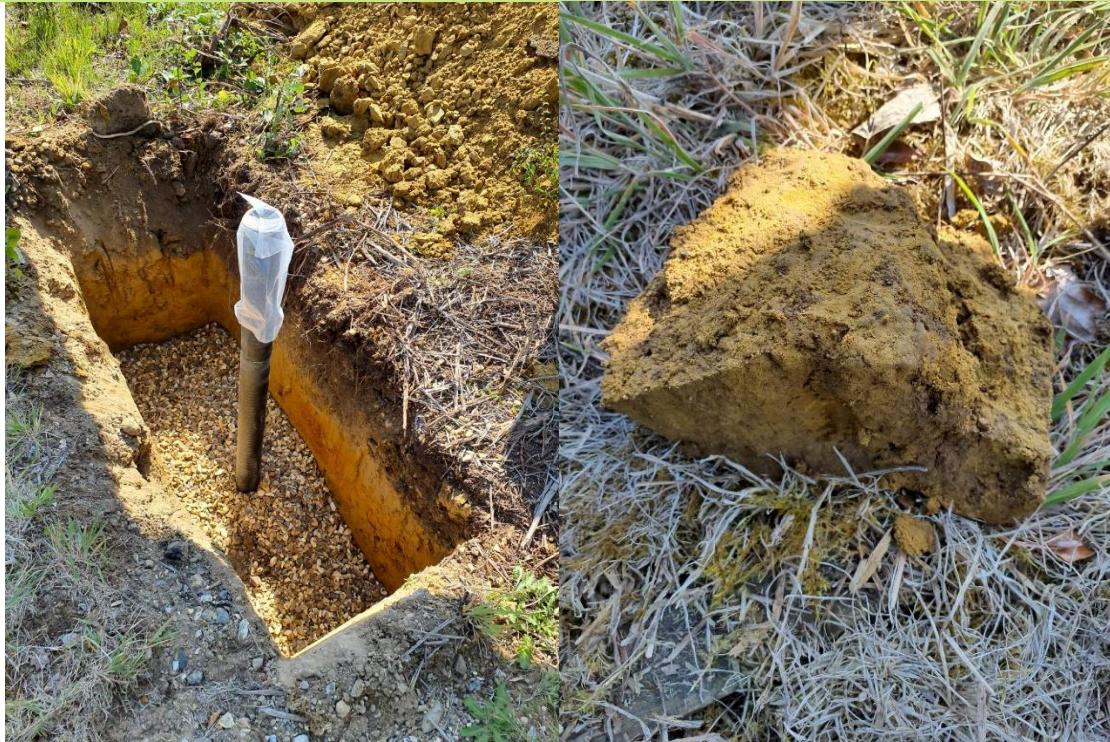
Plate 23 – Overview of SA401 installation (left) and sandy clay Head Deposit (right).

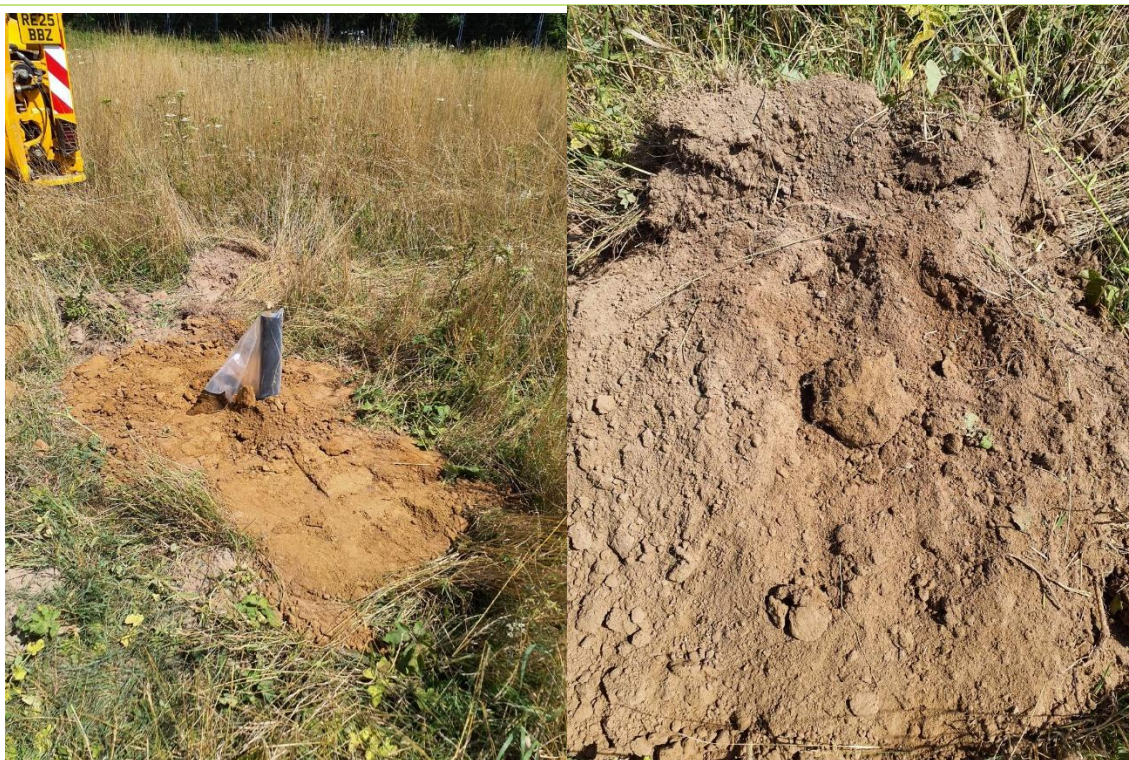
Plate 24 – SA403 installation (left) and recovered topsoil (right)
