OUR REFERENCE: 3750966/PWC

DATE: 03/11/2025

**RE: New Place Farm, Pulborough – Preliminary Waste Classification Report for 2 No. Stockpiles**

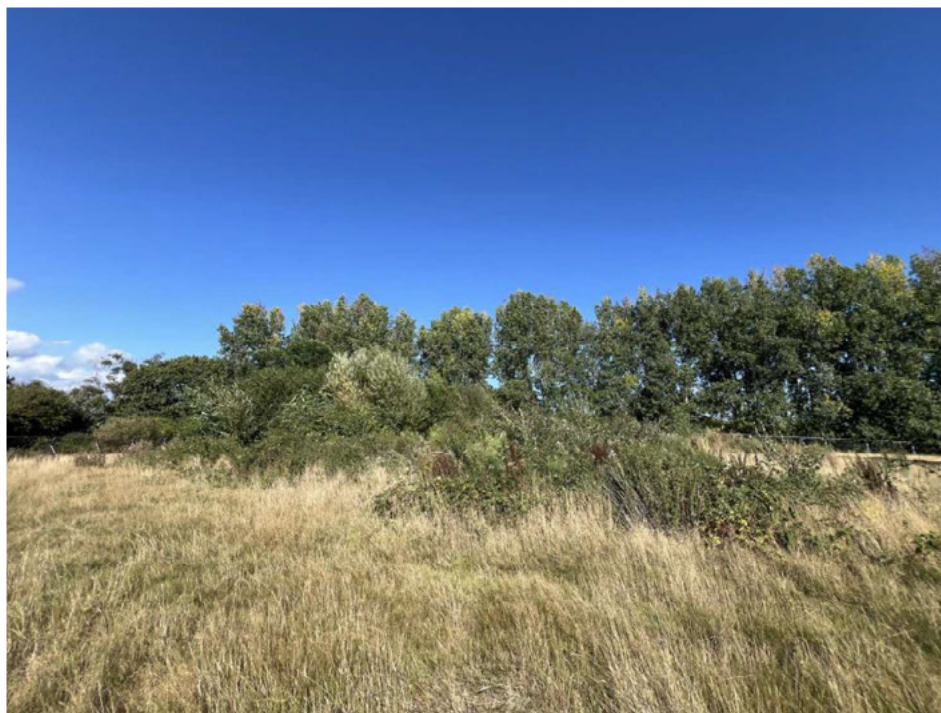
are illustrated in **Appendix B**, Drawing No. 3750966-LW-222-XX-D-G-22204-C01. Stockpile SP1 comprised plant/tree container arisings, with some pieces of broken plastic container. The arisings comprised brown gravelly and silty sandy loam with quartzite, sandstone and abundant roots and other woody plant material. Anthropogenic inclusions are estimated to comprise <1% of this stockpile, however vegetation matter is estimated to comprise up to 30% of this material, following excavation, if the vegetation is not segregated.

Plate 1 – Overview of plant pot arisings stockpile (SP1) in the northeastern region of the site.

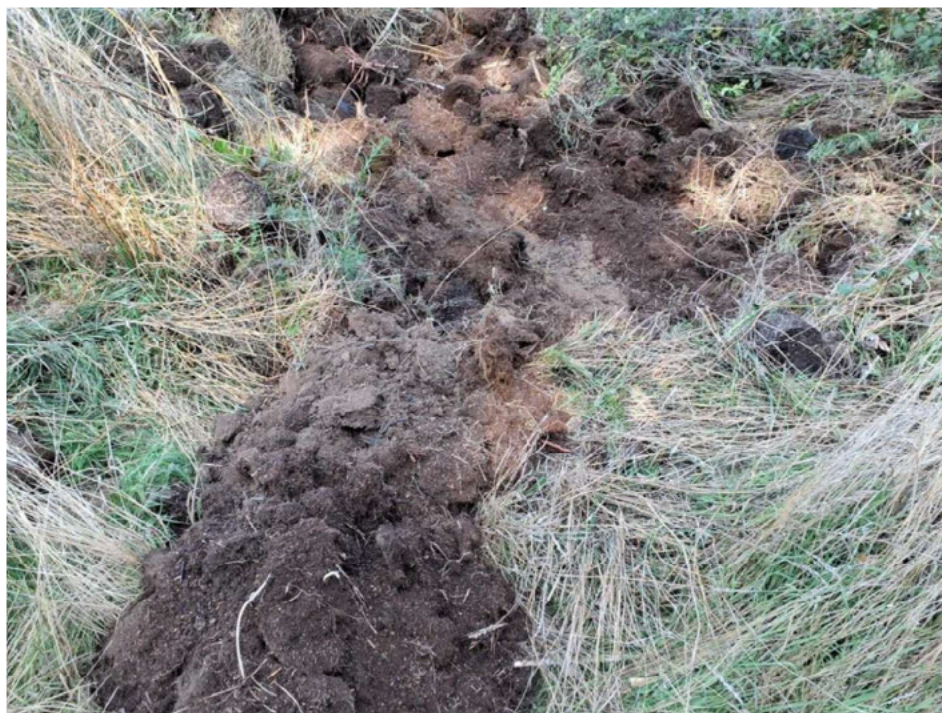
| Stockpile Ref No. | Estimated Volume (m³) | Sample Location | Description | Sample Depth & Testing Scheduled |
|---|---|---|---|---|
| SP1 | 300 | SP1-1 | 0.00 – 0.25: Spongy brown slightly sandy silty HUMUS with abundant rootlets. Sand is fine.<br>0.25 – 0.30: Light brown sandy slightly gravelly SILT with occasional plastic sheeting debris (2%) and woody material (2%). Sand is fine to medium. Gravel is subangular fine of sandstone. | 0.10 m: 1 No. RSK Hazardous Waste Suite with Classification |

Plate 3 – Overview of recovered arisings from sample location SP1-1.

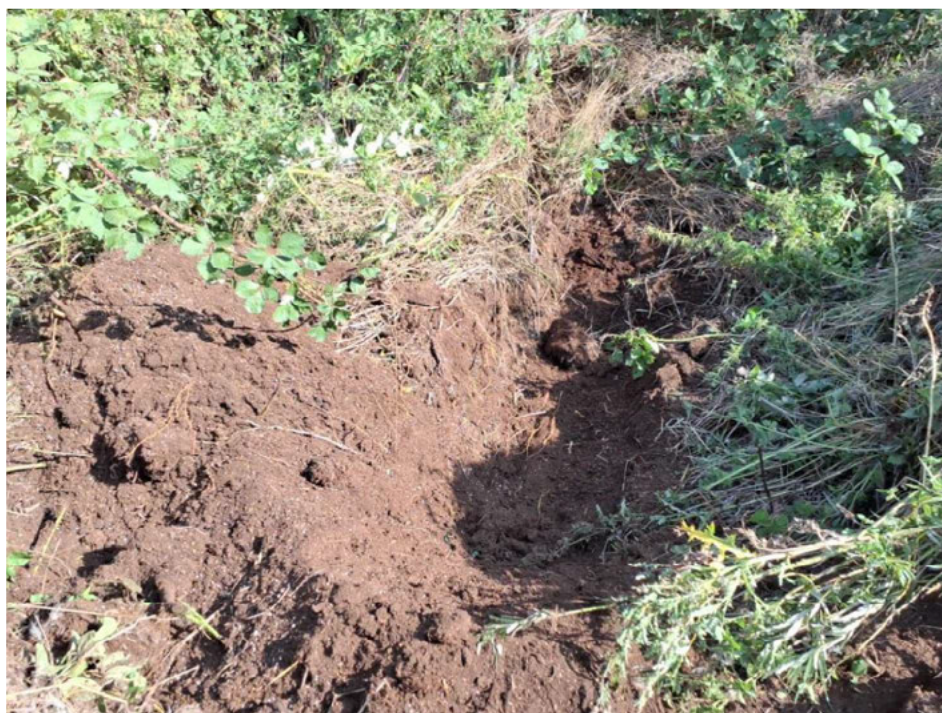
| Stockpile Ref No. | Estimated Volume (m³) | Sample Location | Description | Sample Depth & Testing Scheduled |
|---|---|---|---|---|
| | | SP1-2 | 0.00 – 0.30: Spongy brown slightly sandy silty HUMUS with abundant rootlets. Sand is fine. Rare plastic debris. | 0.15 m: 1 No. RSK Hazardous Waste Suite with Classification and 1 No. Single Stage 1:10 WAC E Inert |

Plate 4 – Overview of recovered arisings from sample location SP1-2.

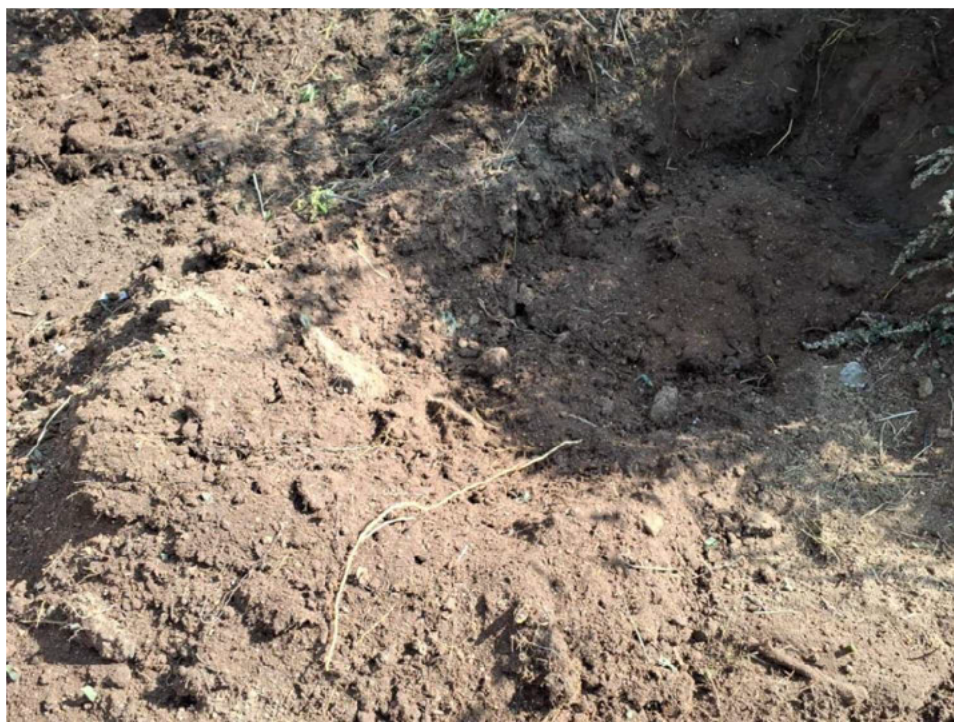
| Stockpile Ref No. | Estimated Volume (m³) | Sample Location | Description | Sample Depth & Testing Scheduled |
|---|---|---|---|---|
| | | SP1-3 | 0.00 – 0.30: Spongy brown slightly sandy silty HUMUS with abundant rootlets. Sand is fine. Occasional plastic debris (2%). | 0.20 m: 1 No. RSK Hazardous Waste Suite with Classification |

Plate 5 – Overview of recovered arisings from sample location SP1-3.

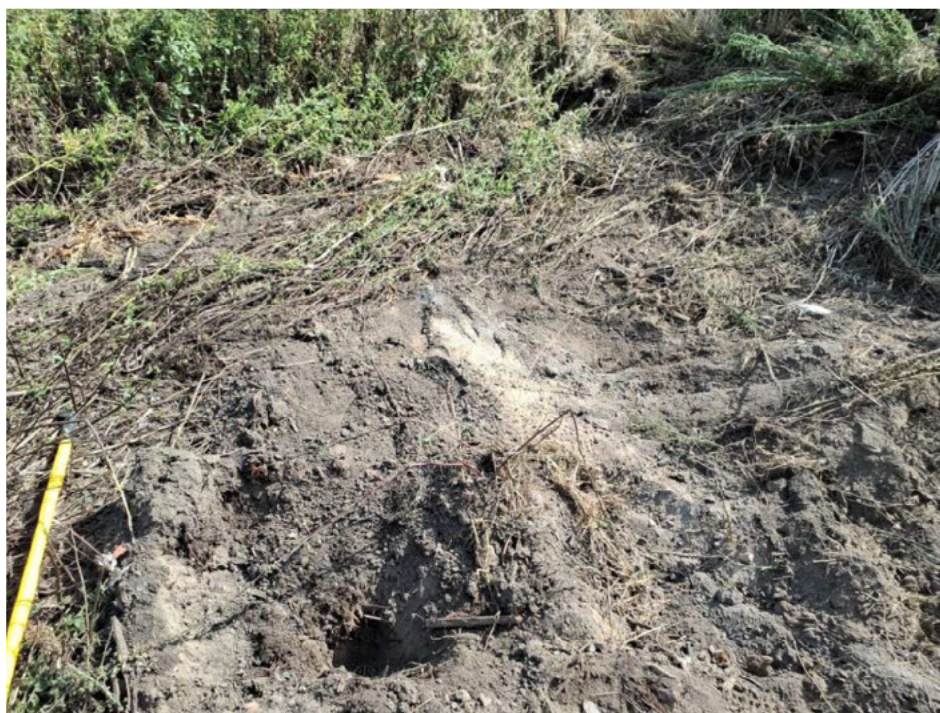
| Stockpile Ref No. | Estimated Volume (m³) | Sample Location | Description | Sample Depth & Testing Scheduled |
|---|---|---|---|---|
| SP2 | 150 | SP2-1 | 0.00 – 0.25: Light brown sandy slightly gravelly SILT. Sand is fine to medium. Gravel is angular to subrounded fine to medium sandstone with occasional plastic debris (2%), rare ceramic tile (1%), and occasional charcoal (2%).<br>0.25 – 0.30: Orangish brown sandy SILT. Sand is fine to medium. | 0.15 m: 1 No. RSK Hazardous Waste Suite with Classification |

Plate 6 – Overview of recovered arisings from sample location SP2-1.

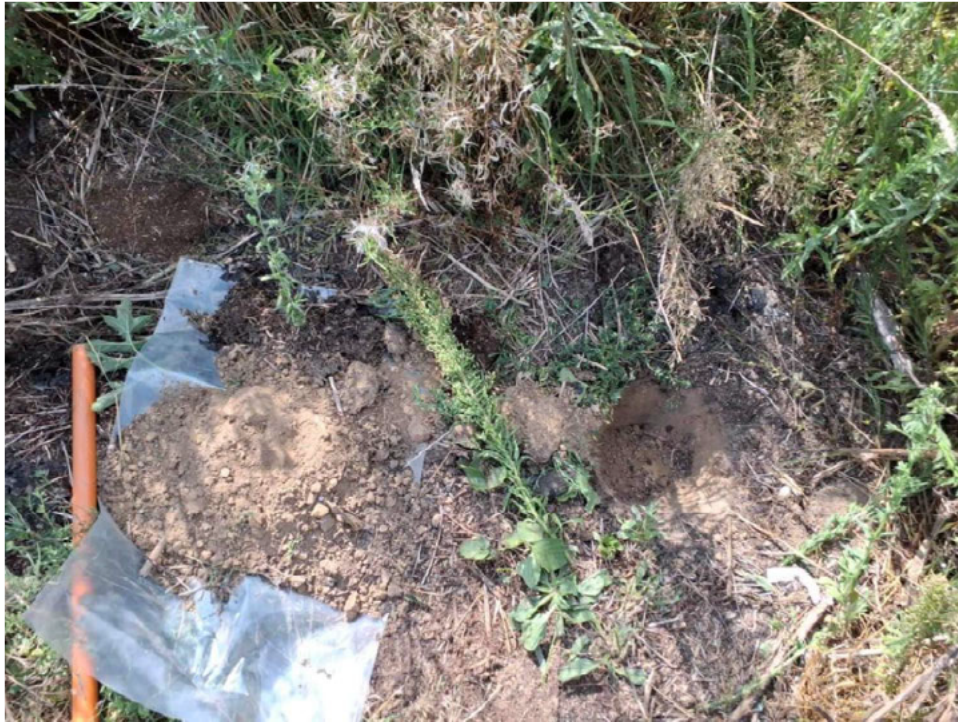
| Stockpile Ref No. | Estimated Volume (m³) | Sample Location | Description | Sample Depth & Testing Scheduled |
|---|---|---|---|---|
| | | SP2-2 | 0.00 – 0.05: Brown sandy SILT with remains of burnt vegetation (2%) and rare charcoal (1%).<br>0.05 – 0.15: Light brown sandy slightly gravelly SILT. Sand is fine to medium. Gravel is fine to medium, subangular to subrounded sandstone. | 0.10 m: 1 No. RSK Hazardous Waste Suite with Classification |

Plate 7 – Overview of recovered arisings from sample location SP2-2.

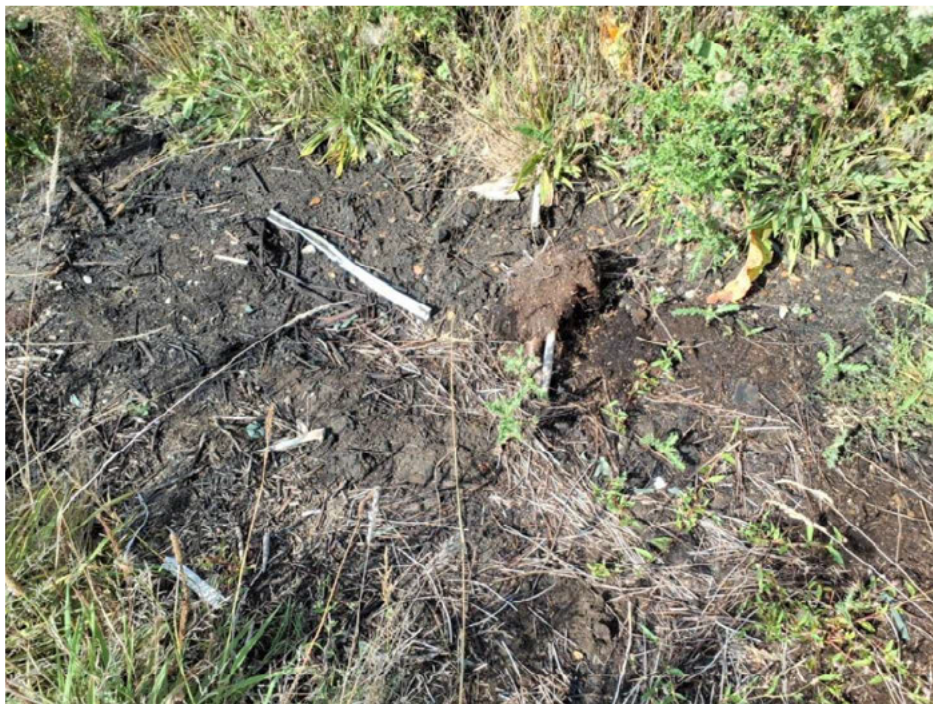
| Stockpile Ref No. | Estimated Volume (m³) | Sample Location | Description | Sample Depth & Testing Scheduled |
|---|---|---|---|---|
| | | SP2-3 | 0.00 – 0.15: Blackish brown and brown slightly sandy slightly gravelly clayey SILT with burnt and decayed vegetation. Sand is fine to medium. Gravel is subangular to rounded flint pebbles and ceramic tile fragments, charcoal. Strong organic odour.<br>0.15 – 0.30: Light orangish brown and brown sandy clayey SILT. Sand is fine to medium.<br>0.30 – 0.45: Light orangish brown slightly sandy silty CLAY. Sand is fine to medium. | 0.10 m: 1 No. RSK Hazardous Waste Suite with Classification and 1 No. Single Stage 1:10 WAC E Inert<br>0.20 m: LEAP Standard Soil Suite (Suite E) |

Plate 8 – Overview of sample location SP2-3.

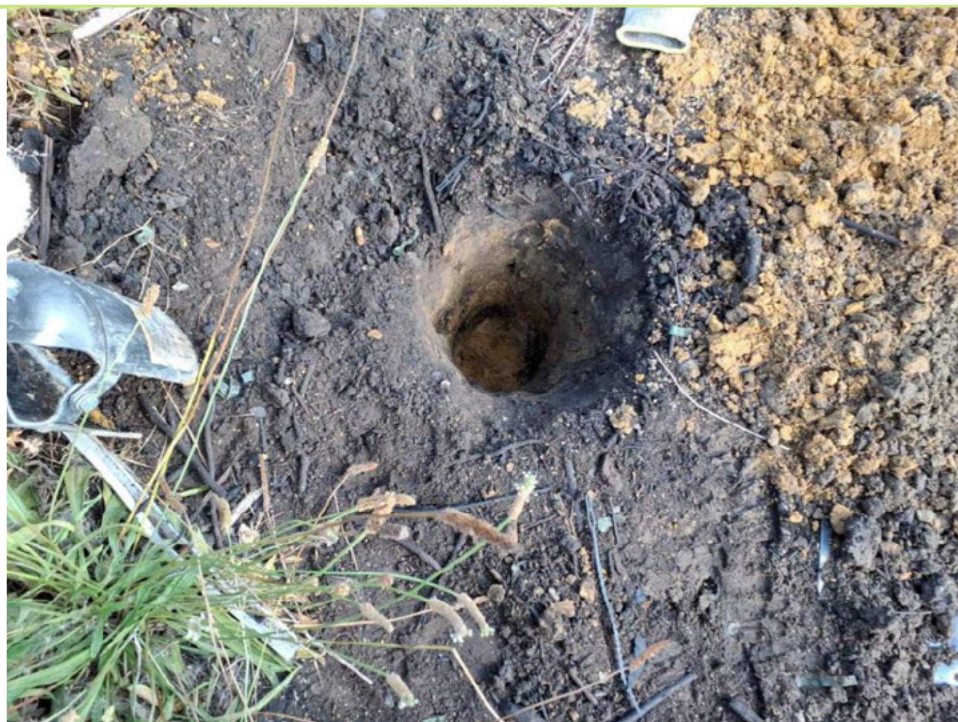
Plate 9 – Overview of hand-dug pit for sample location SP2-3.

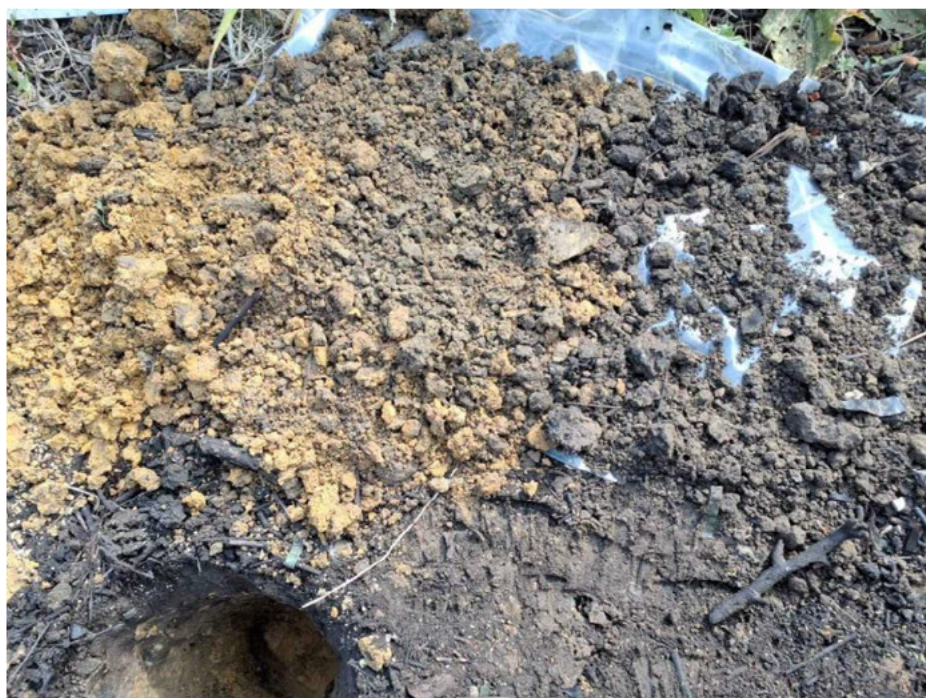
It should be noted though however that elevated TPH was identified in Sample SP2-3 (21,438 mg/kg corrected to wet weight). The laboratory ID confirmed unknown hydrocarbons and no petrol/diesel; therefore, we can potentially assess as unknown oil. Additionally, no visible or olfactory evidence of hydrocarbons were noted during the sampling of stockpile SP2, however it is likely that any identified hydrocarbons are associated with engine oil or greases/lubricants used for maintenance on farming machinery. In order to assess this elevated TPH, and in accordance with the EA's WM3 Technical Guidance, where TPH from an unknown oil source is greater than 0.1% (ie 1,000 mg/kg), then benzo[a]pyrene (BaP) may be used as a marker compound to assess if the waste exhibits HP7 carcinogenic and HP11 mutagenic hazardous waste properties. Using this marker compound assessment, if the BaP concentration is less than 0.01% (1/10,000th) of the TPH concentration, the oil contaminating the waste may be classified as non-carcinogenic/non-mutagenic. The recorded BaP concentration for sample SP2-3 is 0.031 mg/kg (corrected to wet weight). Therefore, the concentration is less than 0.01% of the TPH concentration, and as a result, this sample was assessed as non-hazardous due to TPH where the oil source considered to have arisen from an 'unknown oil'.

Plate 10 – Overview of recovered arisings from sample location SP2-3.

For sample SP2-3 at 0.20 m, no TPH testing was carried out and therefore the assessment for these soils should be considered incomplete and classification of this material should be tentative unless further testing is carried out, especially as the TPH concentration of the overlying material is particularly elevated.
