## VERIFICATION REPORT

**15-22 FAIRFIELD COTTAGES  
(FORMERLY 15-18  
FAIRFIELD COTTAGES)  
COWFOLD  
WEST SUSSEX**

**PROJECT REFERENCE: C17051**

**REPORT REFERENCE: R17250**

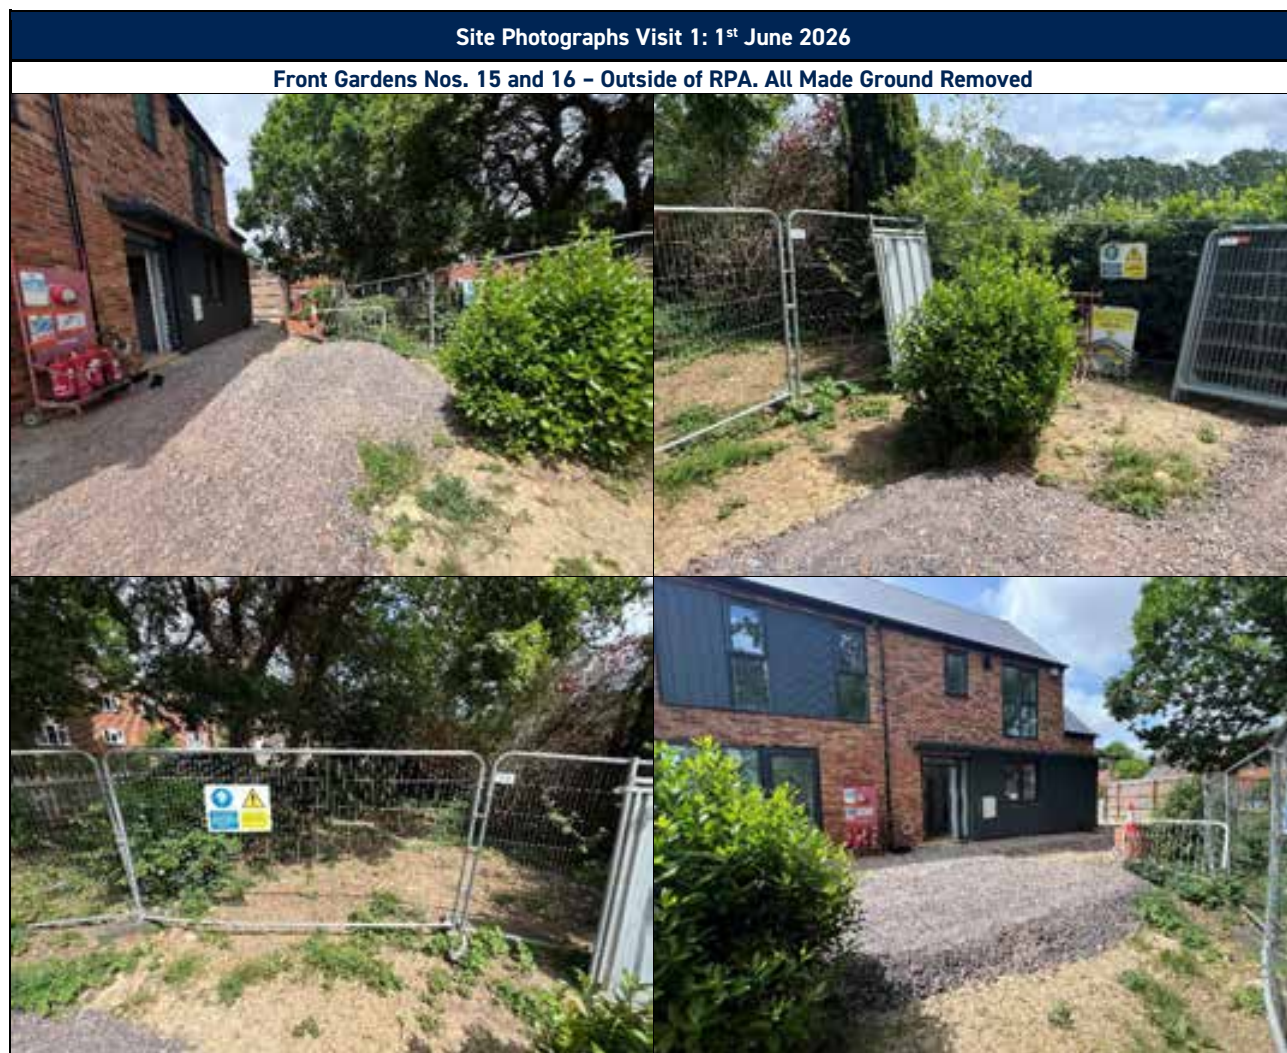
**Site Photographs Visit 1: 1<sup>st</sup> June 2026**

It is noted that a larger area of patio/pathway has been constructed compared with the original plan to the front of Nos. 15 and 16, and consequently the areas of soft landscaping are smaller than that shown on the plan in Appendix A. In addition, there is now no soft landscaping to the rear of No. 15.

**Rear Gardens Nos. 15 (no soft landscaping), 16 and 17. All Made Ground Removed**

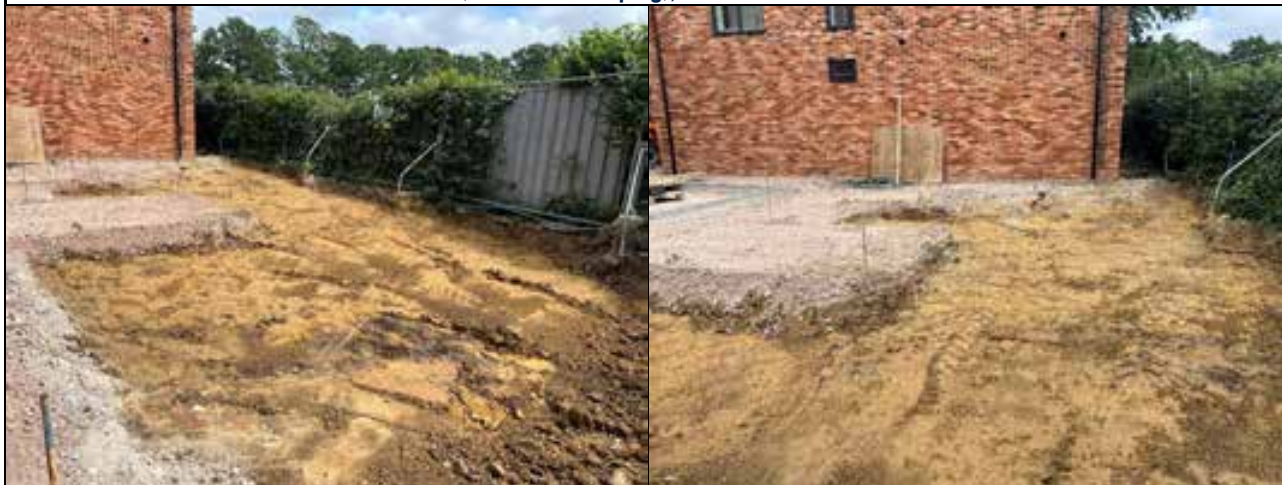
**Rear Gardens Nos. 17 and 18. All Made Ground Removed**

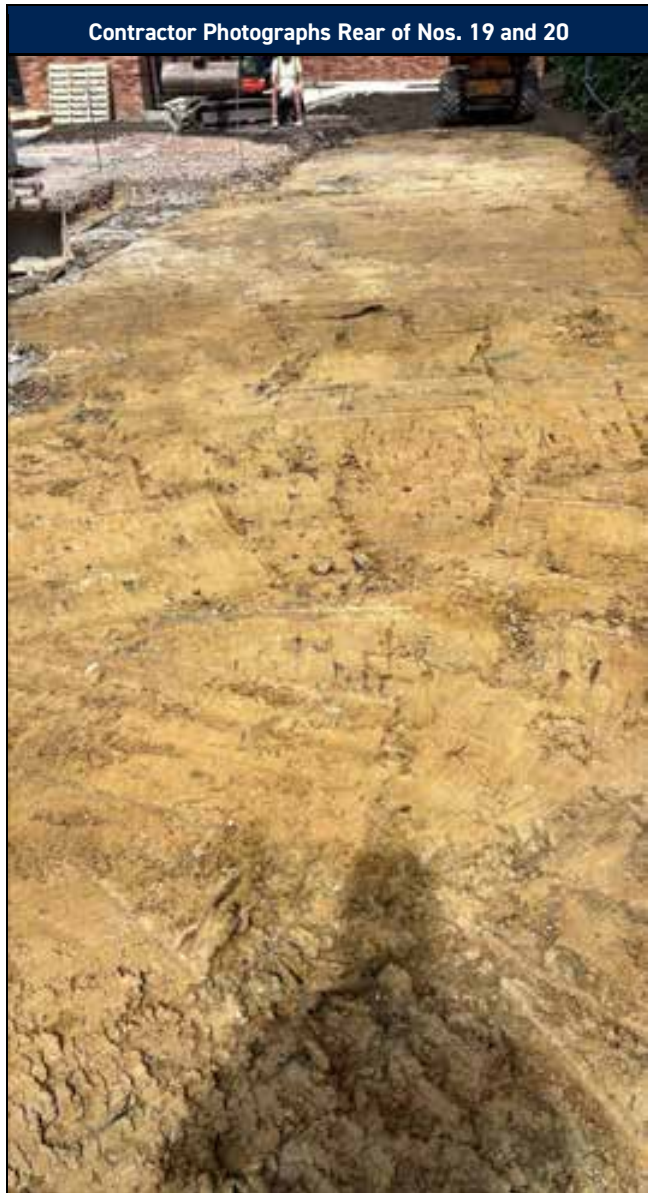
As the stripping works continued, the following photo was provided by the contractor showing the rear gardens of Nos. 19 and 20 with all made ground removed and the undisturbed soils at the formation level.

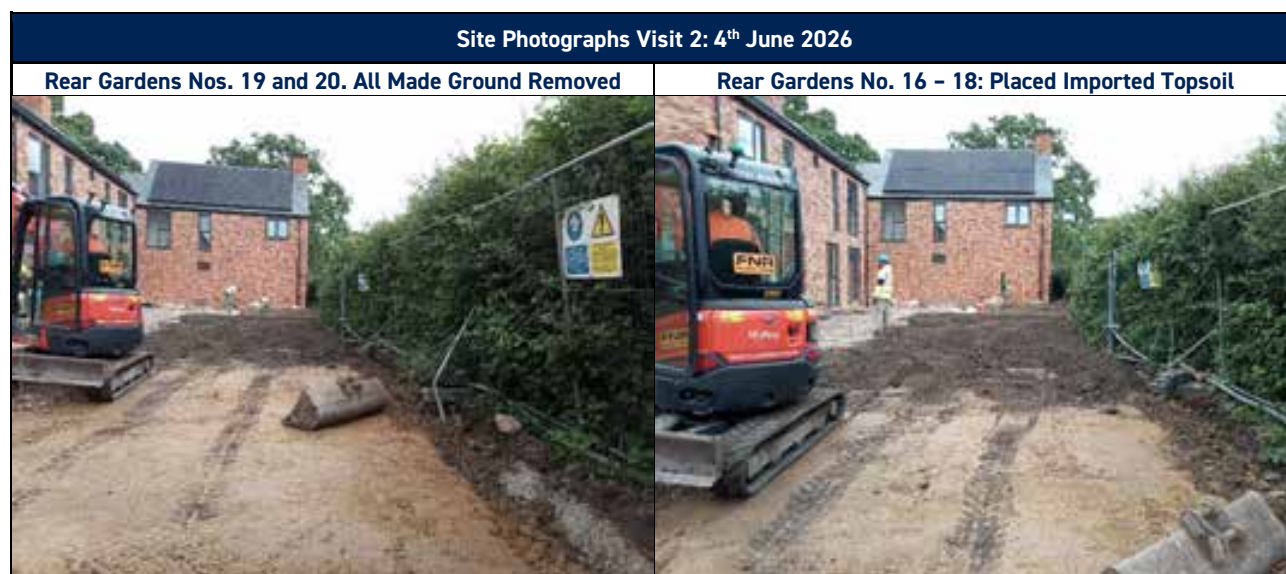
Site Photographs Visit 2: 4<sup>th</sup> June 2026

TS01

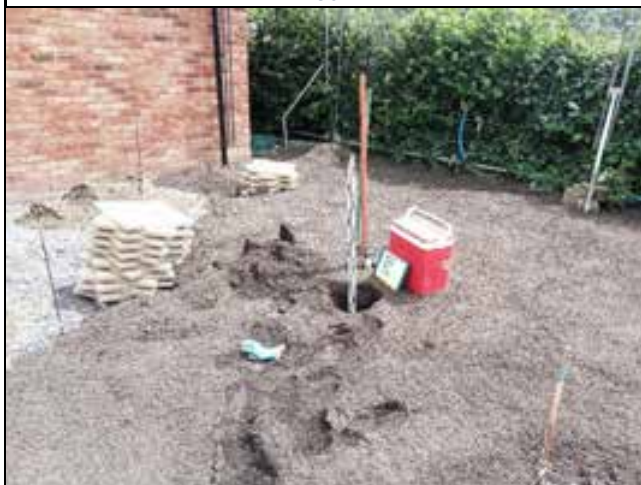
TS01 - Depth of Imported Topsoil

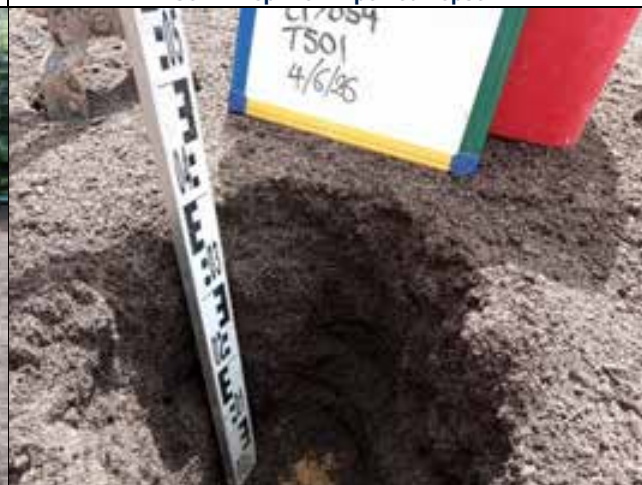
TS01 - Weald Clay Formation at Base of Excavation

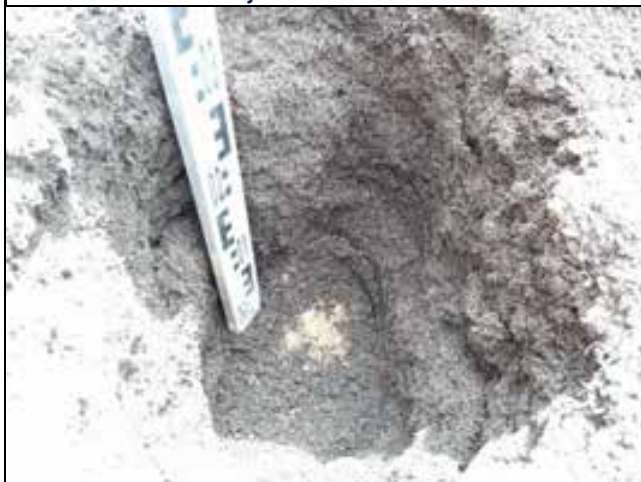
TS02

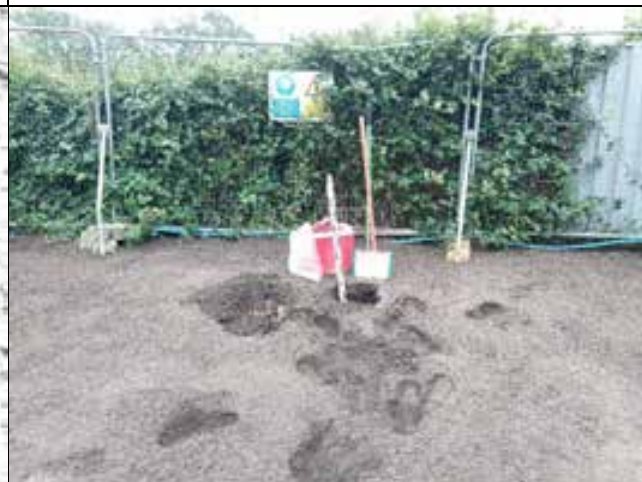
TS02 - Depth of Imported Topsoil

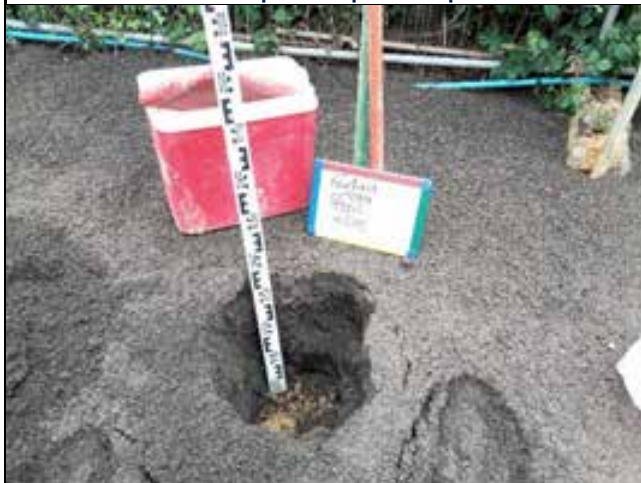
TS02 - Weald Clay Formation at Base of Excavation

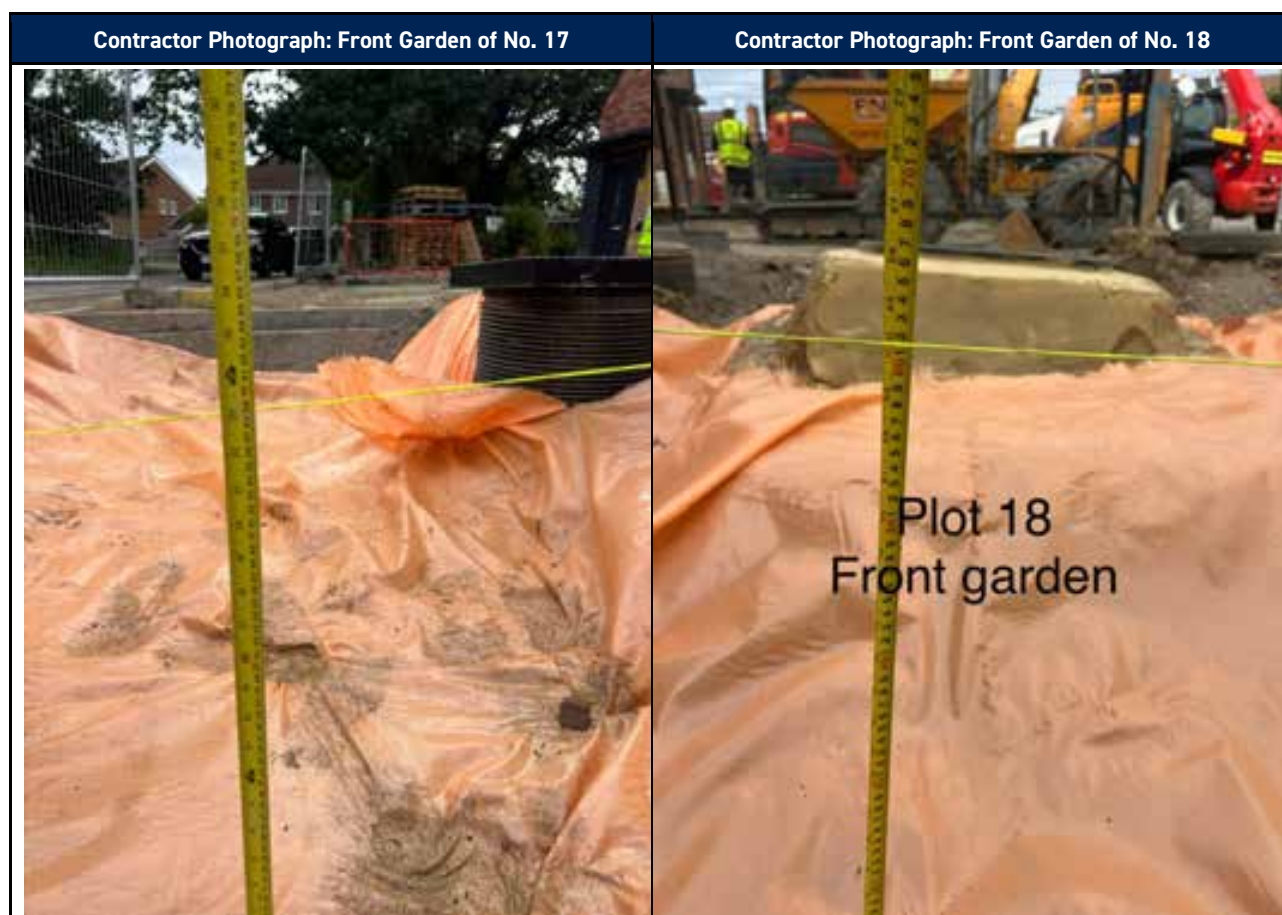
Contractor Photograph: Front Garden of Nos. 19 and 20

The contractor proceeded to install the cover system in the front gardens of Nos. 17 – 22 and in the rear garden of No. 21. Photographs were provided by the contractor showing the installation of the high visibility geotextile marker with tape measurements demonstrating that sufficient space (>600mm) was available for the placement of the cover soils in the front gardens of Nos. 17 - 20.

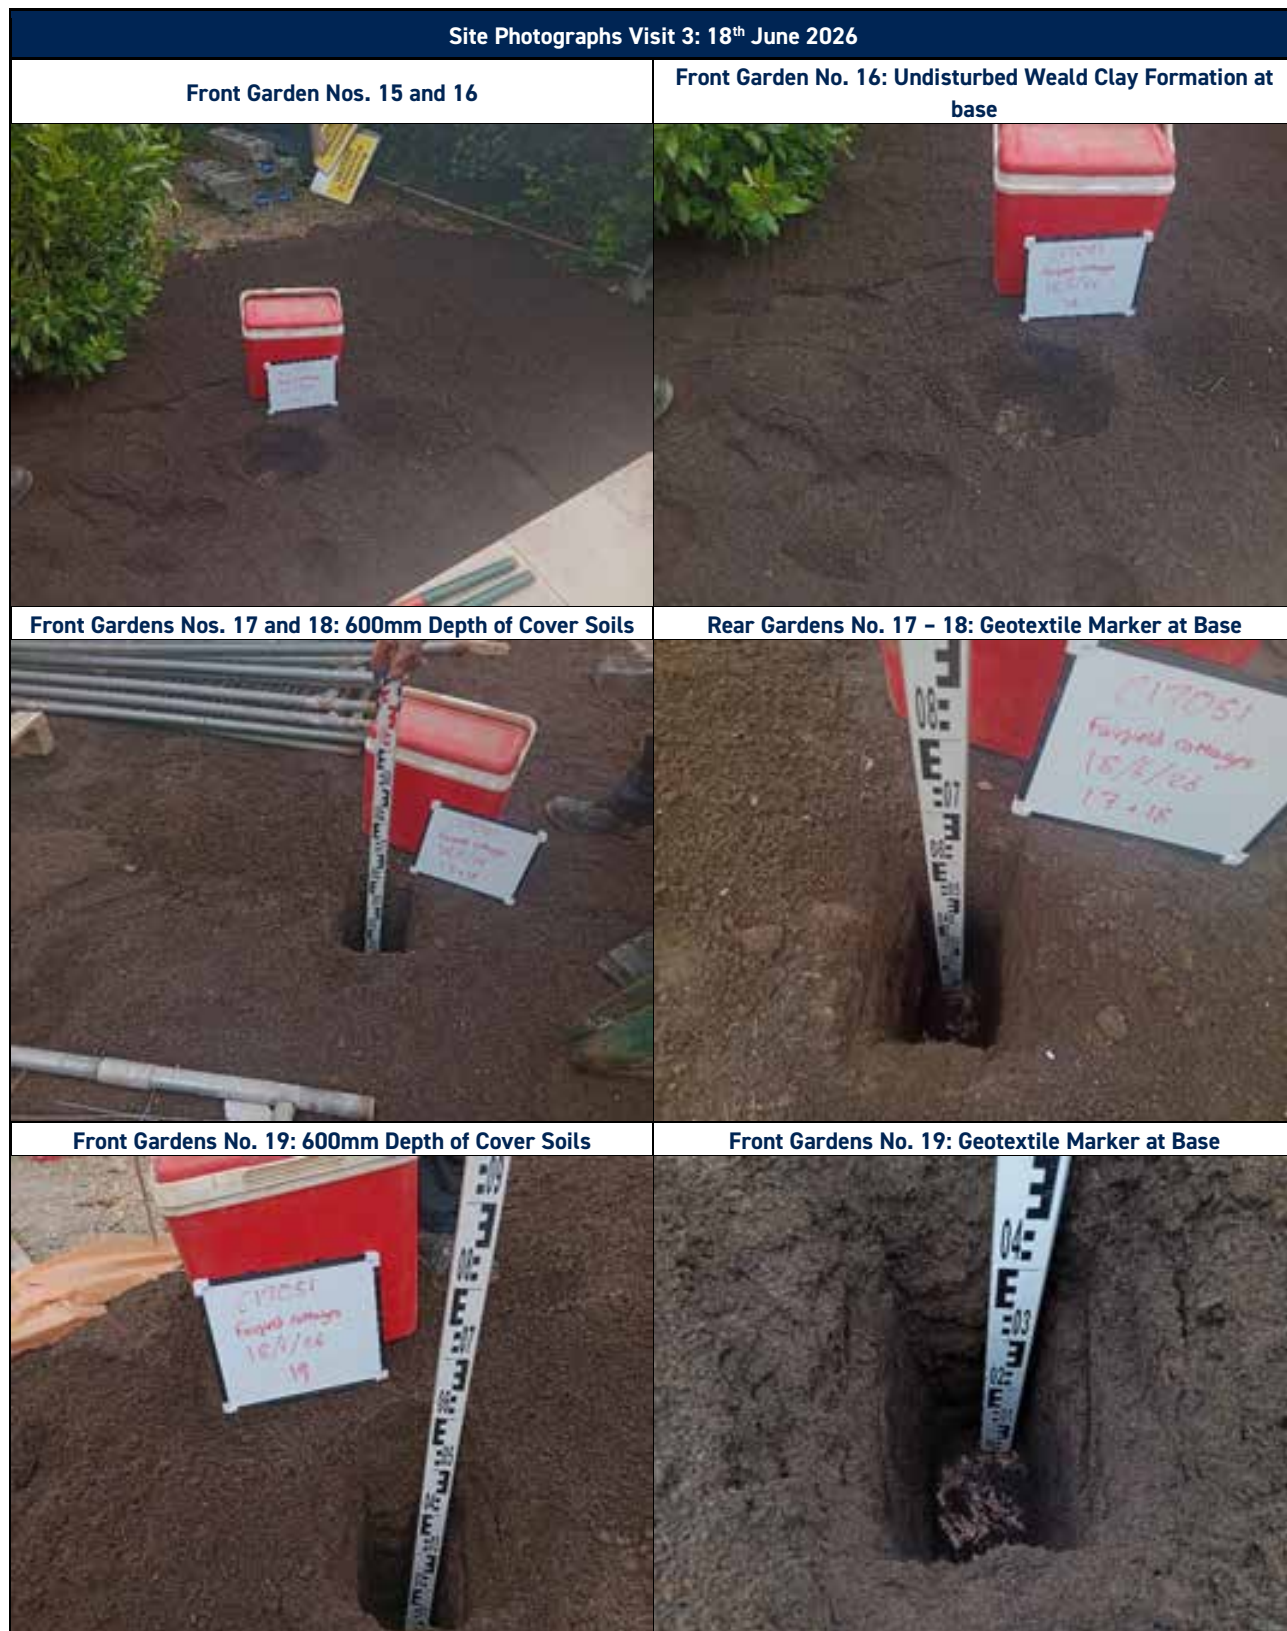
Site Photographs Visit 3: 18<sup>th</sup> June 2026

Imported Topsoil to be Placed

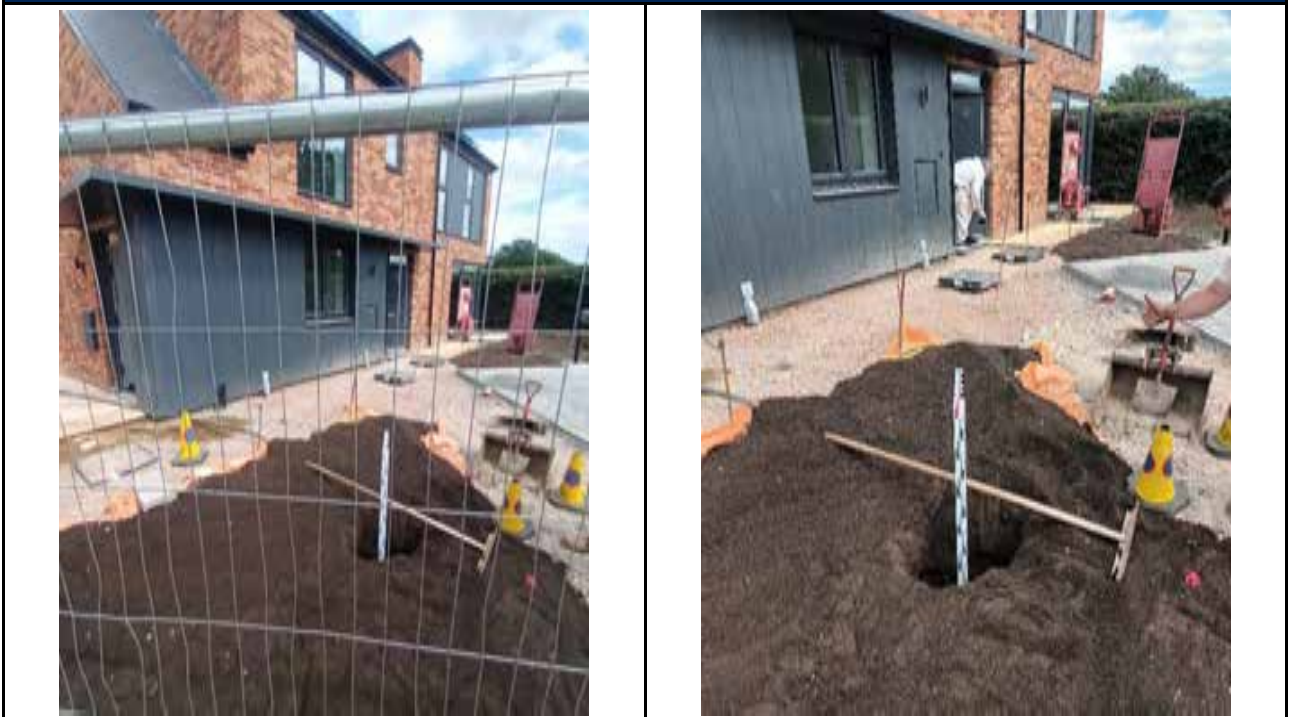
Contractor Photograph: Landscaped Area to the Front of No. 21

- Provision of 600mm of topsoil placed above a high visibility marker in the landscaped area to the front of No. 21.

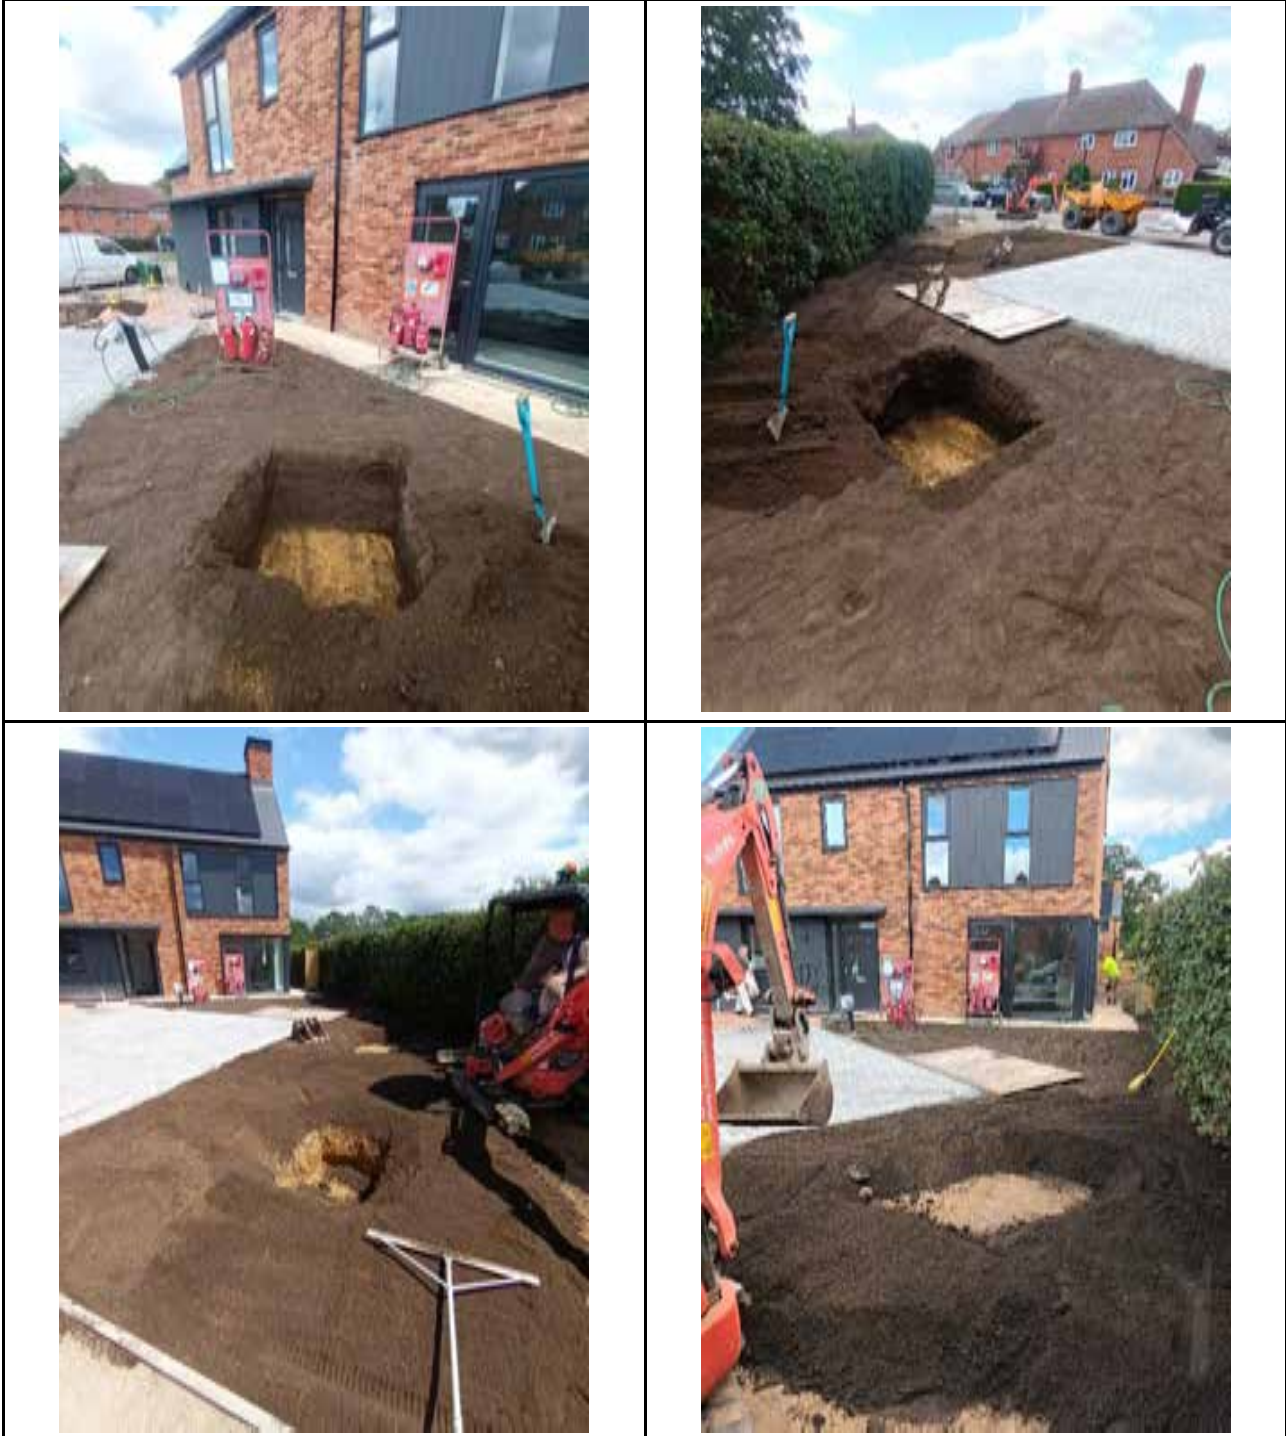
**Contractor Photograph: Landscaped Area to the Front of No. 22**

- Evidence of the removal of all made ground soils from beneath the placed topsoil in the landscaped area to the front of No. 22 and around the parking spaces.

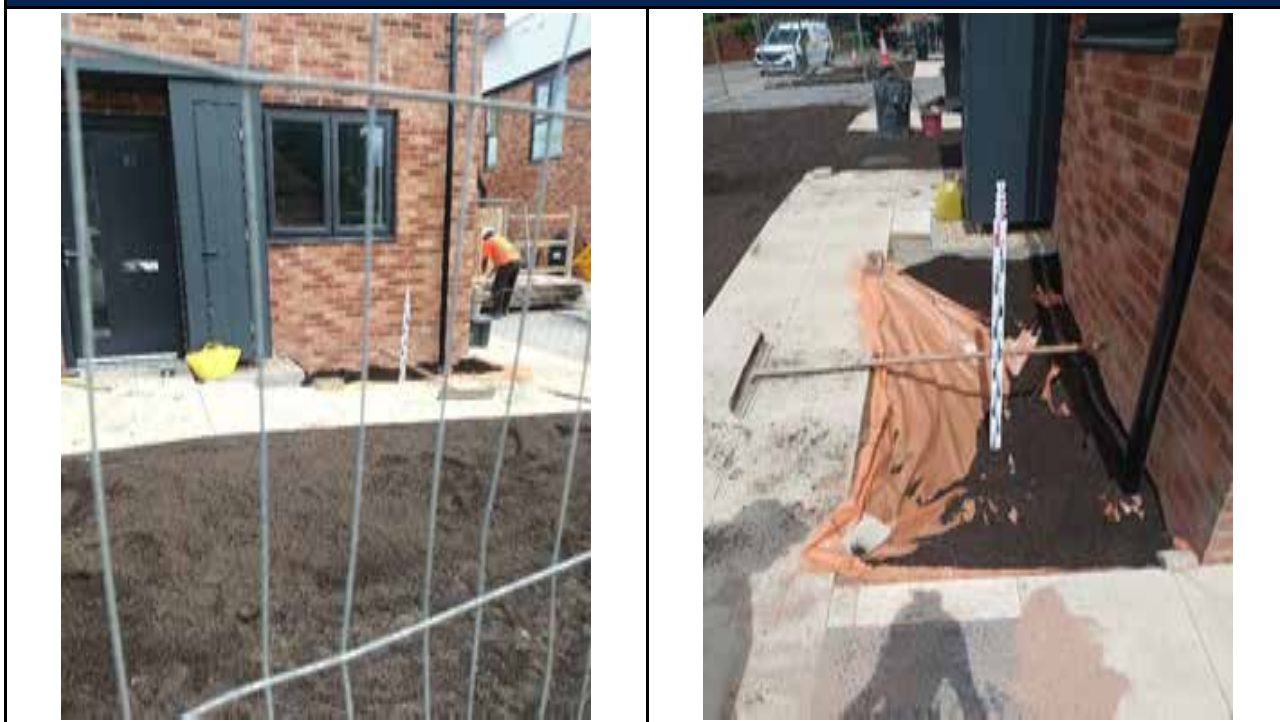
Contractor Photograph: Narrow Landscaped Area to the Front of No. 20

- 450mm of topsoil with a high visibility marker at the base in the narrow landscaped area to the front of No. 20.

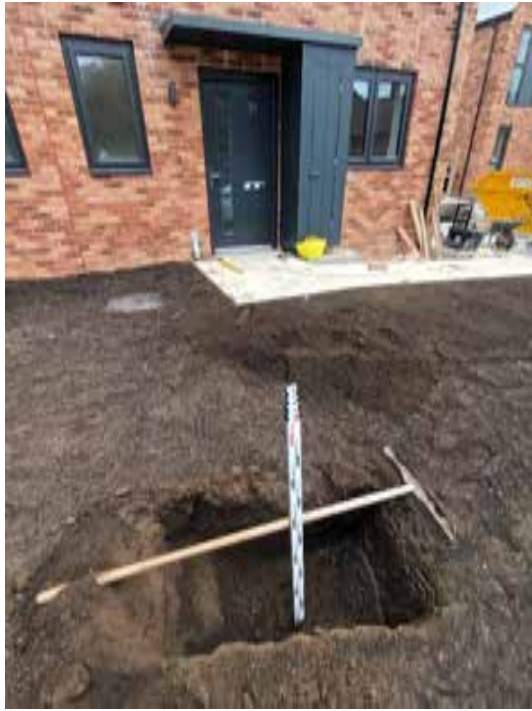
Contractor Photograph: Tree Pit – Front Garden No. 20

- 500mm of topsoil in the location of the tree pit in the front garden of No. 20.

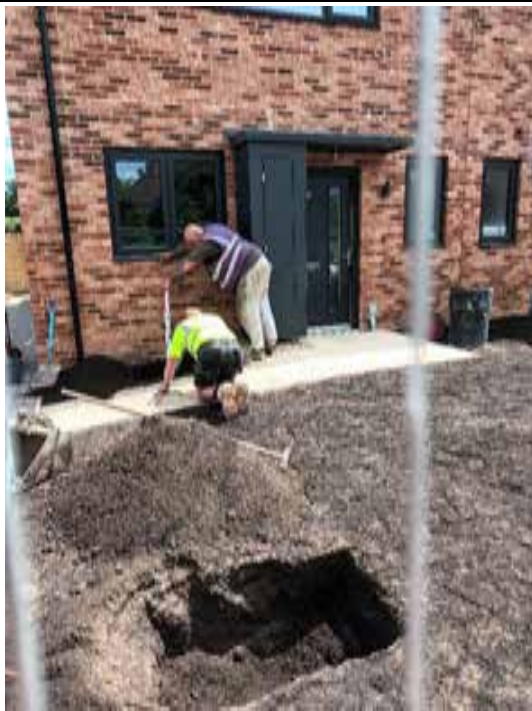
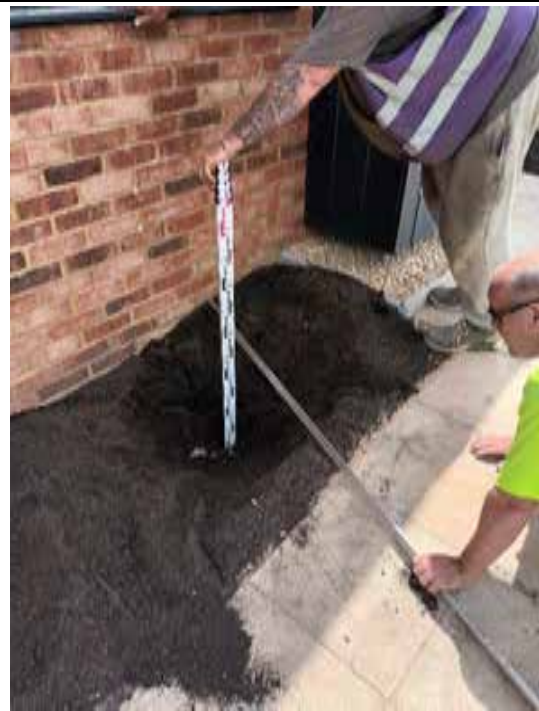
Contractor Photograph: Narrow Landscaped Area to the Front of No. 19

- 450mm of topsoil with a high visibility marker at the base in the narrow landscaped area to the front of No. 19.

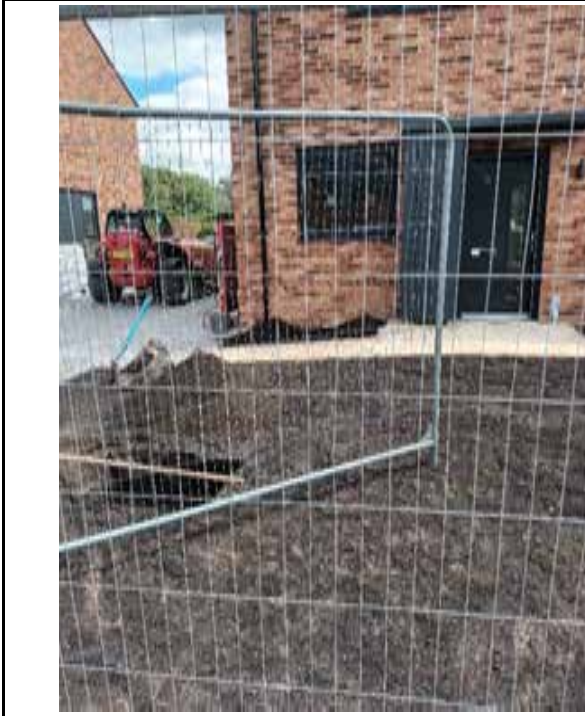
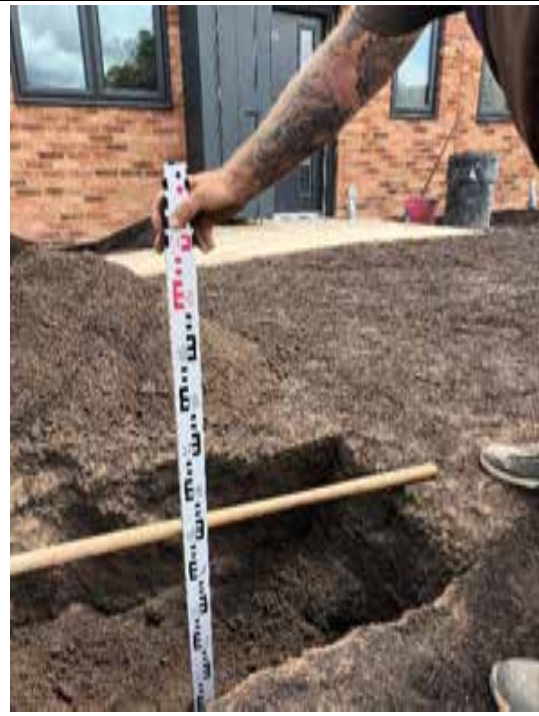
Contractor Photograph: Tree Pit – Front Garden No. 19

- 500mm of topsoil in the location of the tree pit in the front garden of No. 19

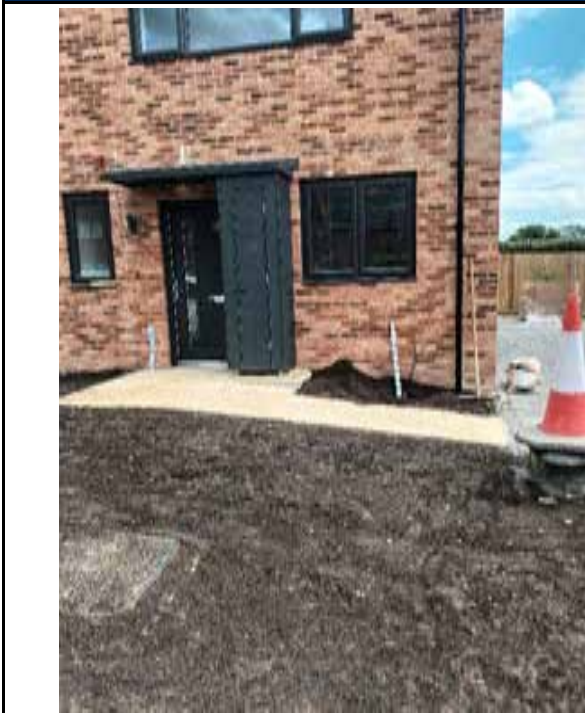
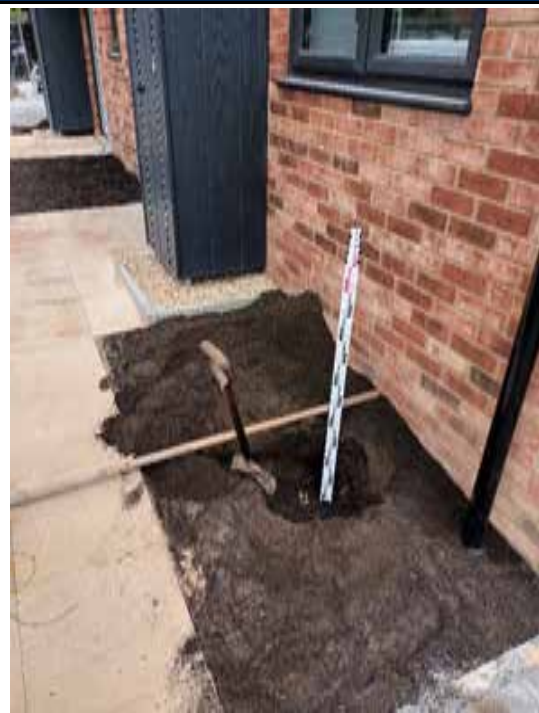
Contractor Photograph: Narrow Landscaped Area to the Front of No. 18

- 450mm of topsoil with a high visibility marker at the base in the narrow landscaped area to the front of No. 18

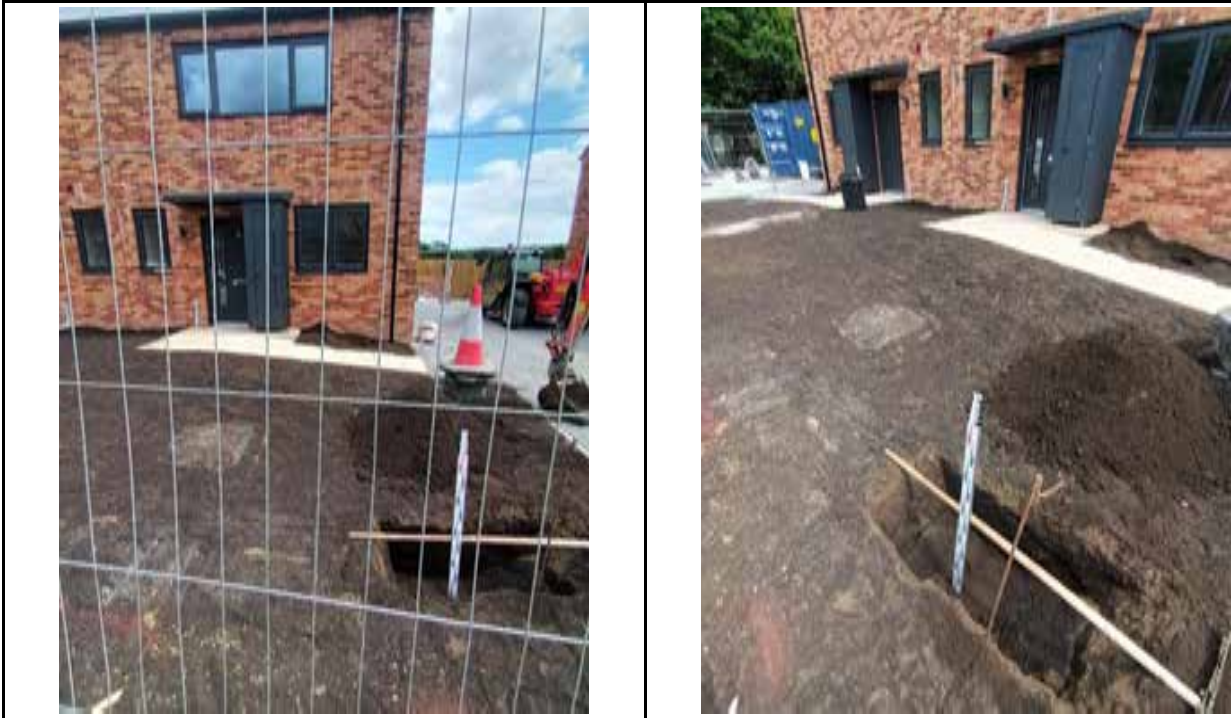
Contractor Photograph: Tree Pit – Front Garden No. 18

- 500mm of topsoil in the location of the tree pit in the front garden of No. 18

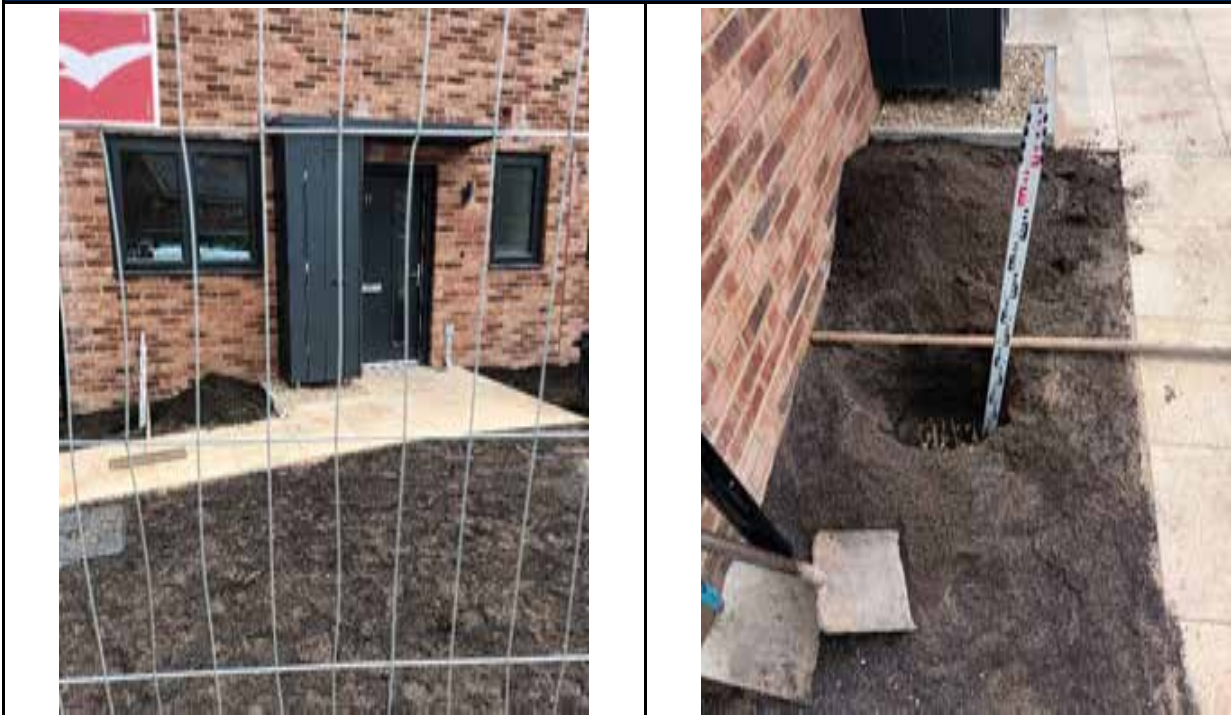
Contractor Photograph: Narrow Landscaped Area to the Front of No. 17

- 450mm of topsoil with a high visibility marker at the base in the narrow landscaped area to the front of No. 17
