**WYCHWOOD BARNES, WYCHWOOD LANE, BRIGHTON ROAD,  
SHERMANBURY, WEST SUSSEX, RH13 8HE**

**Contamination Risk Assessment**

| <b>Requirement</b> | <b>Data</b> |
|---|---|
| Report Ref: | 911/PRowe/Hilden/CRA |

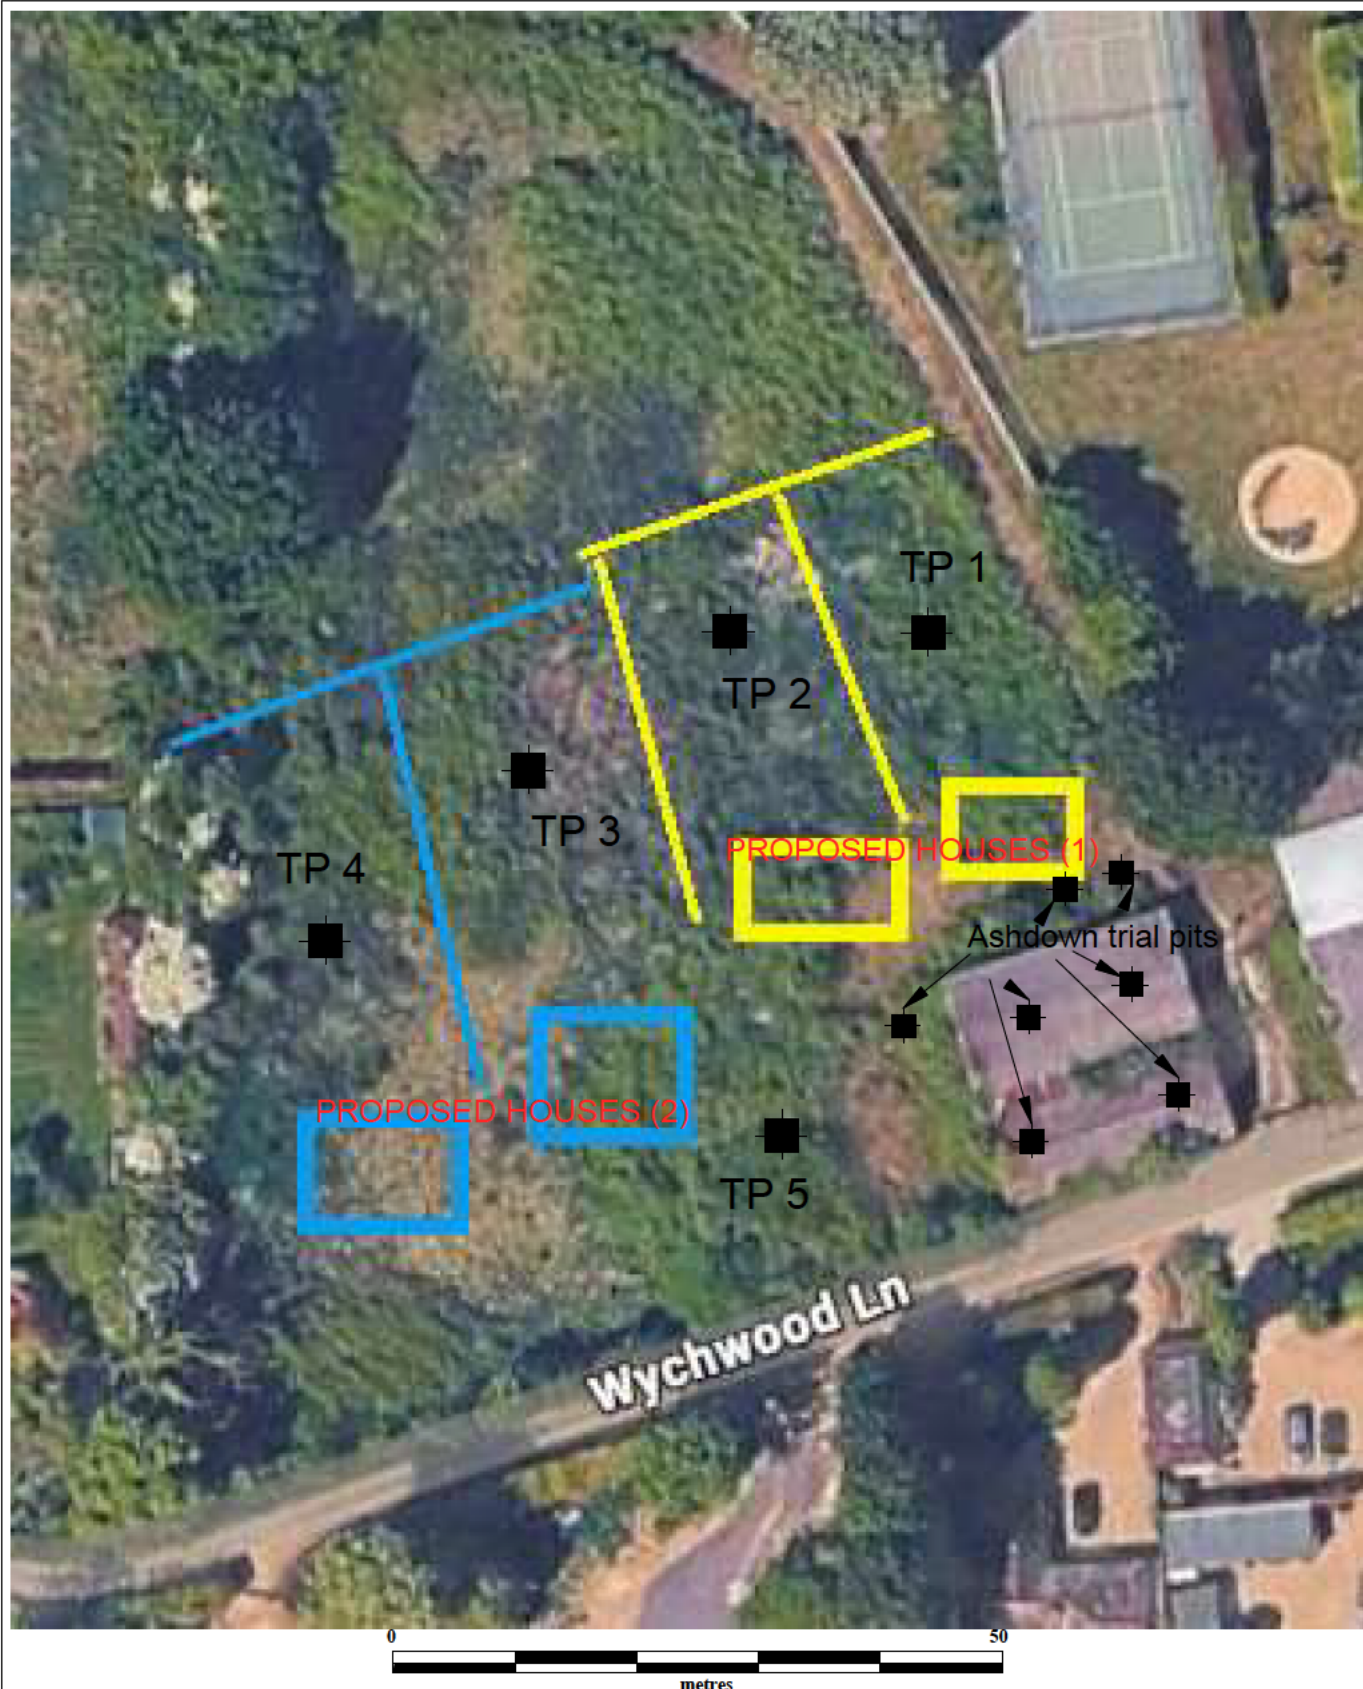
**Figure 2: The Site, Proposed Redevelopment and Trial Pit Locations**

- 1.2 It is proposed to redevelop the site for two houses with gardens, with a further two houses with gardens to follow. See Figure 2 for the site as existing and the trial pit locations.

- 2.1 The site comprises the existing barn, and area to the rear and a further area to the west. See Figure 2.
- 2.2 It is proposed to redevelop the site for two houses initially, with two further houses (in the western part of the site) to follow. See Figure 3. The houses will have domestic garden areas to the rear and parking spaces, with a small amount of soft landscaping. See Figure 3.
- 2.3 The area of the site outside of the barn is presently rough ground where brambles and other vegetation has partly been cleared.

- 5.3 The trial pit locations are shown in Appendix A, Figure 2.
- 5.4 The soil samples were sent to i2 Analytical Ltd of Croxley Green, Watford, for analysis. All the trial pits were tested for speciated polycyclic aromatic hydrocarbons (PAHs), petroleum hydrocarbons, toxic and phytotoxic heavy metals / metalloids, water soluble Sulphate, pH, soil inorganic matter, and asbestos.
