# ARBORICULTURAL METHOD STATEMENT

**For Protection of Trees**

**Rascals Farm**

SJA ams 25385-01

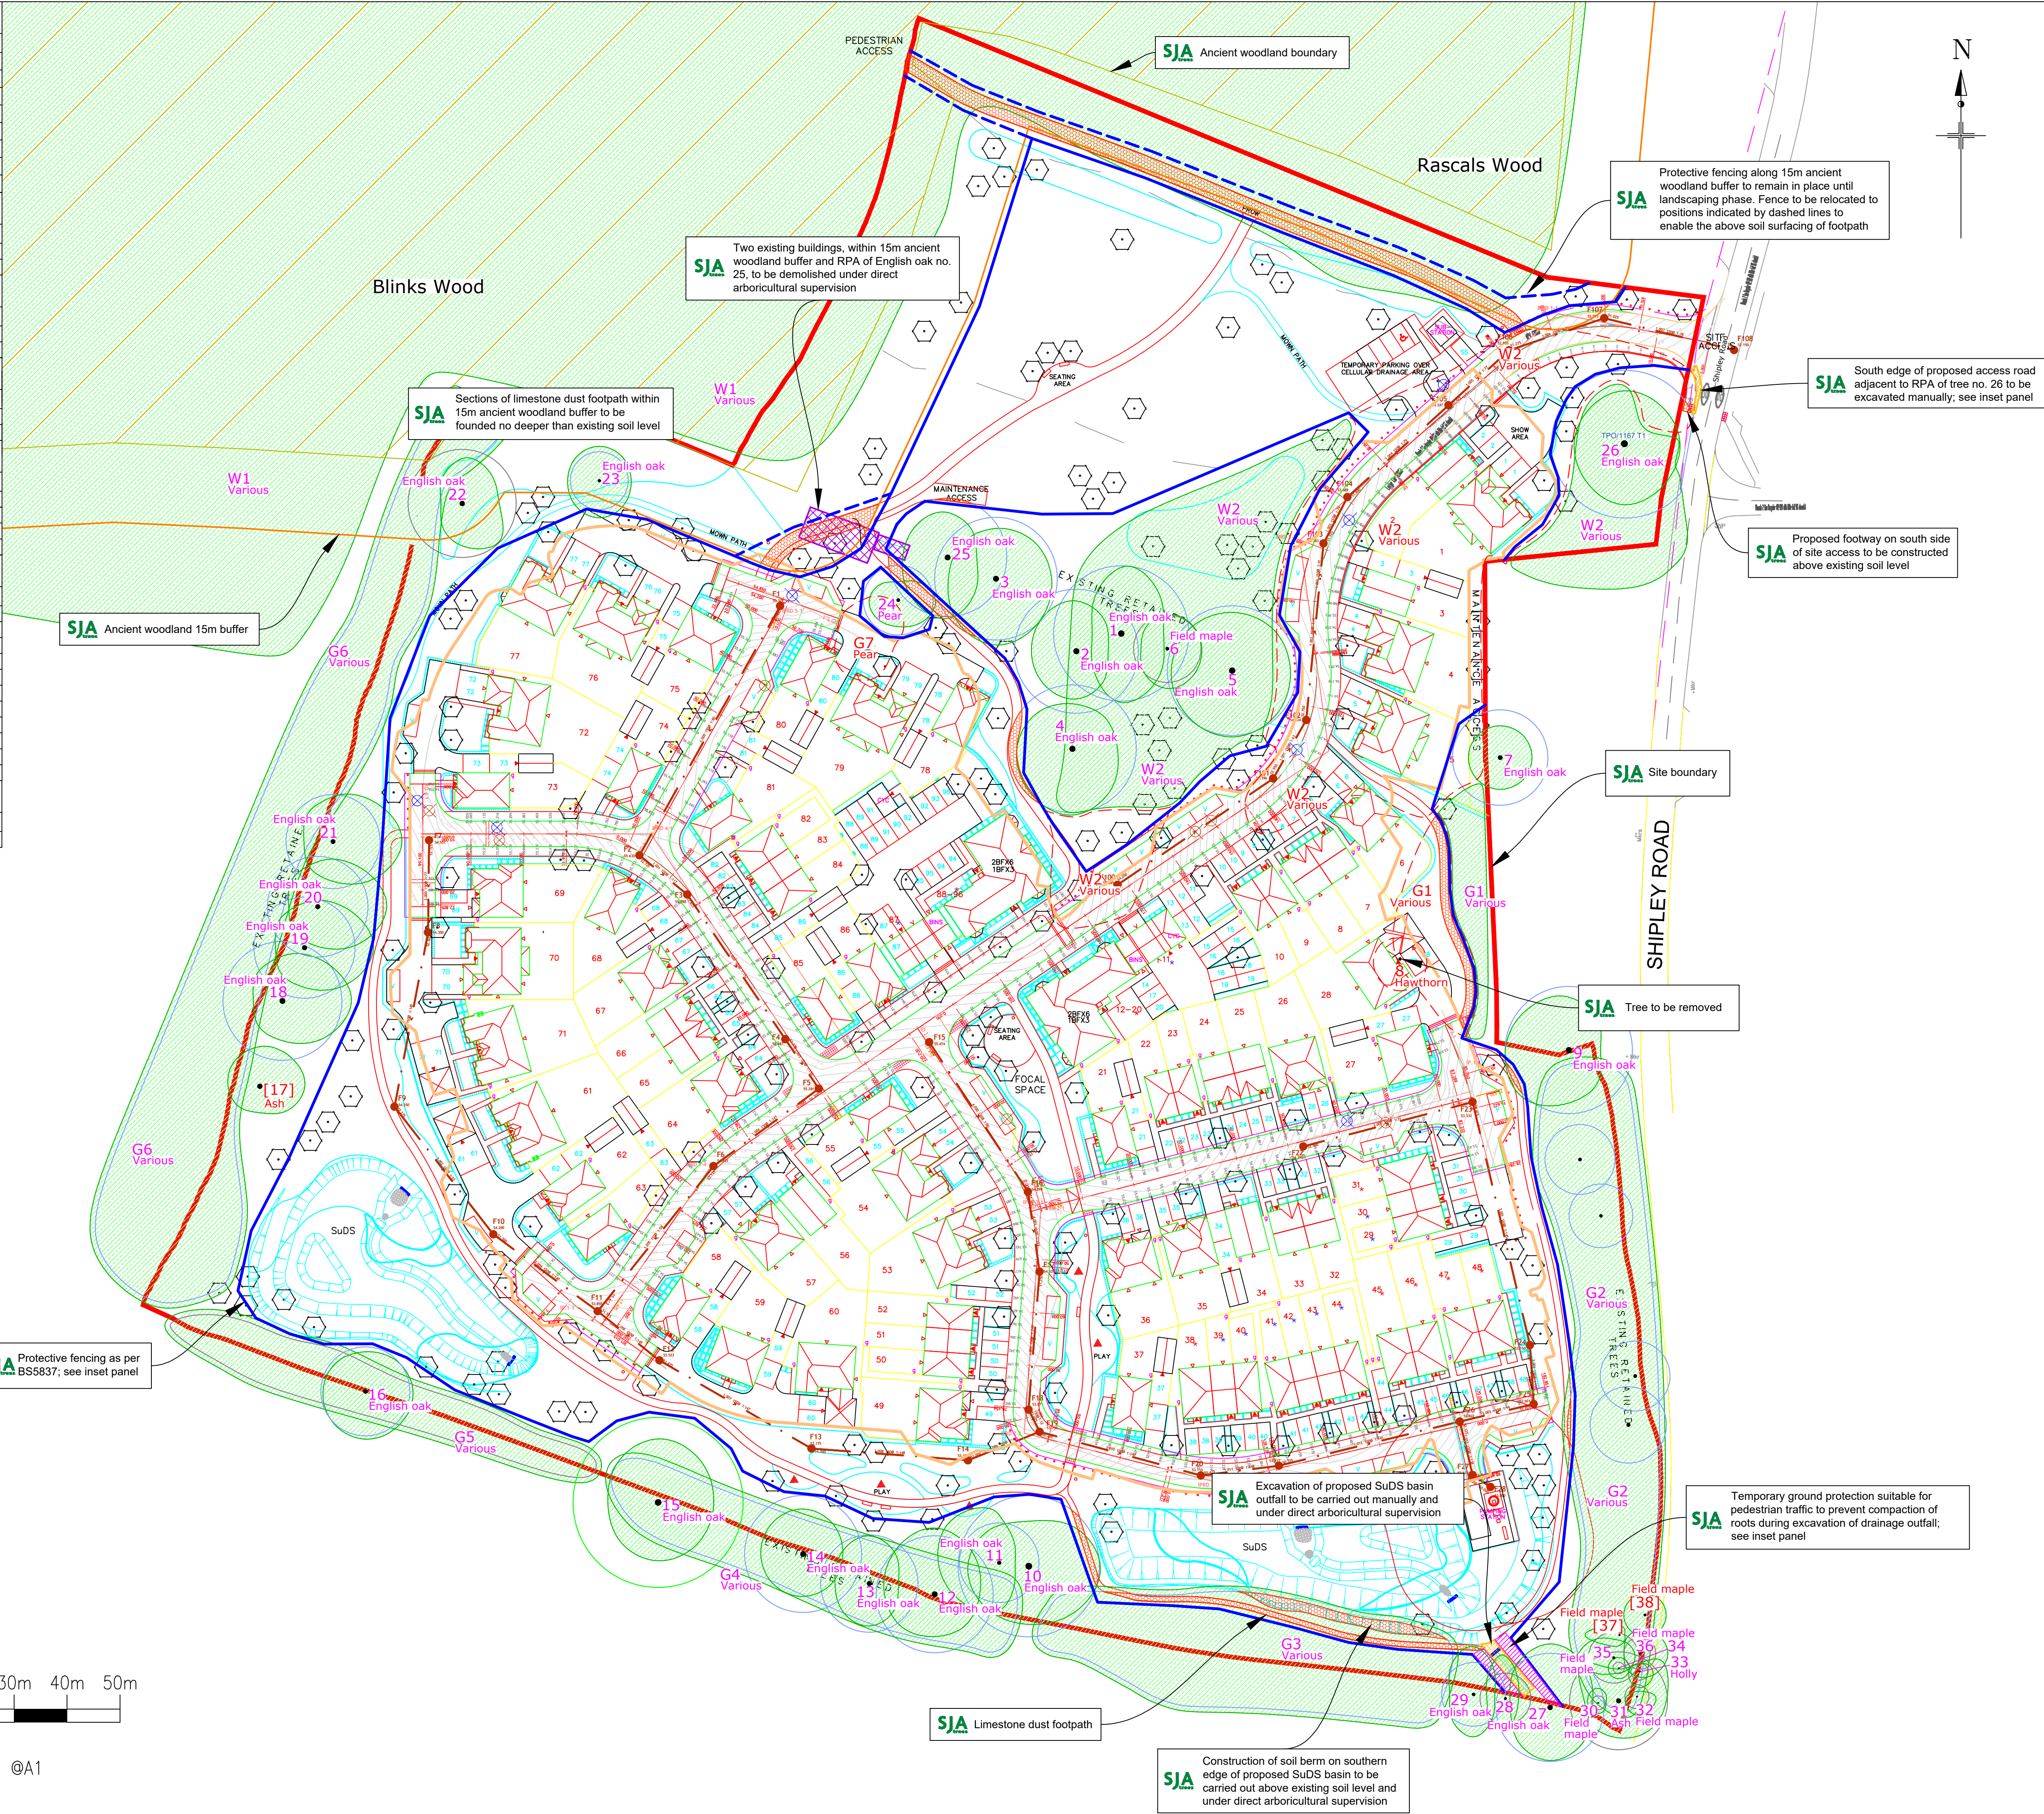
### Protective Fencing

To be erected prior to the commencement of all works on site, and retained in place throughout construction. To comprise 2m tall 'Heras' welded mesh panels on rubber or concrete feet. The panels shall be joined together with two anti-lamper couplers, installed so that they can only be removed from inside the fence. Distance between the couplers should be at least 1m and should be uniform throughout the fence. Panels should be supported (where possible) on the inner side by stabilizer struts, which should normally be attached to a base plate secured with ground pins (see Figure 3a below). Where the fencing is to be erected on retained hard surfacing or it is otherwise unfeasible to use ground pins, e.g. due to the presence of underground services, the stabilizer struts shall be mounted on a block tray (see Figure 3b) 'TREE PROTECTION ZONE - KEEP OUT' or similar notices to be attached to every fifth panel.

Excavation for the SuDS outfall in the south-east corner of the site, and the south side of the bell mouth access and associated drainage gully shall be undertaken by hand under arboricultural supervision. The soil will be loosened with a pick or fork, and then will be cleared from roots with a compressed air soil pick. All roots will be cut cleanly with a hand saw or secateurs. The edge of the excavation closest to the trees will be covered with hessian sacking to prevent drying out, and if necessary be shuttered with an appropriate material to prevent soil collapse. Where appropriate, the soil beneath this depth may be sheet piled, and deeper excavation may be undertaken by a machine provided it works from outside the root protection areas.

The south-east section of the proposed footway within the root protection area (RPA) of tree no. 26, as well as sections of proposed limestone dust footpaths situated within RPAs of trees nos. 3, 4, 9, 10, 24, 25, groups G2 and G2, and within the 15m ancient woodland buffer are to be constructed in accordance with section 7.4 of BS 5837: 2012. Trees in relation to design, demolition and construction - Recommendations. Other than the careful removal, using hand tools, of any turf layer, surfaces will be installed above existing soil level, so that the soil is not disturbed and no roots are severed. Edge supports will also be installed above existing soil level.

Within the root protection area (RPA) of English oak no. 25 and the 15m ancient woodland buffer, foundations shall be removed with care, under the direct supervision of the arboricultural consultant. Foundations will be broken up with handheld breakers, and then removed by hand, wheelbarrow, or in the bucket of an excavator standing outside the RPA. At the discretion of the arboricultural consultant, an excavator positioned outside the RPA and using an appropriately sized toothless bucket may be used in some instances. Once completed, the base of the excavation and/or the edge closest to the trees will be covered immediately with hessian sacking to prevent drying out of the soil, and where necessary be shuttered to prevent soil collapse.

1.4. Details of the trees can be found in the tree survey schedule at **Appendix 1**. Their locations are shown on the tree protection plan (SJA TPP 25385-042) at **Appendix 2**, based on the proposed site layout drawing, no. CB\_17\_420\_601.
