**BAT SURVEY REPORT**

Site: Bottings Farmhouse  
London Road  
Henfield  
West Sussex, BN5 9AD

**Bat Survey, Bottings Farmhouse, London Road, Henfield, West Sussex, BN5 9AD**  
**OS Grid Ref: TQ 20923 18040**

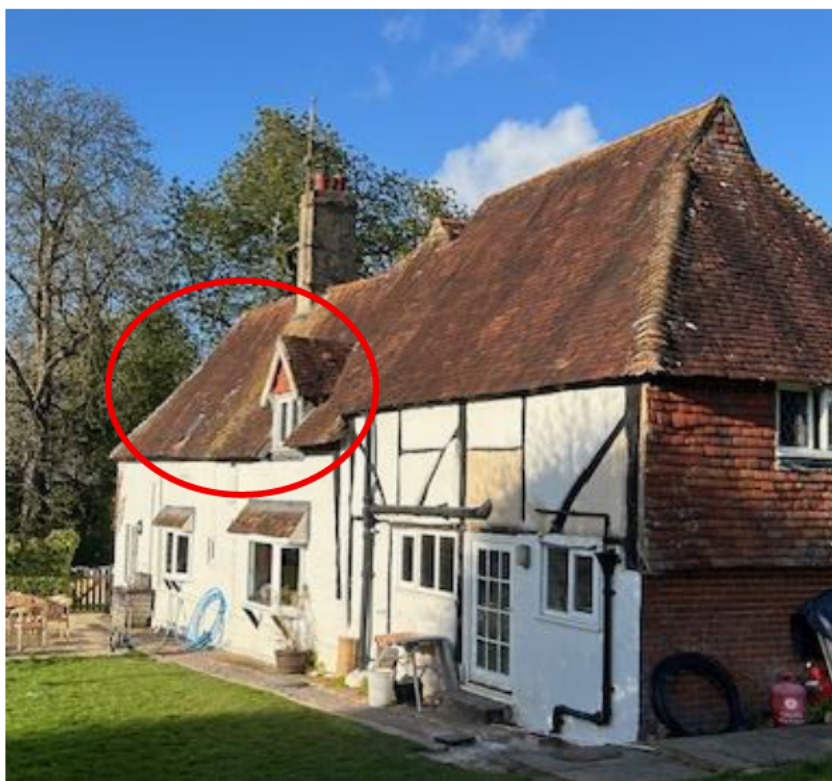
Fig. 1 – New dormer window to be fitted to left of existing dormer, replacing old skylight window  
This section of roof (NW) to be re-tiled (Property owner's photograph)

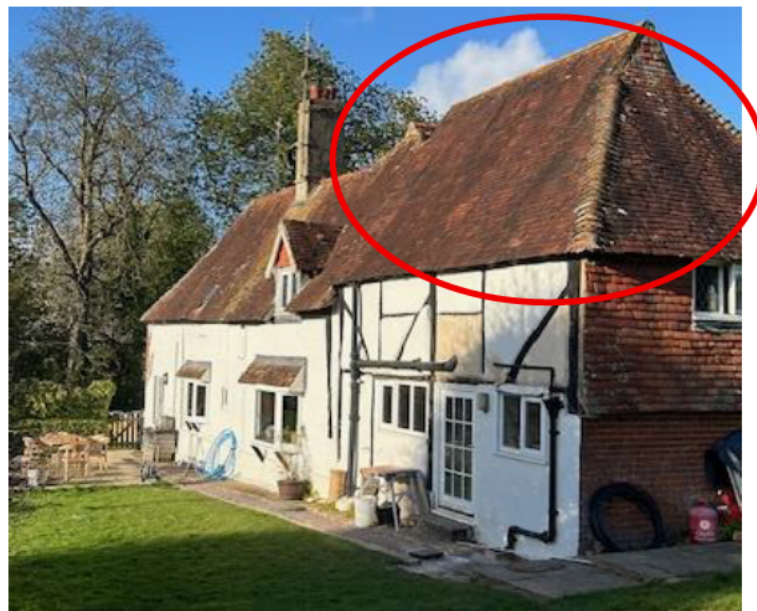
Fig. 3 – Two small Velux windows to be added to this SW side section; no re-tiling proposed  
(Property owner's photograph)

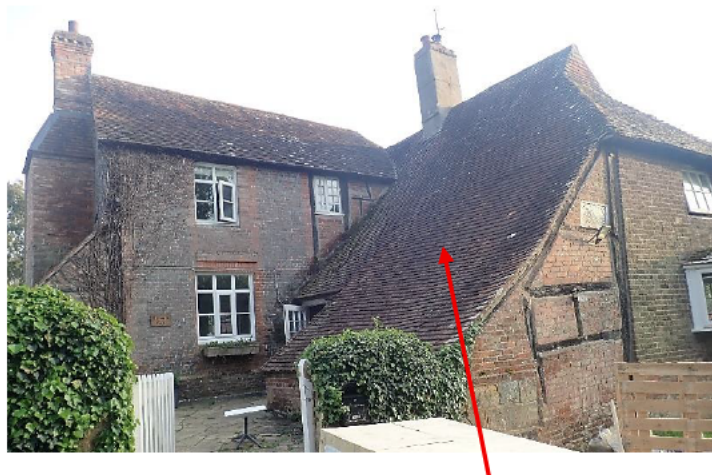
The house dates from the 17<sup>th</sup> Century or earlier, with later additions. Some walls are clad with hanging tiles and the roof is covered with clay tiles. No bats or evidence of bat use was seen around the exterior of the building. However, there are numerous roosting opportunities, for crevice-dwelling bats, beneath lifted and uneven roof tiles and hanging tiles, throughout the property.

Fig. 5 – The house, viewed from the NE – catslide roof to be renovated

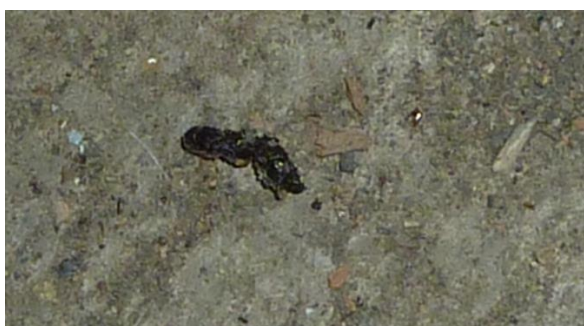
A single bat dropping was seen in the roof void of the E-W section of roof (see photo above) suggesting an occasional visit by a long-eared bat (*Plecotus* sp.). No works are planned to this roof, which is in a relatively good condition. No bats or evidence of bat use was seen elsewhere. The floors of the voids are insulated with fibre-glass type material.

Fig. 7 - Bat dropping on floor of E/W roof void

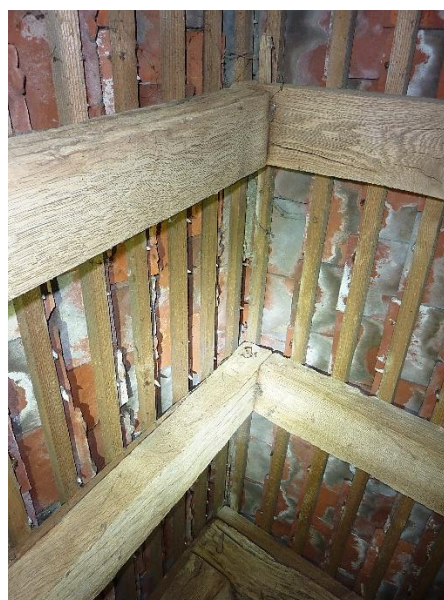
Fig. 8 – Unlined section of roof (E/W section)

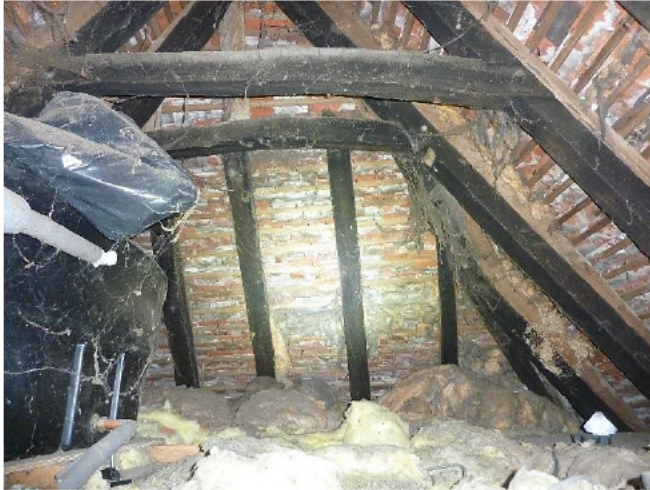
Fig. 9 – Unlined roof in older section of building (N/S)

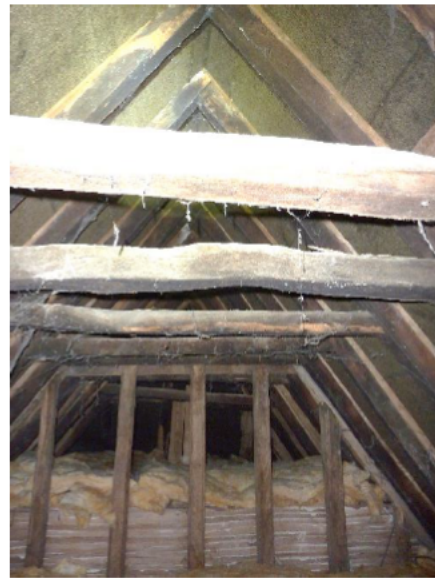
Fig. 10 – Lined section of roof, to south

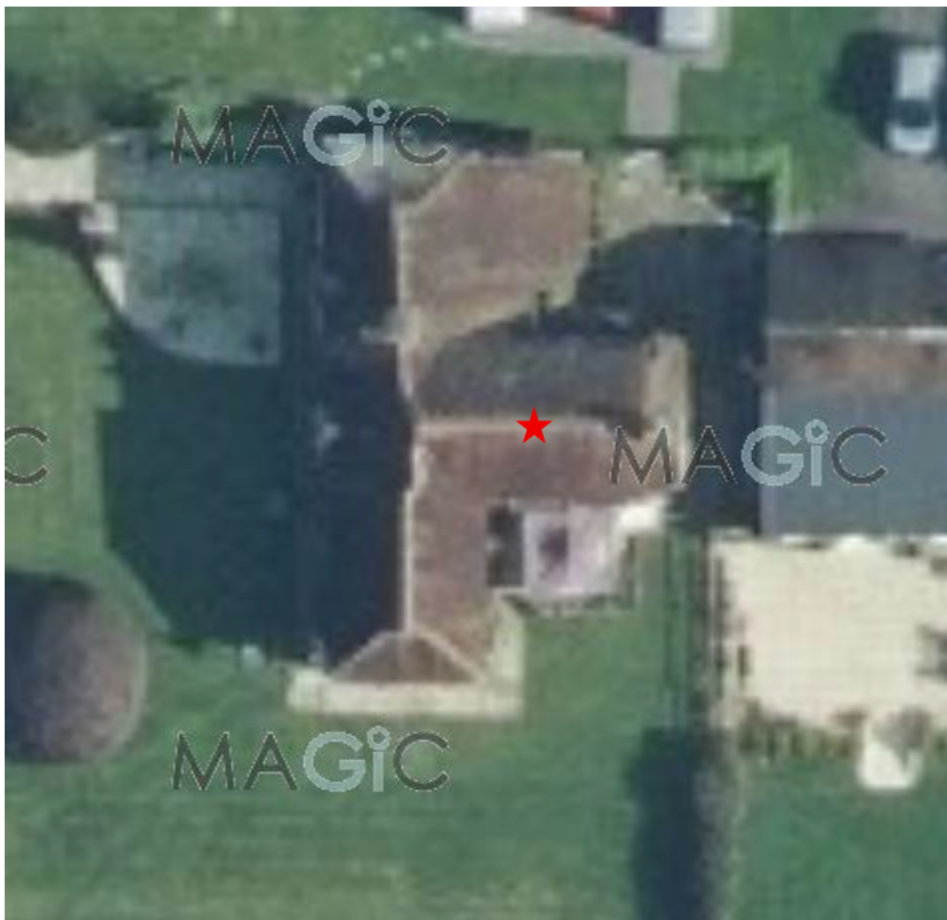
Fig 11 – Aerial view of house (MAGIC Maps) ★ Indicates void where bat dropping located

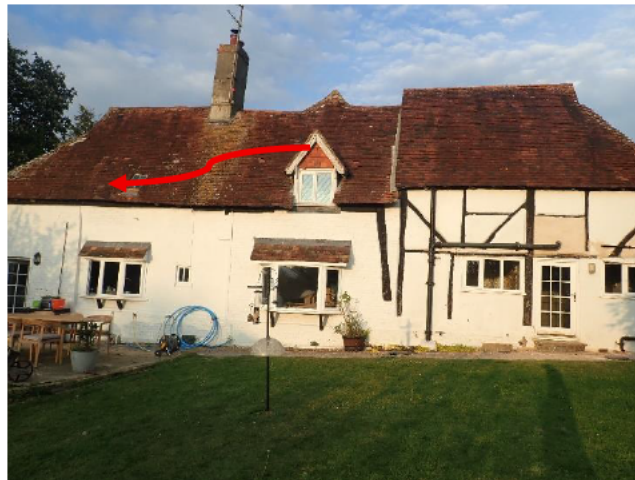
- 5.1 Three common pipistrelles emerged from the building during the first Phase 2 survey; one from beneath hanging tiles on the west facing dormer and two from the SW edge of the south facing hipped roof. The roost area on the west side is likely to be affected by the proposed renovation works. Bats seen and heard were as follows:

| Time | Species | Activity |
|---|---|---|
| 20:37 | Common pipistrelle ( <i>Pipistrellus pipistrellus</i> ) | Emerged from apex of dormer, W side (see photograph) flew to N |

Fig. 17 – Svy 1 - Emergence point of pipistrelle, W side dormer

- **Roof Tiles – Reinstatement of Roosting Opportunities.**  
It must be ensured that roosting provisions for crevice-dwelling bats such as pipistrelles are reinstated. If hand-made roof tiles are to be re-used, it is likely that roosting potential will be maintained, due to the uneven nature of these tiles. However, consideration could be given to fitting a minimum of two additional bat access tile sets\*<sup>2</sup> (or bespoke 'lifted' tiles) to roof slopes, as well as one in the dormer, where the bat is roosting at the present time.

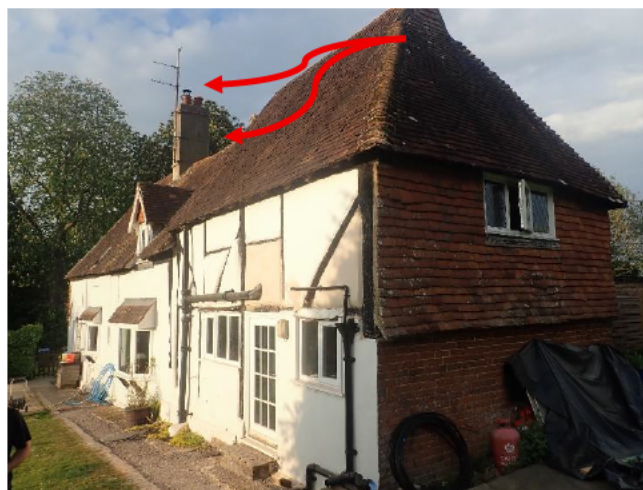
| Time | Species | Activity |
|---|---|---|
| 20:44 | Common pipistrelle | 2 x bats emerged from bonnet tile on S gable (see photograph) |

Fig. 18 – Svy 1 - Emergence point of two pipistrelles, S end roof
