# **BAT EMERGENCE SURVEY REPORT**

## **5 Ivy Cottages, Billingshurst**

| <b>Reference:</b> | LLD3864-ECO-REP-002-00-BES | | | |

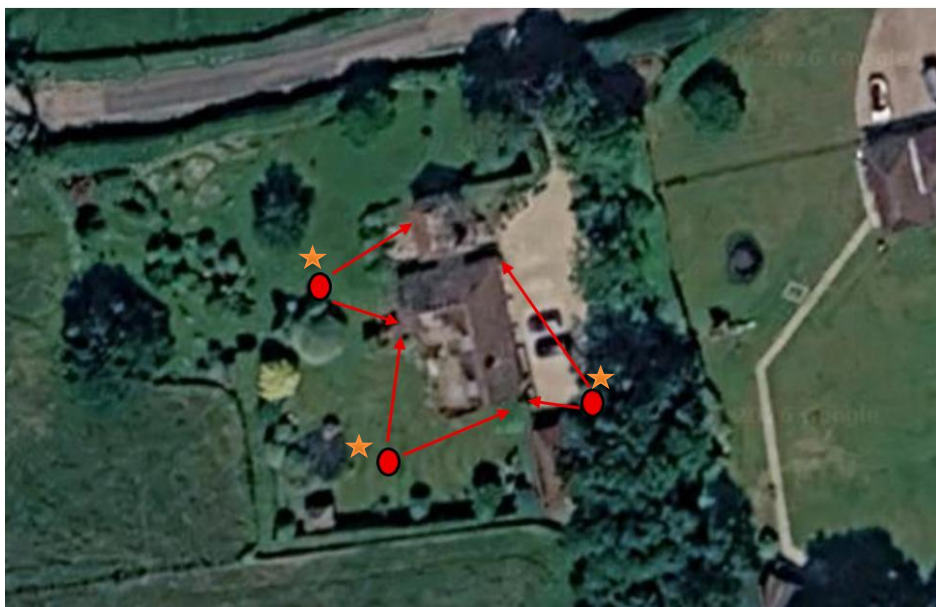
**Figure No. 02 – Location of Survey Points (red circles) and IR camera (orange star)**

3.1.2 3 no. bat surveyors were assigned a point each to adequately cover all potential roost features of each building. 3no. infra-red cameras with additional illuminators were also used to aid the survey (*Refer to Figure No. 02 – Location of Survey Points*).
