**LAND NORTH-WEST OF SOUTHWATER, HORSHAM**

**2025/2026 BAT SURVEY REPORT**

**Prepared for Berkeley Strategic Land Ltd**

**HDA ref: 2090.78**

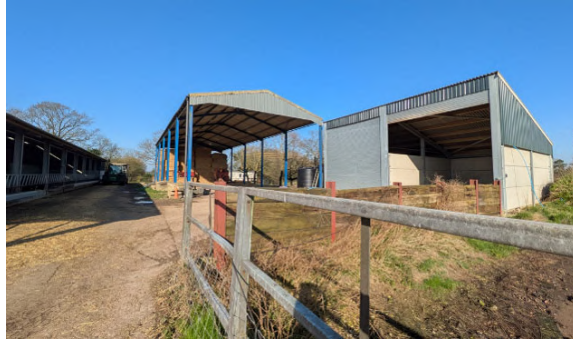
**Photo 1:** Southern and eastern elevations of B1 in the centre of the image, with northern elevation of B2 in left-side of photo and southern and eastern elevations of B16 in right side of photo.

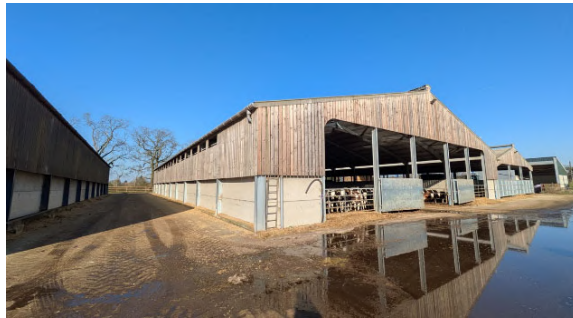
| <b>B16</b><br>(Photos 1 & 2) | A single-storey grain store, with single-skinned corrugated metal walls and a sloping corrugated metal roof. | <b>External</b><br>No suitable features for roosting bats recorded.<br><br><b>Internal</b><br>No suitable features for roosting bats recorded.<br><br><b>Evidence of bat activity</b><br>None recorded. | <b>Negligible</b> |

**Photo 2:** Southern and eastern elevations of B3 in the centre of the image, with northern elevation of B4 in left-side of photo and southern and eastern elevations of B2 and B16 in right side of photo.

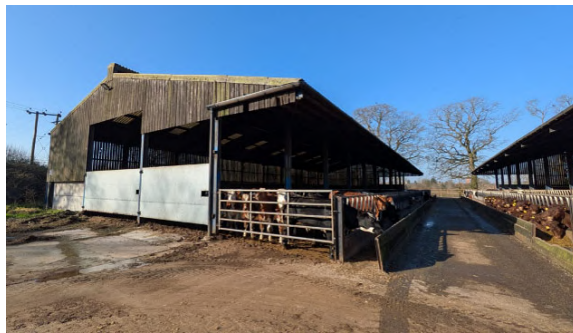
**Photo 3:** Northern and eastern elevations of B4 in the centre of the image, with southern elevation of B3 in right side of photo.

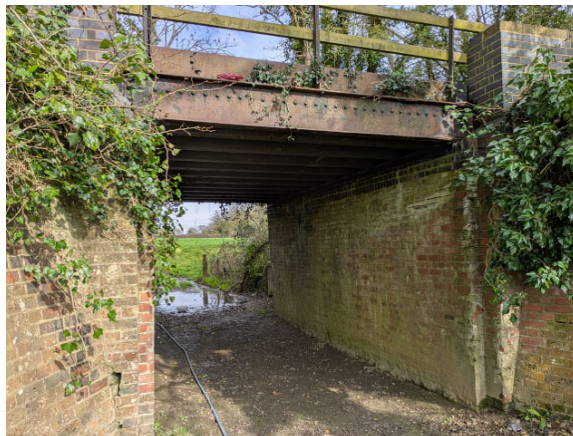
| Building | Description | Findings | Bat roost potential |
|---|---|---|---|
| <b>B5</b><br>(Photo 4) | Bridge going underneath footpath with brick walls and iron girders as ceiling. | <p><b>External</b><br/>No suitable features for roosting bats recorded.</p> <p><b>Internal</b><br/>Limited gaps in from missing mortar and gaps between the brickwork.</p> <p><b>Evidence of bat activity</b><br/>None recorded.</p> | <b>Low</b> |

**Photo 4:** Southern elevation of B5.

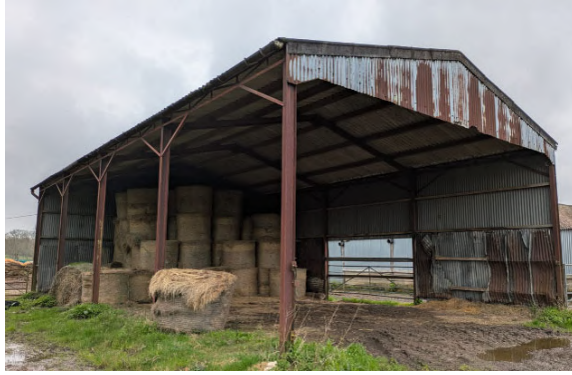
| Building | Description | Findings | Bat roost potential |
|---|---|---|---|
| <b>B8</b><br>(Photo 5) | A single skinned, single-storey, corrugated metal shelter with two open sides and a pitched, corrugated asbestos roof with no lining. | <p><b>External</b><br/>No suitable features for roosting bats recorded.</p> <p><b>Internal</b><br/>No suitable features for roosting bats recorded.</p> <p><b>Evidence of bat activity</b><br/>None recorded.</p> | <b>Negligible</b> |

**Photo 5:** Northern and eastern elevations of B8.

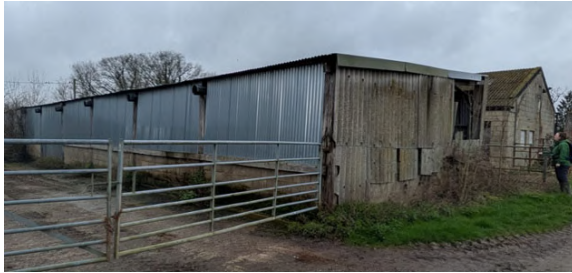
| <b>B9</b><br>(Photos 6 & 7) | Single-storey, single skinned corrugated metal building with two open sides and a sloping corrugated metal roof. | <p><b>External</b><br/>No suitable features for roosting bats recorded.</p> <p><b>Internal</b><br/>No suitable features for roosting bats recorded.</p> <p><b>Evidence of bat activity</b><br/>None recorded</p> | <b>Negligible</b> |

**Photo 6:** Northern and eastern elevations of B9, with B11 in right side of photo.

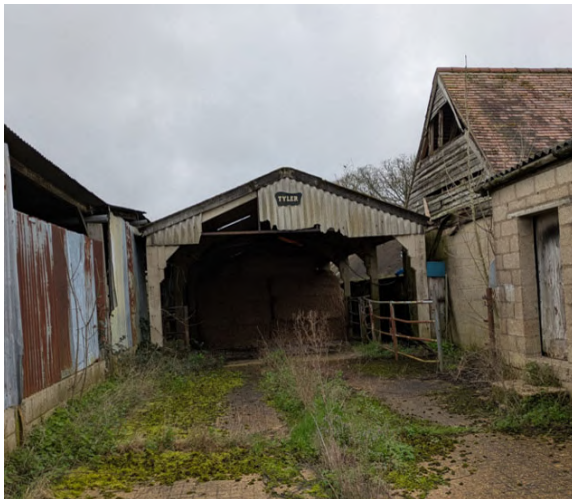
**Photo 7:** Northern elevation of B10 in centre of image, with eastern elevations of B12 and B11 in right side of photo and western elevation of B9 in left side of photo.

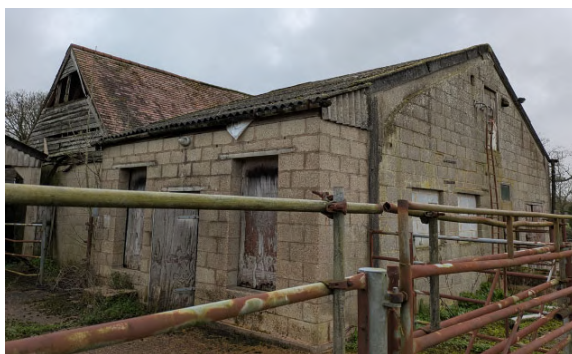
**Photo 8:** Eastern and northern elevations of B11 in forefront, with northern and eastern elevations of B12 in rear of photo.

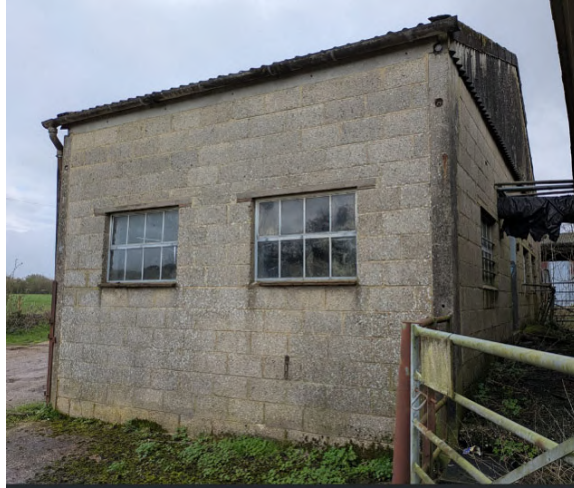
| <b>B11</b><br>(Photos 6 - 9) | A single-storey disused milking room, with solid breeze block walls and a pitched asbestos roof. | <p><b>External:</b><br/>Potential bat roosting features are limited to gaps between corrugated sheeting on the roof and walls and gaps around the doors.</p> <p><b>Internal:</b><br/>Ceiling has an inaccessible void above.</p> <p><b>Evidence of bat activity</b><br/>None recorded.</p> | <b>Low</b> |

**Photo 9:** Southern and western elevations of B11.

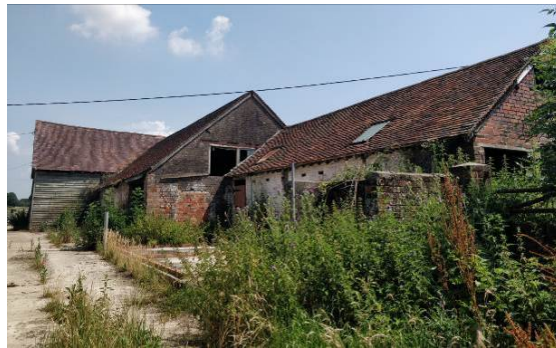
| <b>B12</b><br>(Photos 7, 8 & 10 - 14) | <p>A T-shaped single skinned, brick cow shed. Comprising a two-storey building with a pitched tiled roof lined with roofing felt and brick and waney edge boarding walls.</p> <p>Connected to the building is a large single-storey cattle shed with a pitched tiled roof which is unlined.</p> | <p><b>External</b><br/>Potential bat roosting features include multiple lifted and missing tiles, open doorways and gaps under rafters and between the waney edge boarding.</p> <p><b>Internal</b><br/>Access to the second storey of the building was limited due to the condition of the floor. The ceiling between the first and second floors in the two-storey section of the building is boarded above and below the rafters to form a cavity within which occasional holes are present. In addition, the walls are lined with waney edge boarding that have gaps leading to cavities between the internal and external wall. The two-storey section of the building is constructed in a traditional method with mortise and tenon joints.</p> <p><b>Evidence of bat activity</b><br/>Below one mortise and tenon joint on the ground floor of the two-storey section of the building was staining and approximately 100 bat droppings.</p> <p>The 2022 emergence surveys recorded day roosts for up to six Common Pipistrelle bats, one Soprano Pipistrelle and possibly one <i>Myotis</i> sp. bat (call indicative of Brandt's bat) (HDA, 2022).</p> | <b>Confirmed roost</b> |

**Photo 10:** Western and southern elevations of B12.

- 5.2.3 A strategy for mitigating the loss of the identified roost sites in B12 is described below. The provision of replacement roosting opportunities should be reviewed at an appropriate stage in light of detailed design and/or the findings of updated surveys, if appropriate, to ensure mitigation is proportionate to the status of bat roosts in B12, at the time of works.

- 5.2.4 Current proposals indicate that the proposed works to B12 will result in the loss of the associated roosts. However, Common Pipistrelle, Soprano Pipistrelle and Brandt's bat are known to roost in trees and/or bat boxes (University of Bristol, 2010; Dietz et al, 2011), with records of bat boxes having been used for successful Common and Soprano Pipistrelle breeding. It would therefore, be possible to provide suitable replacement opportunities during the construction phase prior to replacement roosting opportunities being created within new buildings.

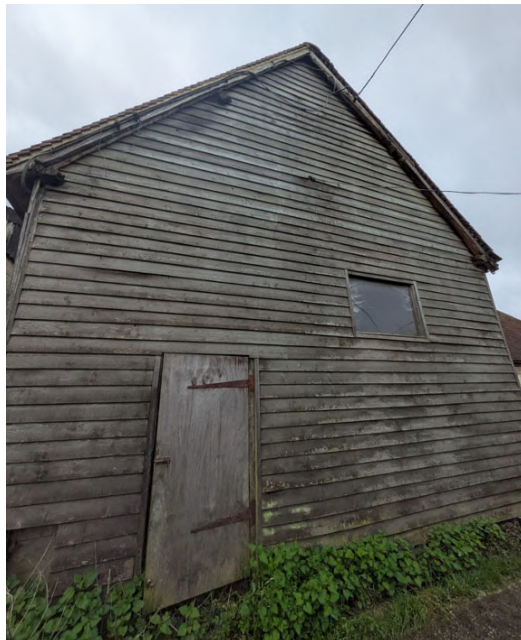
**Photo 11:** Western elevation of B12.

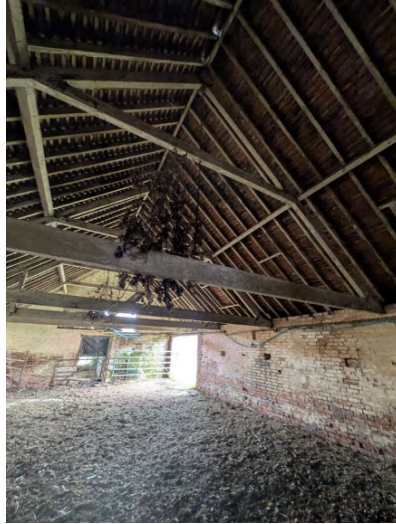
**Photo 12:** Internal view of central section of B12.

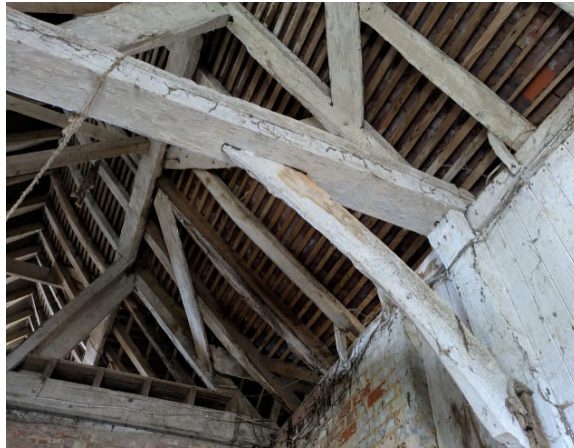
**Photo 13:** Internal view of northern section of B12 (with bat droppings below this mortise and tenon joint – see Photo 14).

5.2.12 All works affecting features with the potential to conceal roosting bats should be overseen by a licensed bat worker under an Ecological Watching Brief. Potential features on the building include lifted and missing tiles, gaps under rafters and between floors, gaps into mortise and tenon joints and between the waney edge boarding. The internal voids should be thoroughly inspected prior to any works commencing. Suitable features should be inspected prior to works to any area commencing and a cautious approach should be employed, particularly in the vicinity of the known roost locations, with key features removed by hand and gently lowered to ground where appropriate.

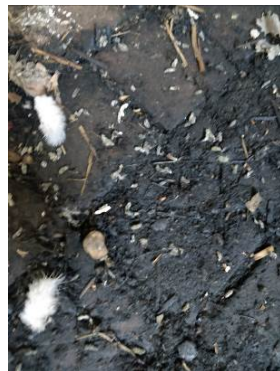
**Photo 14:** Bat droppings on floor below this mortise and tenon joint.

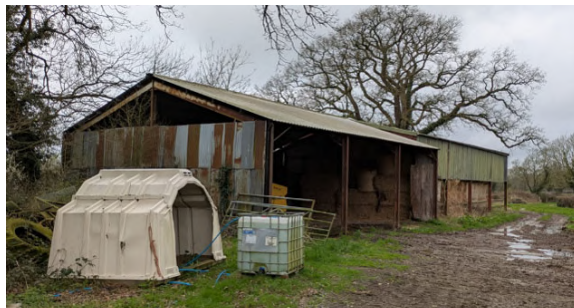
| <b>B13 &amp; B14</b><br>(Photo 15) | Two single-storey, metal frame shelters with two open sides and pitched corrugated metal roofs. | <p><b>External</b><br/>No suitable features for roosting bats recorded.</p> <p><b>Internal</b><br/>No suitable features for roosting bats recorded.</p> <p><b>Evidence of bat activity:</b><br/>None recorded</p> | <b>Negligible</b> |

**Photo 15:** Northern and eastern elevations of B13 and B14.

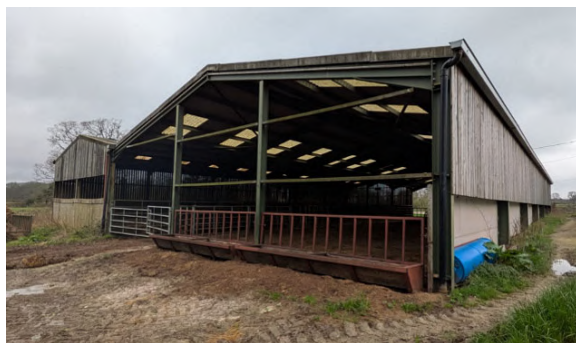
| <b>B15</b><br>(Photo 16) | A large single-storey barn with a double pitched, corrugated asbestos roof and walls constructed of a single skinned breeze block base above which were wooden slated walls. | <b>External</b><br>No suitable features for roosting bats recorded.<br><br><b>Internal</b><br>No suitable features for roosting bats recorded.<br><br><b>Evidence of bat activity</b><br>None recorded. | <b>Negligible</b> |

**Photo 16:** Southern elevation of B15.

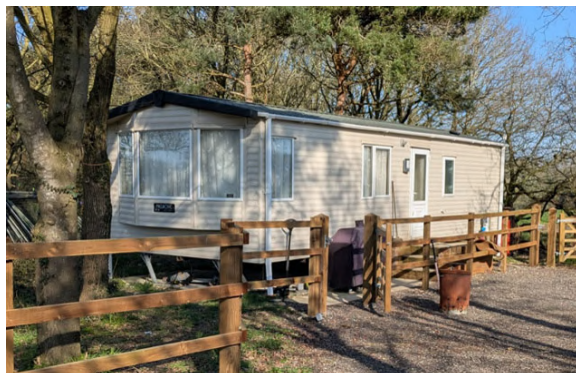
| <b>B17</b><br>(Photo 17) | A single-storey static caravan, with plastic walls and a pitched roof covered with roofing felt. | <b>External</b><br>No suitable features for roosting bats recorded.<br><br><b>Internal</b><br>No suitable features for roosting bats recorded.<br><br><b>Evidence of bat activity</b><br>None recorded. | <b>Negligible</b> |

**Photo 17:** Southern and eastern elevations of B17.
