**LEONARD AND PENELOPE WARNER**

WAPPINGTHORN LODGE, HORSHAM ROAD, STEYNING, BN44 3AA

**Contamination Risk Assessment**

June 2026  
(Revised August 2026)

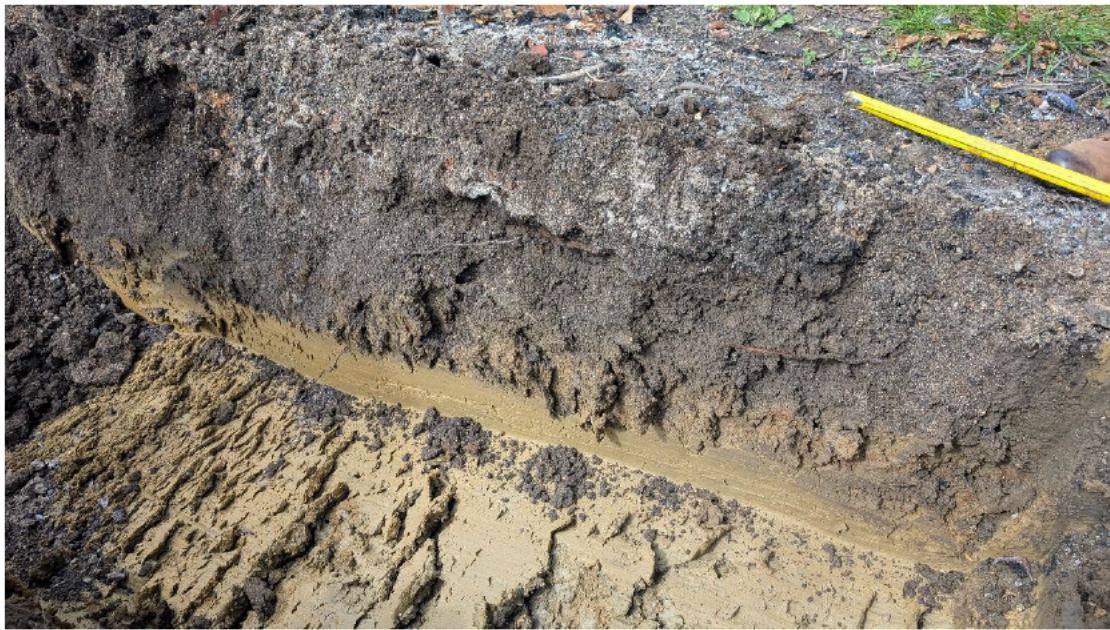
Trial pit 1

- 7.1.1. Oil staining, unusual colouring, odour and other superficial indications of significant contamination were not noted in the trial pits. However, it was immediately apparent that the upper soil in TP1 contained ash residues from a green waste bonfire.
- 7.1.2. Photographs taken at the site during the current investigation are provided in Appendix B.

| Standpipe | Sampling | | | Strata | | | |
|---|---|---|---|---|---|---|---|
| | | | | <br><br> | 0.08 m<br><br><br>0.28 m<br><br><br>0.5 m | | Surface bare ground with ash residues from green waste bonfire<br><br>Dark brown clay subsoil<br><br>Light brown natural clay ground |

- 3.3. The remnants of a bonfire was identified between the sand school and garage. The incomplete combustion / burning of waste and ash residue are a potential source of PAH (Polycyclic Aromatic Hydrocarbon) contamination. This ash and any underlying soil which has been impacted will be / need to be removed as part of the site's redevelopment.

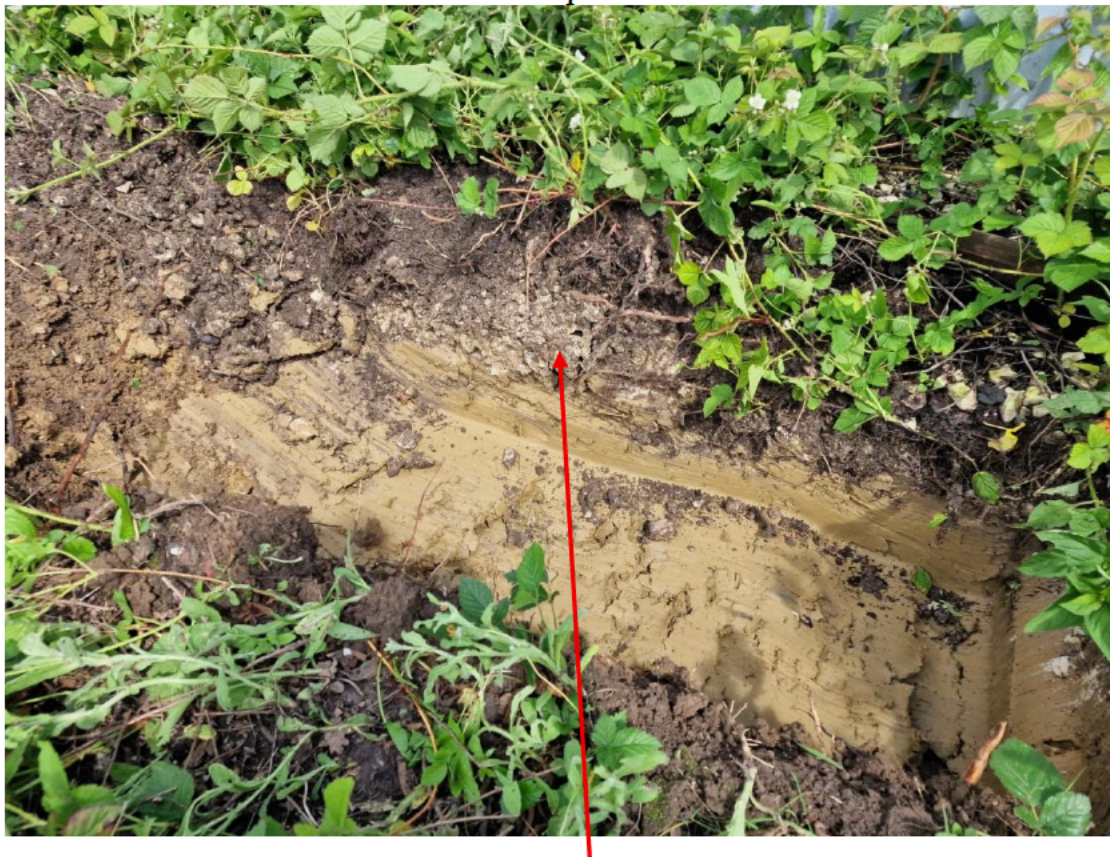
Trial pit 2

- 5.6. The natural clay sample for TP2 was taken from the point where chalk fill and natural clay meet topsoil. The sample consisted of the upper levels of the chalk and natural clay ground. This sample would identify any potential contamination of the underlying chalk surface or natural ground caused by contaminants with increased mobility that would not be able to infiltrate the less permeable chalk and clay.

| Standpipe | Sampling | | | Strata | | | |
|---|---|---|---|---|---|---|---|
| | | | | | 0.2 m<br>0.45 m | | Surface brambles<br>Mid-dark brown clayey topsoil<br><br>North side MADE GROUND chalk fill<br>South side light brown natural clay ground |

**Chalk Fill**

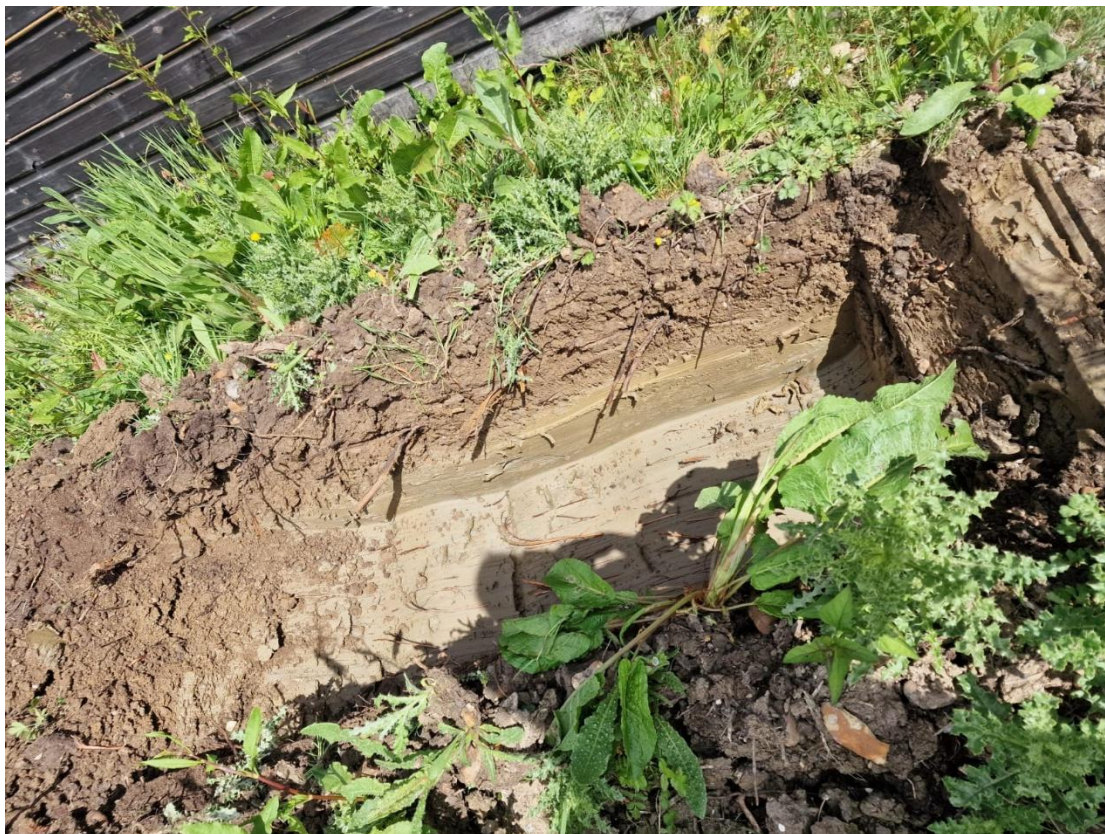
Trial pit 3

| Standpipe | Sampling | | | Strata | | | | |
|---|---|---|---|---|---|---|---|---|
| | | | | <br> | 0.25 m<br><br>0.5 m | | Disturbed ground, topsoil with roots.<br><br>Light brown clay fading to mottled light brown/grey clay. | |

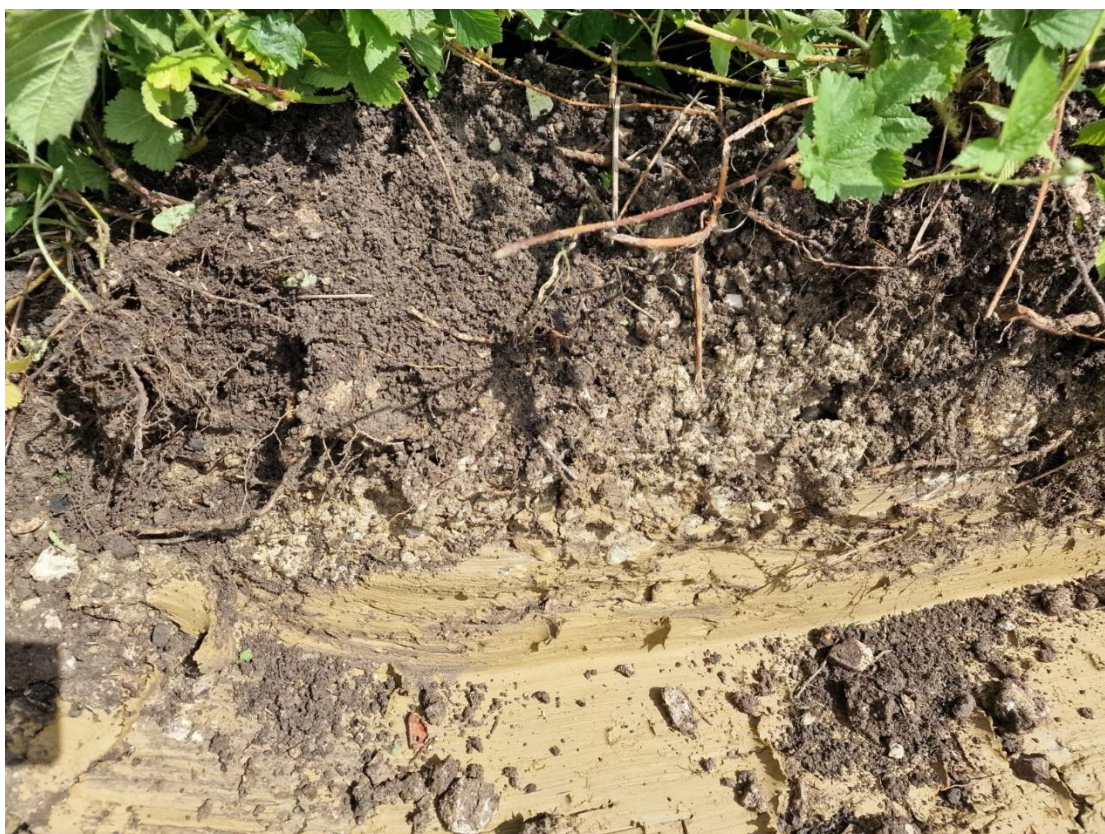
Trial pit 4

- 5.7. The sample for TP4 comprised material from the interface between the topsoil and the chalk. In this case the sample comprised a mix of the lower level topsoil and the upper level of the chalk. This sample was selected to target any potential contamination of the chalk surface when exposed, and to target any potential contamination in the soil above. The more mobile contaminants in the soil may move down and accumulate above the less permeable compressed chalk.

| Standpipe | Sampling | | | Strata | | | |
|---|---|---|---|---|---|---|---|
| | | | | | <div><div>0.15 m</div><div>0.25 m</div><div>0.5 m</div></div> | | <div>Grass over dark brown topsoil</div> <div>Chalk fill MADE GROUND</div> <div>Light brown clay</div> |

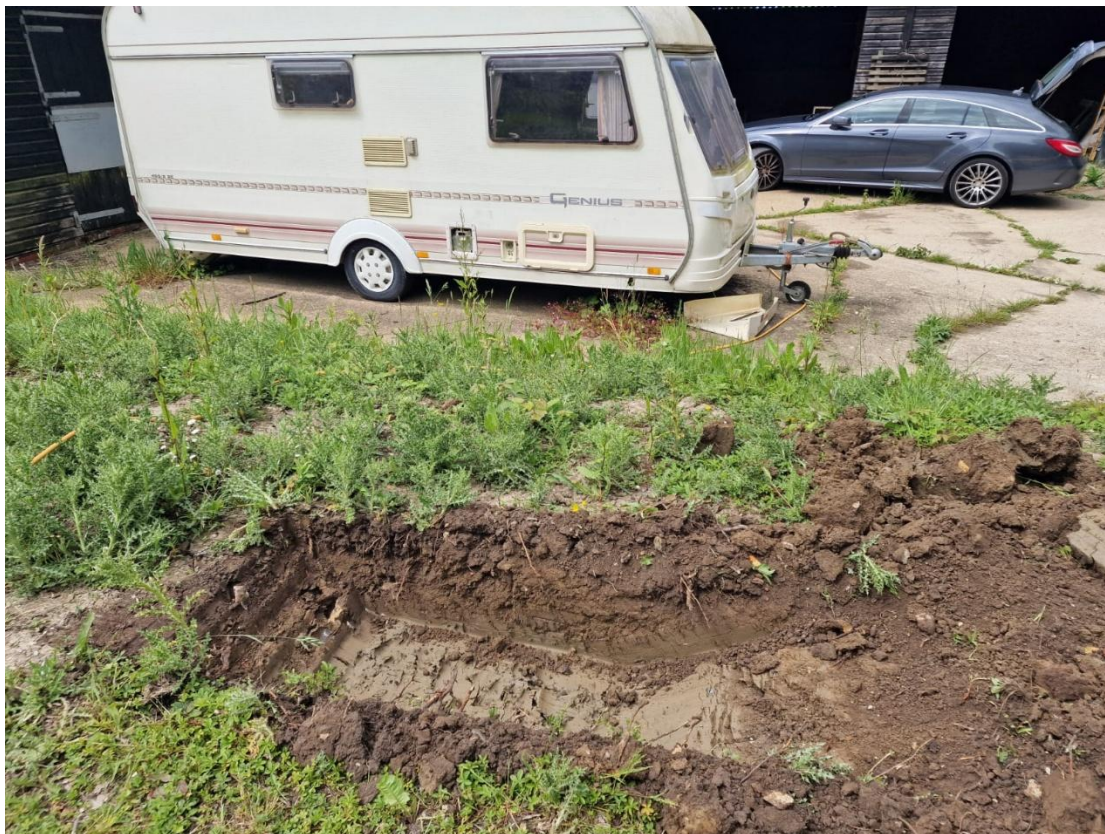
Trial pit 5

| Standpipe | Sampling | | | Strata | | | | |
|---|---|---|---|---|---|---|---|---|
| | | | | <br> | 0.25 m<br>0.35 m | | Clayey midbrown topsoil<br><br>Light brown clay fading to mottled light brown/grey clay. | |

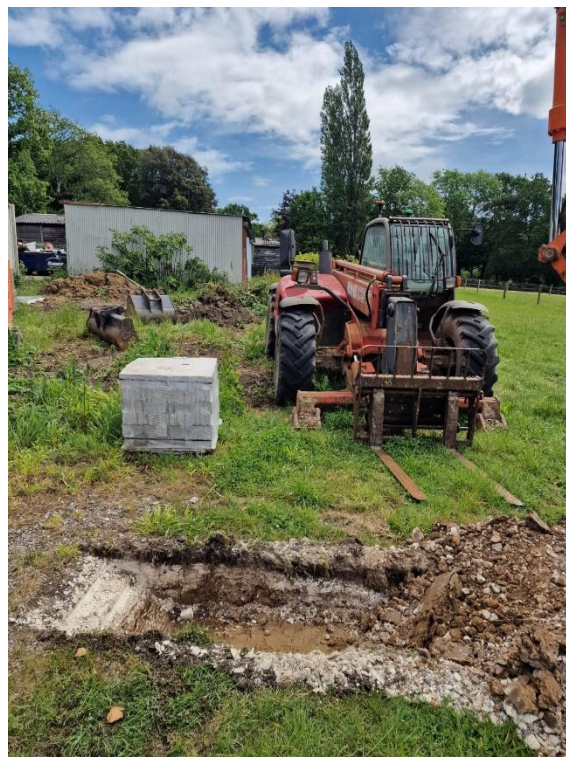
Trial pit 6

- 5.8. TP6 is located within a vegetated area between an unvegetated track and gateway into the field to the south. The trial pit was excavated to confirm what, and if any, surfacing was present in this location. It was found that the materials present were similar to those observed elsewhere within the site (i.e. topsoil over chalk over the natural underlying clay). No sampling was undertaken in this case as it was not deemed that this area is at any significant risk of contamination and materials present were similar to those used elsewhere (and most likely from the same original source). Post development it is understood this area will remain generally as existing. Given that no contamination has been identified across the more actively used areas of the site, and the materials present show no variation, we are not concerned that any significant contamination is present at this location within the site.

| Standpipe | Sampling | | | Strata | | | | |
|---|---|---|---|---|---|---|---|---|
| | | | | <br><br> | 0.05 m<br><br>0.2 m<br><br>0.3 m | | Surface topsoil with grasses<br><br>Chalk fill MADE GROUND<br><br>Light brown natural clay ground | |
