**BECKLEY STUD, REEDS LANE,  
SOUTHWATER, RH13 9DQ  
PHASE I GEO-ENVIRONMENTAL  
ASSESSMENT ("DESK STUDY")  
EQUINE AMERICA  
14<sup>TH</sup> OCTOBER 2025  
LS8882**

| <b>Title:</b> | <b>PHASE I GEO-ENVIRONMENTAL ASSESSMENT ("DESK STUDY")</b> | |
| <b>PROJECT:</b> | <b>ERECTION OF A NEW STORAGE BUILDING ON THE EXISTING SAND SCHOOL</b> | |

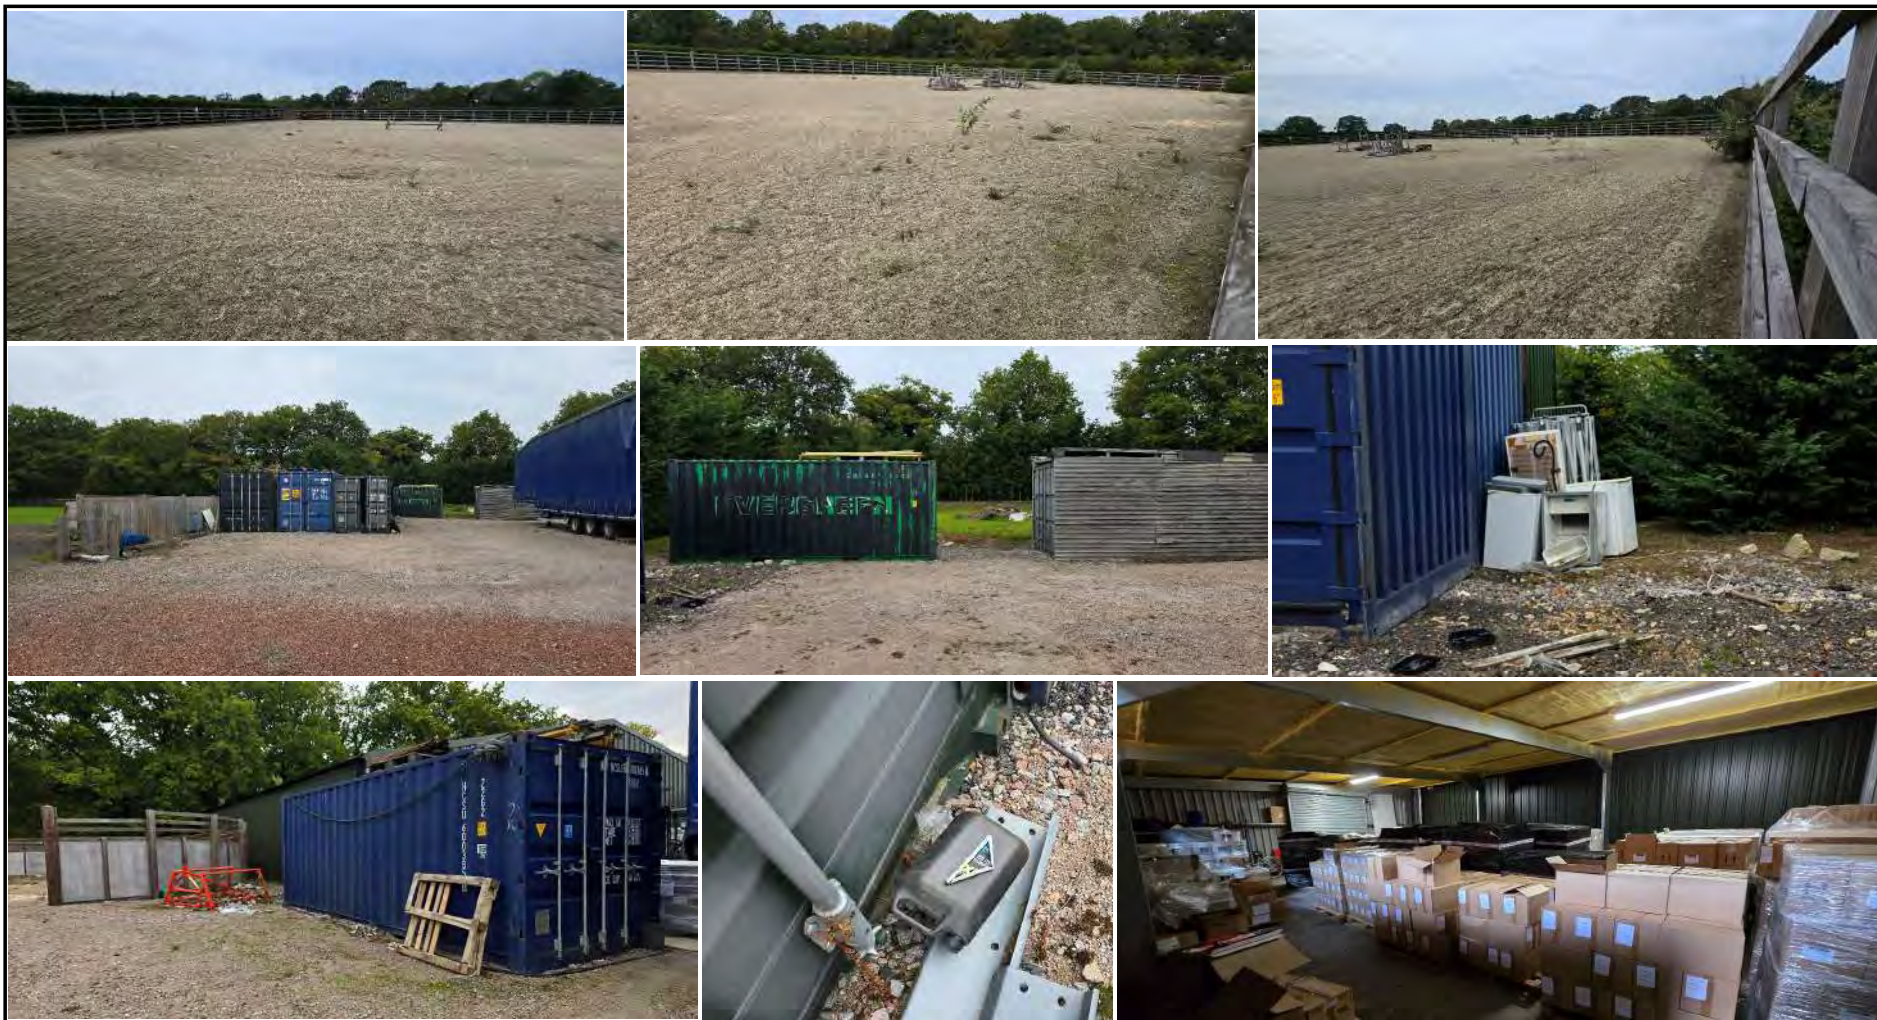
| <b>PROJECT:</b> | Beckley Stud, Reeds Lane, Southwater RH13 9DQ | <b>SHEET:</b> | 1 | <b>CHECKED:</b> | MR |

A walkover survey was carried out in order to provide an assessment of the existing site conditions and to identify potential areas of concern. A record of the inspection is shown in Appendix A, with photographs in Appendix B.
