**Town House Farm**

**House Extension**

Design & Access Statement

May 2026

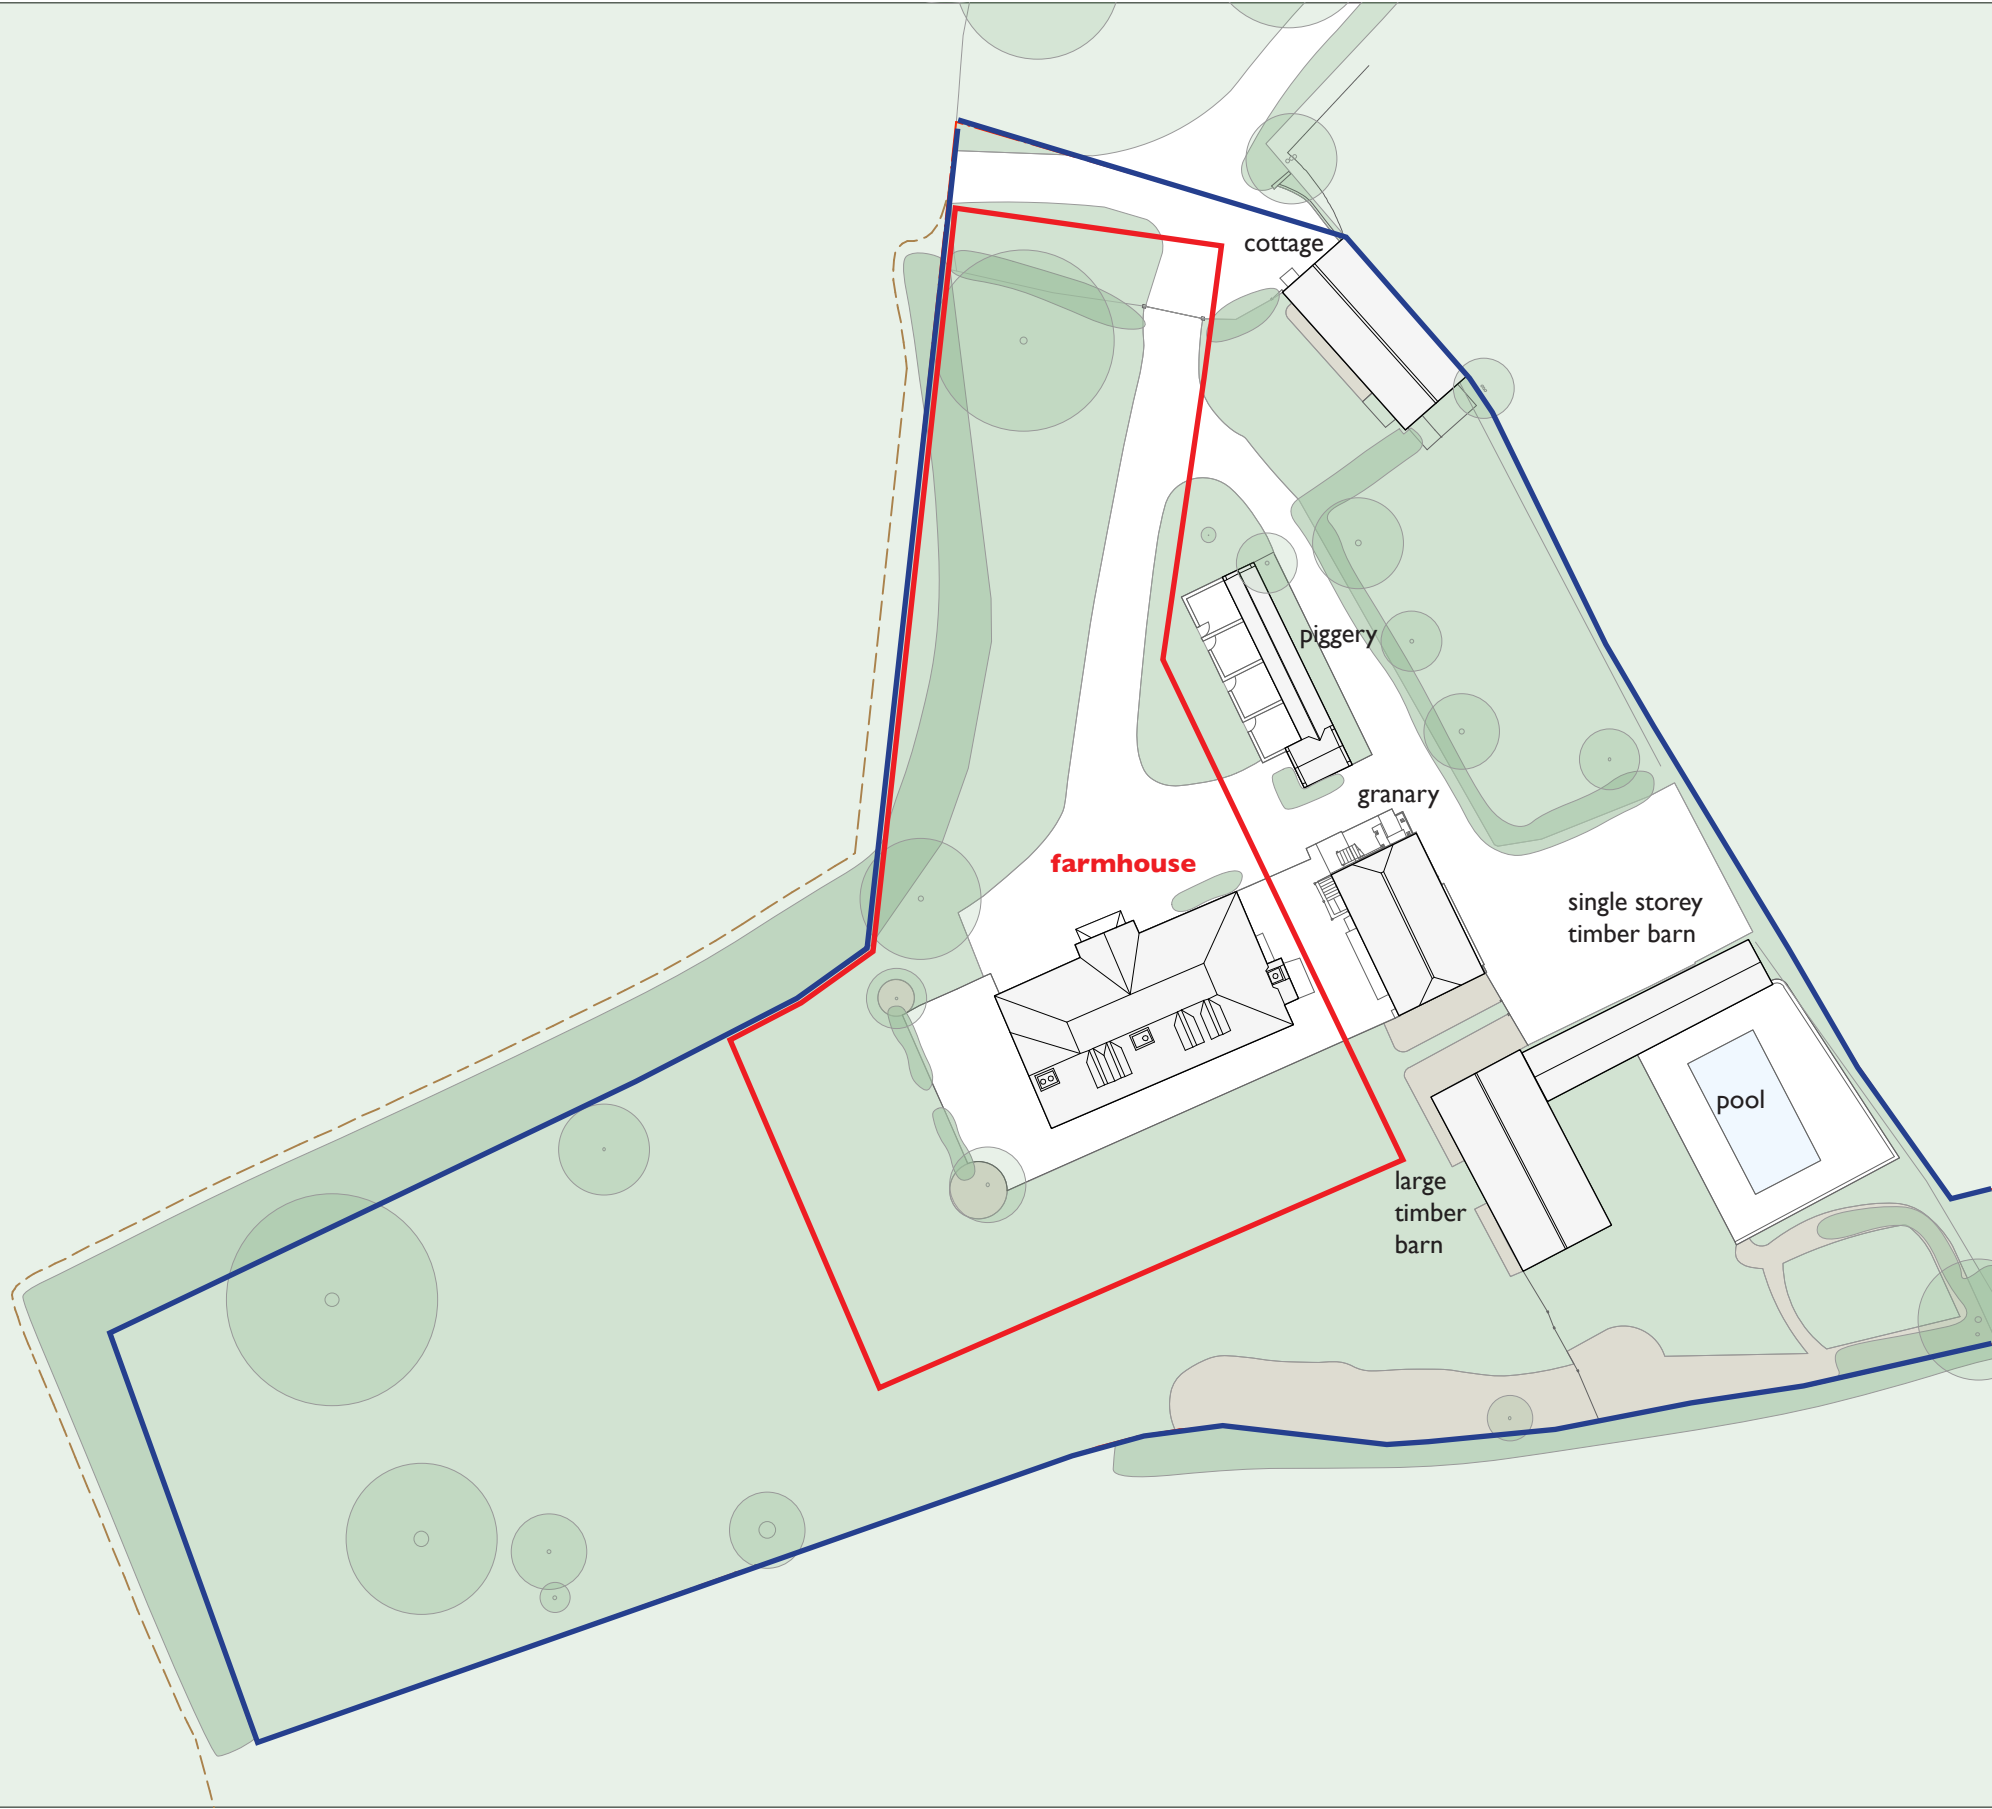
Existing Buildings

- 2.06 The site comprises a group of existing buildings around the entrance driveways.
- 2.07 These are:
- 2.08 The farmhouse - a 3 storey building with traditional brick and clay tiled external walls.
- 2.09 'The cottage' which is a separate registered dwelling within the curtilage with its own front door access onto the access lane
- 2.10 The granary - a 2 storey brick, stone, and timber building with a cellar under half of it.
- 2.11 A timber framed and timber clad building furthest south on the site which is a single large internal volume
- 2.12 A single storey open sided timber frame barn structure which frames the swimming pool
- 2.13 A brick 'piggery'
- 2.14 Our client is seeking to extend the farmhouse to the south and west

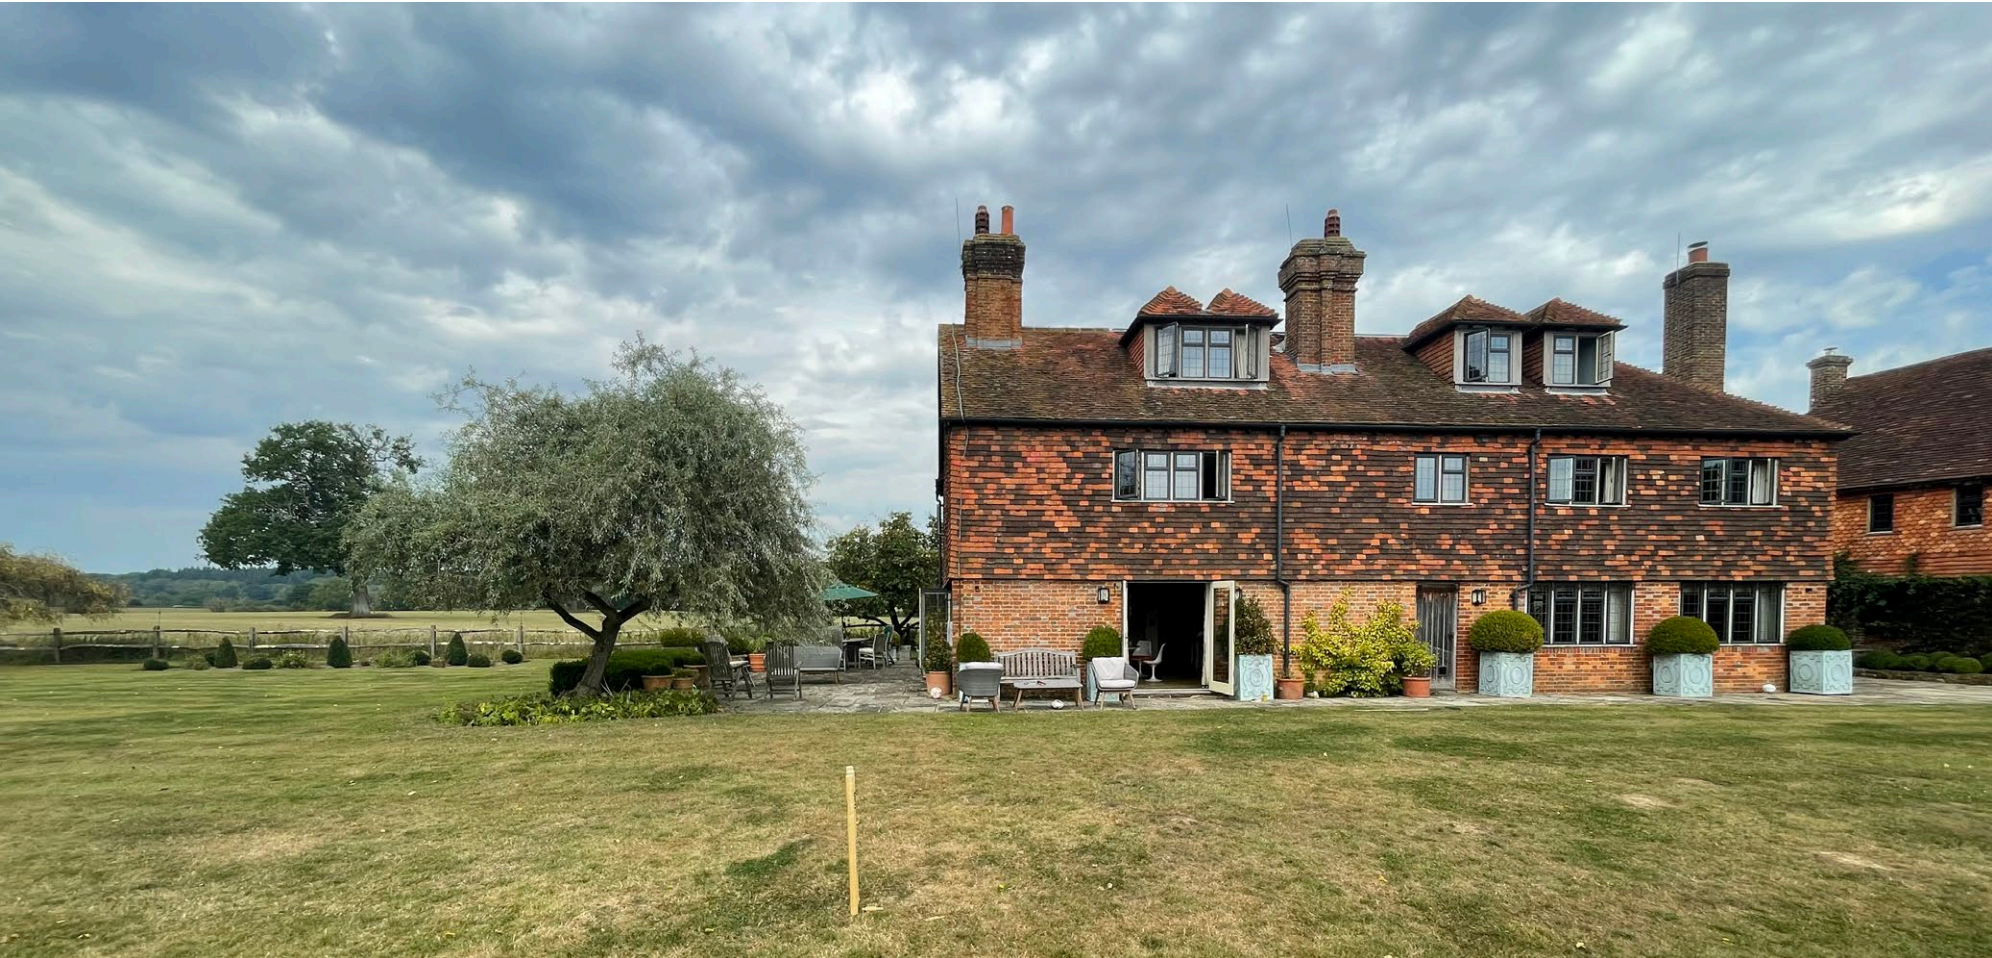
Existing Farmhouse - Facades

- 2.19 The building is surrounded by gardens and landscape but has poor connections to them.
- 2.20 The 1st floor clay tile facade drops low over the windows and doors, dictating the maximum opening height.
- 2.21 There are only 2 openings to the garden on the south and west facade - each a set of timber framed glazed double doors

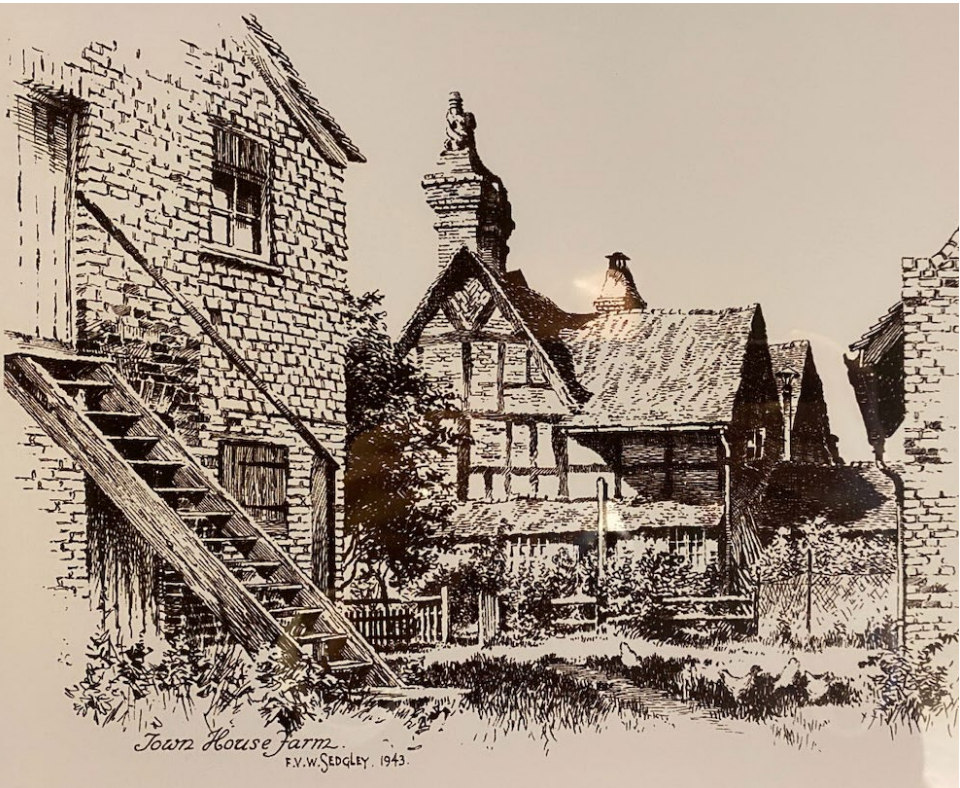
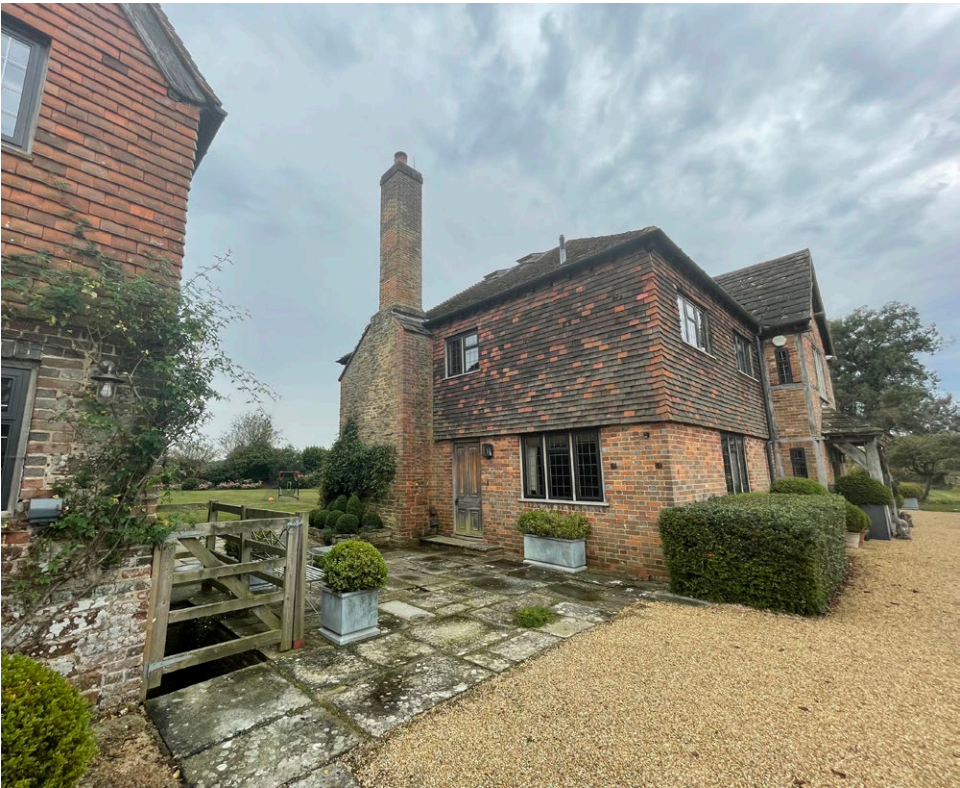
A 1943 sketch of Town House Farm by F.V.W. Sedgeley shows the view of the north east corner of the house from the gap between the granary and the piggery.
- 3.12

As seen from the comparison with a contemporary photograph, the current building is very different from the historic structure in the drawing.
- 3.14

The historic building had two large northern gables, an eastern gable, a single storey pitched roof outreach to the north, ornate chimney pots, and expressed half timber framing and brick infill walling.
- 3.15

What now sits at the property has a single north facing gable defining the house entrance, hipped roofs, modern square brick chimney above roof level, and a 1st floor facade of hung clay tiles.
- 3.16

The reason for this significant change is a major fire shortly after the previous owner's family bought the property in the 1960s. The family lost a child in the fire, and the house was completely re-built. The architectural plans of this re-building are shown on the following page.
- 3.17

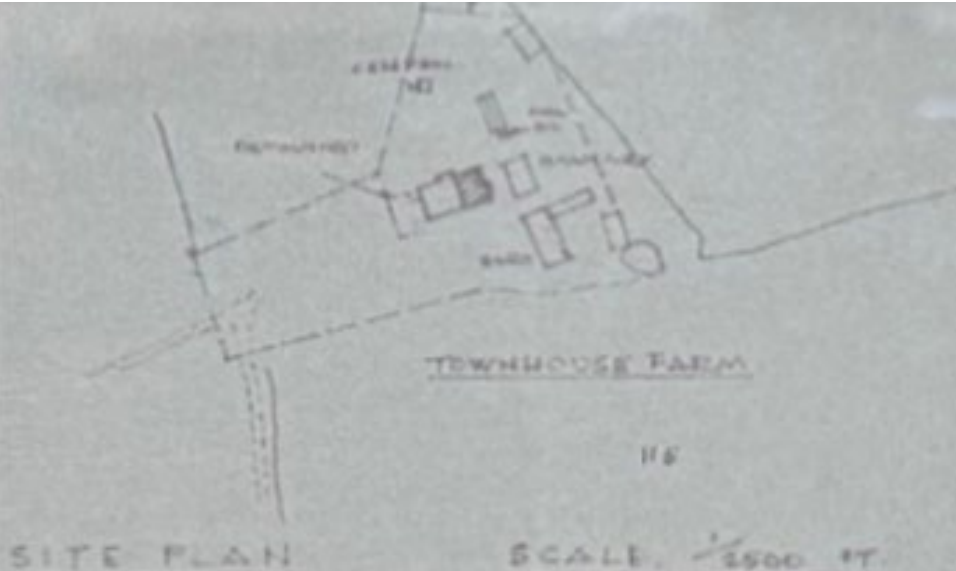
Location Plan Extract

- 3.28 On the location plan extract, a dotted line shows the extent of 'demolished' original fabric to the west, the retained fabric is drawn as outline, and the new fabric (the current living room to the east of the entrance hall) is shown hatched.
