**CHIDHURST LIMITED**

ST JOHN'S FARM, TROUT LANE, BROOKS GREEN,  
HORSHAM, WEST SUSSEX RH13 0JN

**Preliminary Contamination Risk Assessment**

September 2025

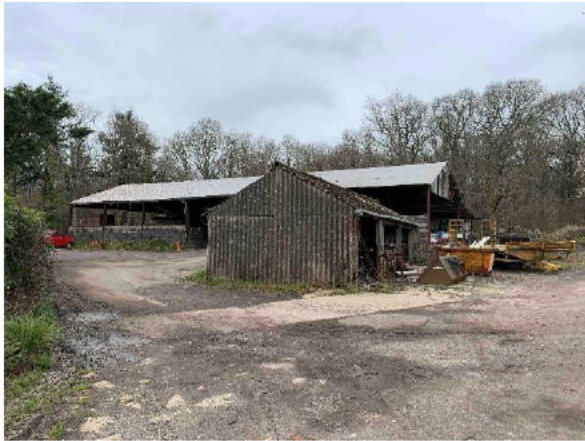
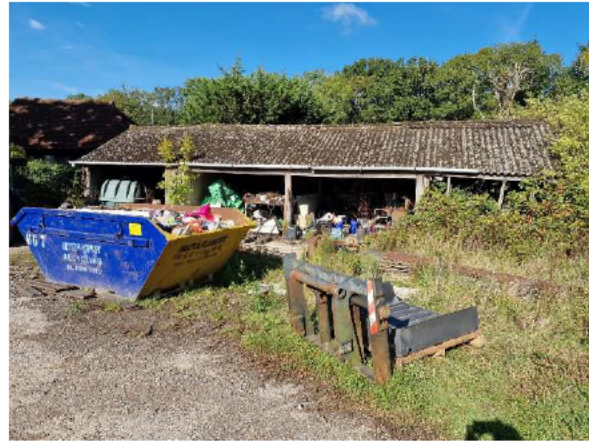
**Photographs 1 and 2:** Workshop and tractor shed (behind) within the northern section of the site.

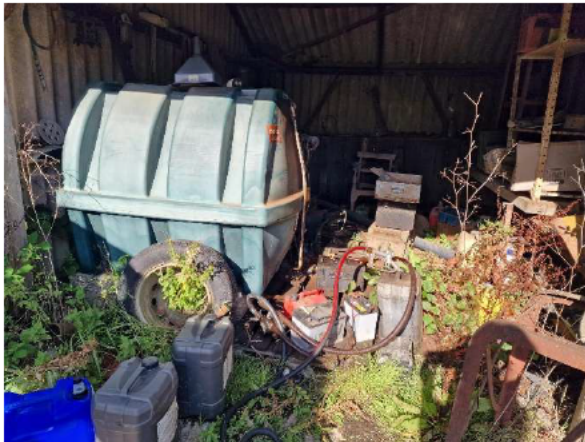
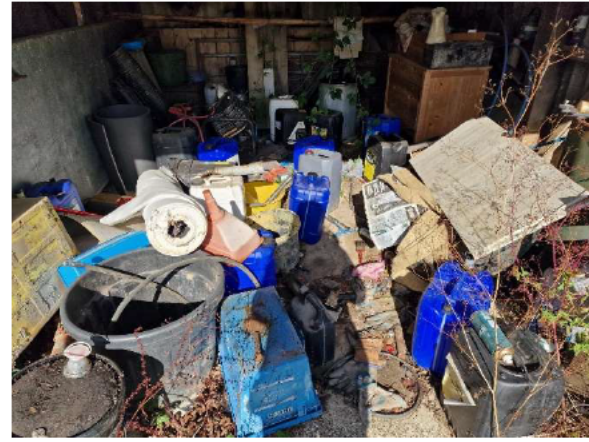
- 5.5.1 The workshop is a small building clad in corrugated asbestos sheets. To the front (east) of the workshop is a small concrete apron and track which extends south towards Sussex Barns (the existing residential dwelling located towards the centre of the site). There is a skip to the east of the building. Inside the building are a variety of small tools and maintenance equipment including oils and fuels. Within the southern section of the building is a gas oil tank adjacent to which is a pallet with old vehicle batteries and fuel containers.

**Photographs 3 and 4:** Items within the workshop.

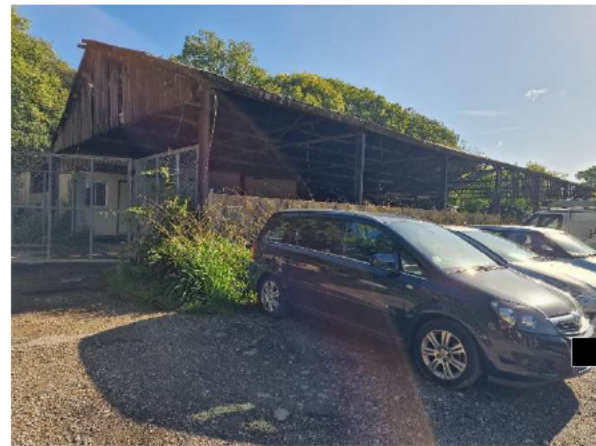
tank was previously located within the southwest corner of the building. This has now been removed and there were no signs of any associated staining.

**Photographs 5 and 6:** Southwest corner of the building illustrating tank removal.

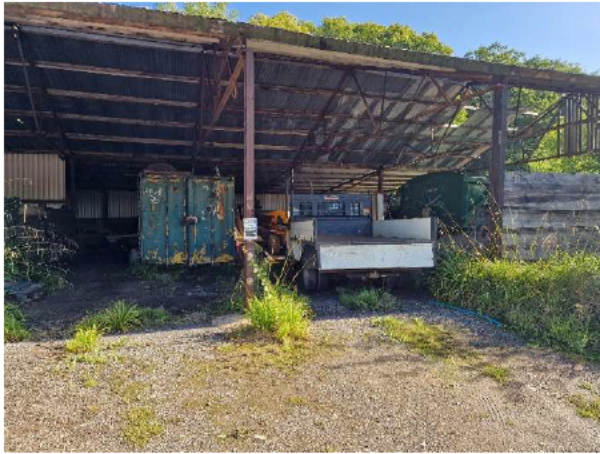
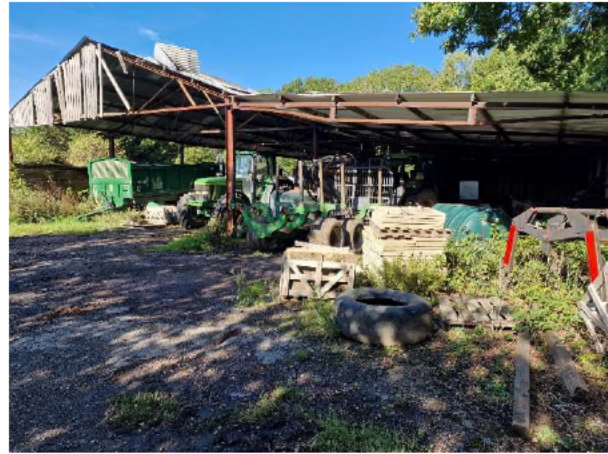
- 5.6.1 The tractor shed is located within the northern section of the site. This is a large metal framed, open-sided structure with metal sheet roofing panels (no asbestos). The internal space is divided into three sections. The main / larger area to the east has a dirt floor and is used for the storage of large farm machinery (including tractors). Other items include two gas oil tanks, wood, a 200 litre drum, jerry cans and a fridge. The western section is divided into two bays, with a concrete floor within the northeast bay and mixed flooring materials within the southeast bay. Both bays are currently vacant with a few items remaining, including a portacabin, piles of bricks and paving and a forklift truck, to suggest these sections may have been used as a builders store. An old metal

**Photographs 7 and 8:** Tractor shed.

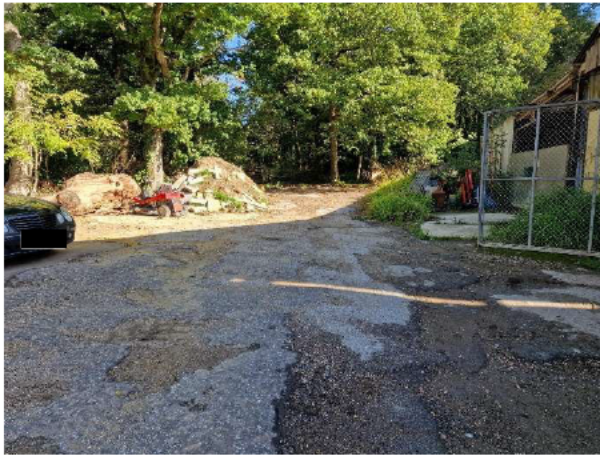
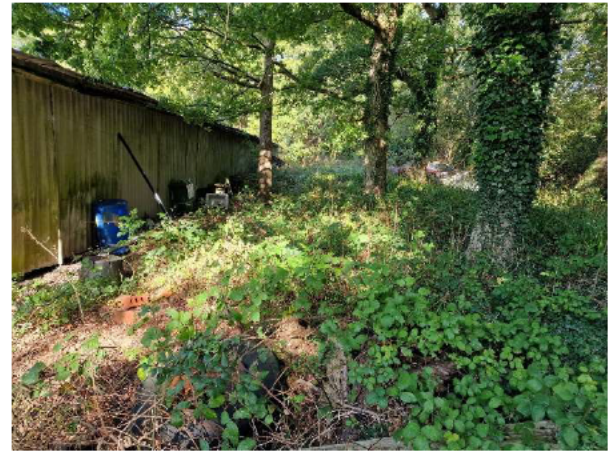
- 5.6.2 To the rear (north of the tractor shed) is woodland. Items stored to the rear of the shed include an old car, tiles, paving slabs and metal sheets. Adjacent to the northwest corner of the shed is waste including concrete, marble and wood materials. To the west of the shed, on the opposite side of an access track, is a pile of mixed earth and rubble. To the east of the shed is loose surfacing and large farm equipment including a plough.

**Photographs 9 and 10:** Hard standings and waste piles to the west of the tractor shed and land to the rear of the tractor shed.

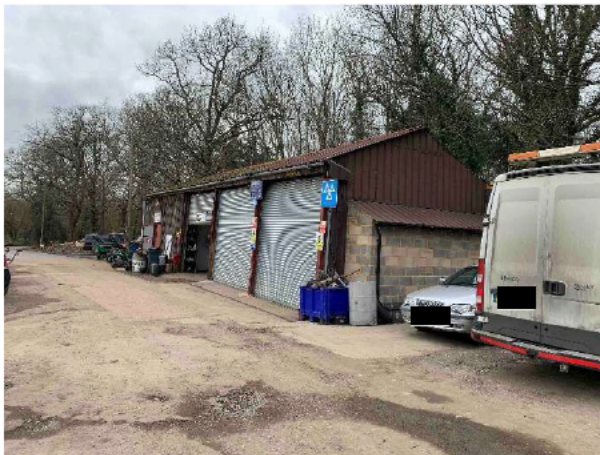
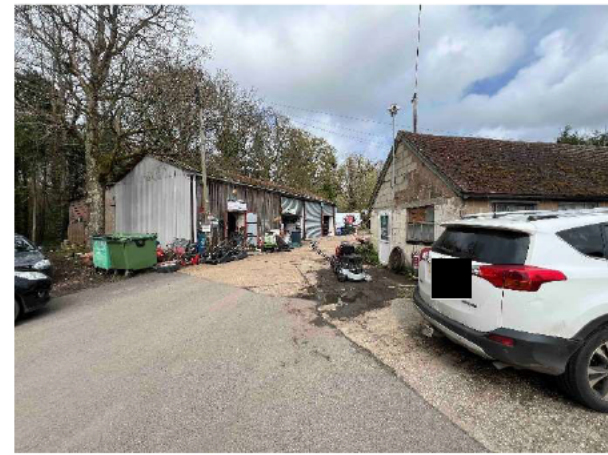
- 5.8.1 Adjacent to the western boundary of the site is a unit of mixed construction. The northern bay is used as a garage and MOT test centre and includes a recently installed inspection pit within the floor. The flooring is painted concrete, in good condition. The southern section of the building is presently vacant but was used for the storage, maintenance and sale of lawn mowers.
- 5.8.2 To the south of this building is a gravel hard standing / parking area. To the north of the garage is a skip used for metal waste and an informal storage area with a row of shed and shipping containers.

**Photographs 11 and 12:** Garage and (now) vacant units to the west of the site.

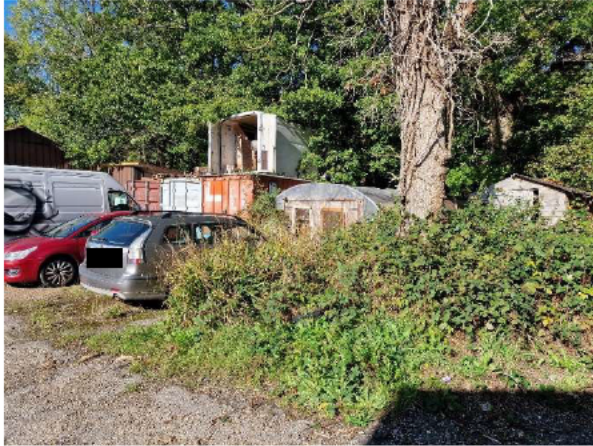
**Photograph 13:**

- 5.9.1 To the north of the garage unit, along the western boundary of the site, is a stacked line of shipping containers and similar units/shed used for additional storage.

Row of shipping containers and storage sheds adjacent to the western boundary of the site to the north of the garage.

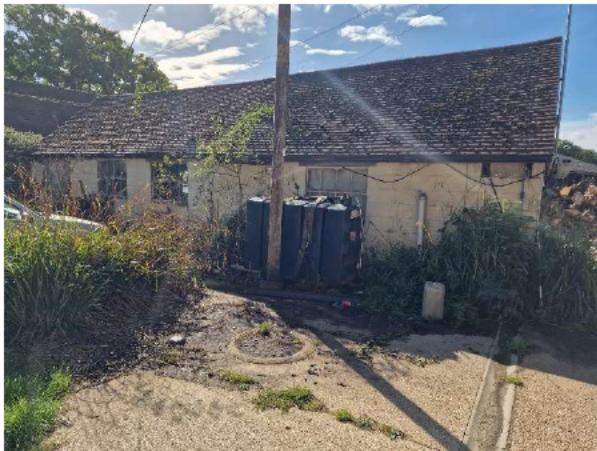
**Photograph 14:**

- 5.11 To the west of Sussex Barn (the existing residence) is a single storey, concrete block office type building with pitched, concrete tile roof, metal window frames and plastic gutters. Staff facilities are located within the western end of the building. This building is presently vacant.
- 5.12 Externally, there is a tank located adjacent to the northwest corner of the office building, together with an inspection cover for an underground feature likely to be for waste water / sewage associated with the toilets in the office building.

Office building and tank adjacent to northern facade.

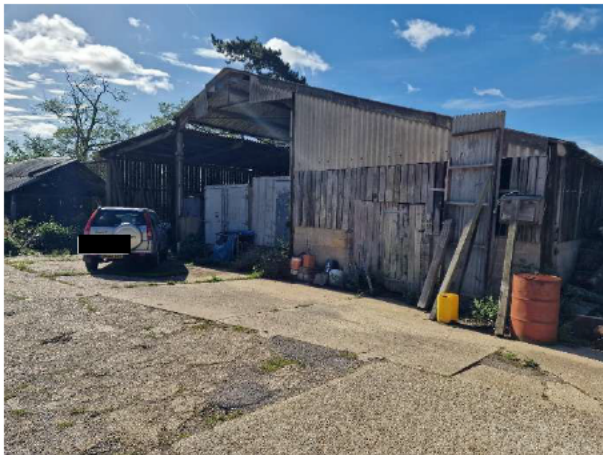
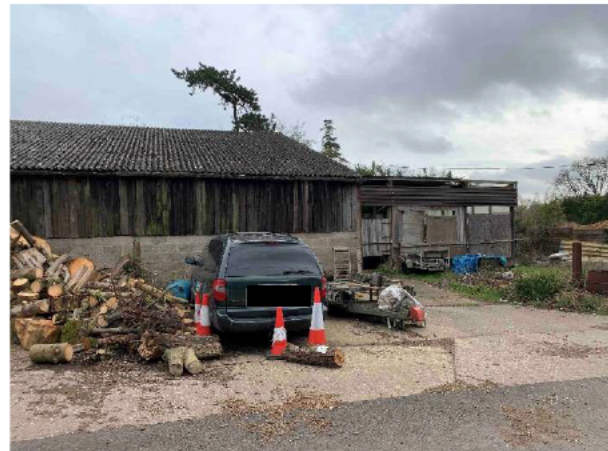
5.14 To the south of the site, east of the tarmac access road, is a metal frame Atcost type barn with corrugated asbestos roofing and wooden cladding, together with a smaller extension to the south of mixed (metal and wood) construction. The flooring within the barns is part compressed dirt, part concrete flooring with matting in the southern barn.

**Photographs 15 and 16:** Atcost barn and adjoining extension to the south of the site.

- 10.1 All asbestos containing materials (ACMs), including roofing, cladding and rain goods, should be removed from the site as part of the site's redevelopment. It is recommended a pre-demolition survey is completed in accordance with HSG264 prior to the commencement of works and, where asbestos containing materials are confirmed to be present, a remedial mitigation scheme to control risk to future site users should be prepared and implemented as appropriate.
