**BS5837:2012 ARBORICULTURAL  
METHOD STATEMENT:  
Springlands Gate, Fryland Lane, Wineham, BN5 9BP**

Dated: 11<sup>th</sup> May 2026

Our reference: GHA/MS/666160:26

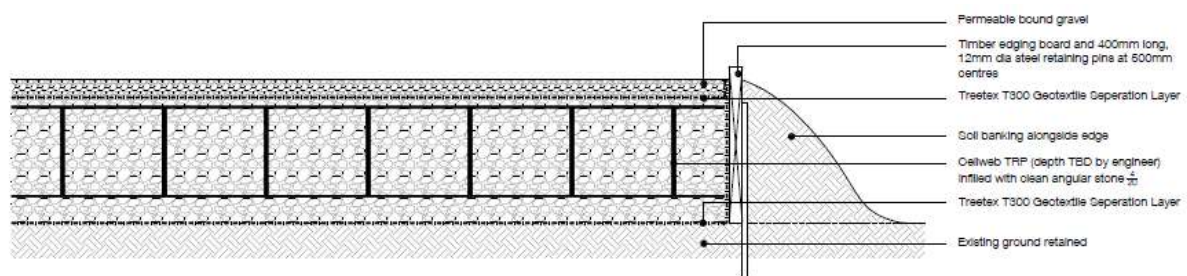
### No dig drive makeup

- 6.5 NO DIG SURFACING CONSTRUCTION METHOD IN ACCORDANCE WITH BS: 5837  
The sections of the new driveway that are within the RPAs of the retained trees **MUST** be constructed as follows. Below is a diagram detailing the makeup of the new drive and also a typical cross the installation methodology is included below this diagram.

- Eradication of all existing ground vegetation must be undertaken using a translocated herbicide. Any product used for this purpose must be selected to ensure that it will not have an adverse affect on the health of the retained trees, and carried out by a suitably trained operative.

- Any major protrusions within the soil must be removed, such as large rocks or existing tree stumps. Any holes should be filled with sharp sand.
- Lay a geotextile membrane over the entire area(s) to be protected, ensuring a one 1m overlap where necessary. All new surfacing **MUST** be positioned at least 500mm from tree stems or buttress roots.

- Construction of the edging of the area is to be implemented with the use of vertical steel pegs driven into the ground at intervals of 500mm with side supports firmly attached. **CHECK FOR UNDERGROUND SERVICES PRIOR TO THE COMMENCEMENT OF SUCH WORK.**

- The three dimensional cellular confinement system (e.g cellweb or similar) must be cut to size and placed within the pre-prepared area. This area must now be filled with a no-fines aggregate infill. This must then be compacted to avoid the possibility of future "rutting".

- Lay a final layer of the geotextile membrane on top of this surface.
- A porous material can now be placed on top to complete the construction.
- Graded top soil will be used to bring the adjacent grassed areas to the same level as the new driveway.
