# Thakeham Tiles, Rock Road

## Phase 1 Desk Study Report

*For Thakeham Concrete Products Ltd*

Doc ref      37212-HYD-XX-XX-RP-GE-1000

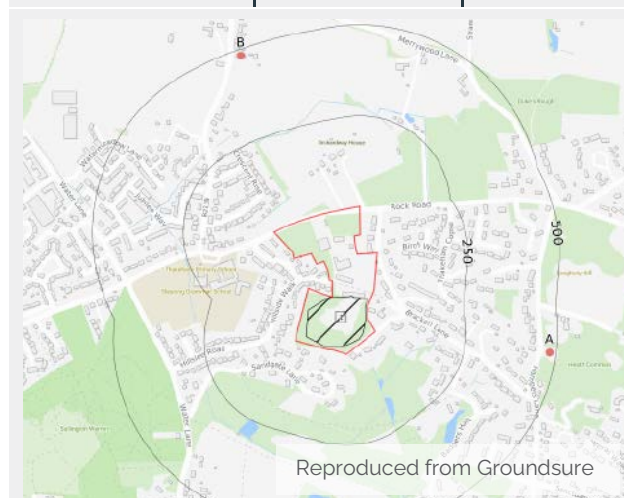
Figure 2-6: Waste management sites within 250m

| Site Name | Location | Details |
|---|---|---|
| Thakeham Tiles | On site - Storrington, Sussex | Status: Closed<br>Operational dates: 1970-1994<br>Waste accepted: inert, (waste products from tile manufacturing) |

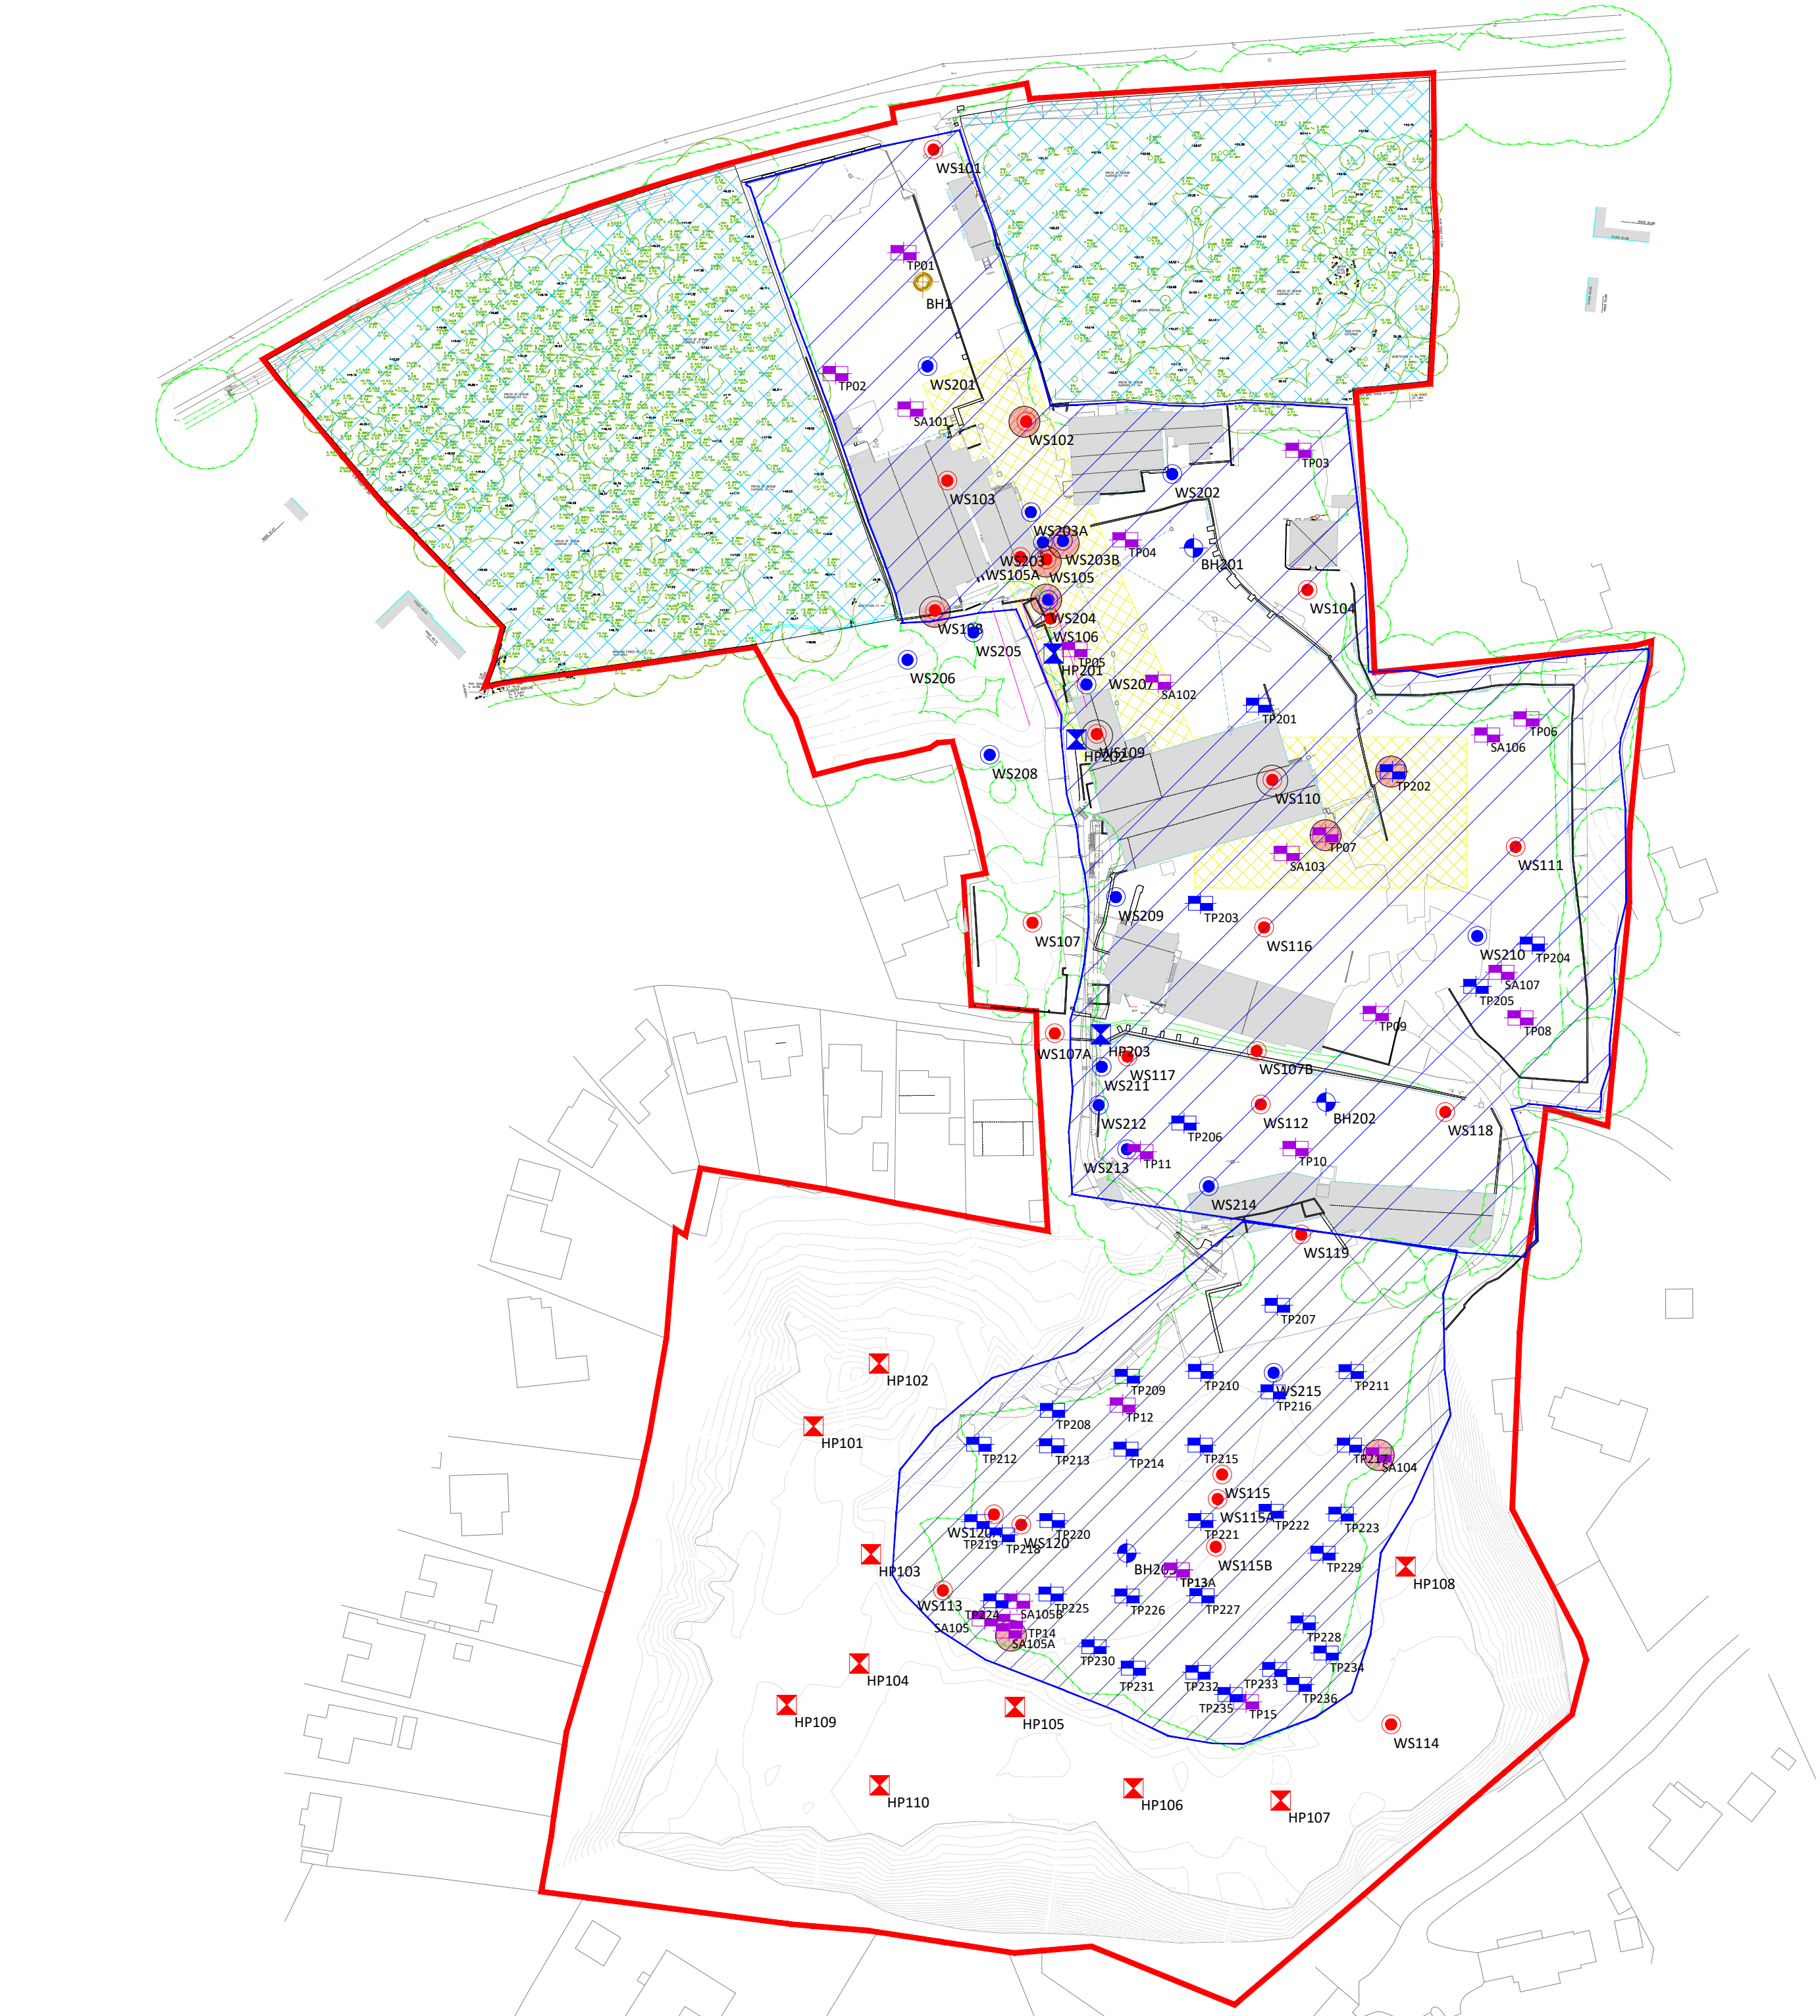
| | Rotary borehole |
| | Historical Trial Pit (Hydrock 2018 and 2021) |
