# **WILLIAM FARMER**

**STUMBLEHOLME FARM, RUSPER ROAD, CRAWLEY,  
WEST SUSSEX RH11 0LQ**

## **Contamination Risk Assessment**

February 2026

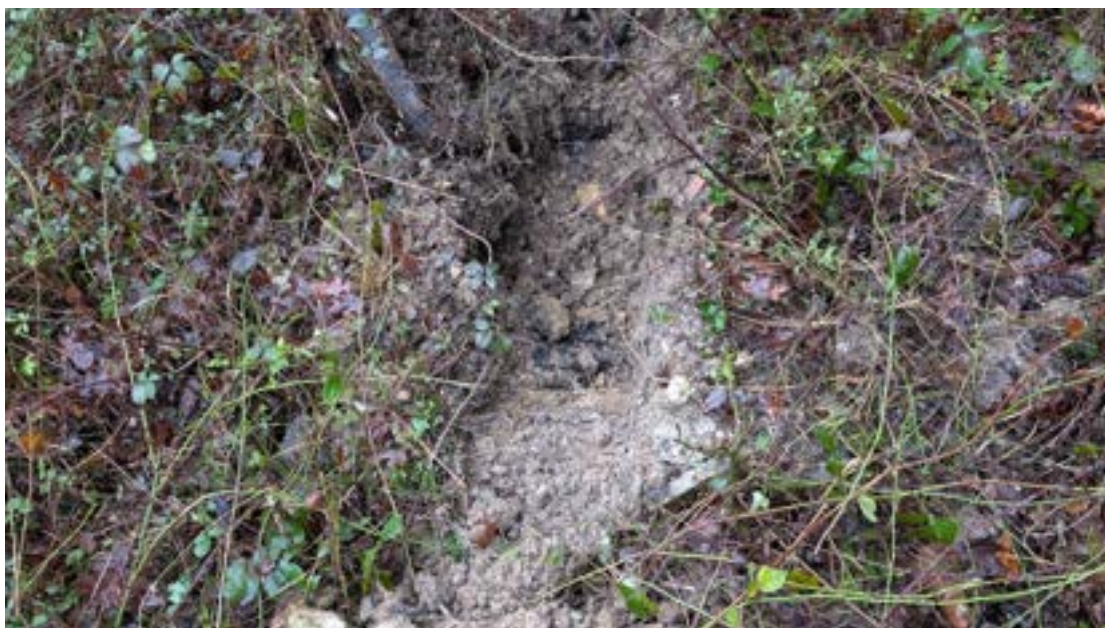
### **Trial Pit B1**

| <b>B1</b> | <b>B2</b> |
|---|---|
| Trial Pit B1 was located east of the northeastern corner of Barn B. The trial pit revealed a layer of topsoil approximately 0.1 m. The sample consisted of brown clay and sand with vegetation and stones. | Trial Pit B2 was located east of the northeastern corner of Barn B. The trial pit revealed a layer of topsoil approximately 0.1 m. The sample consisted of brown sand with vegetation and stones. |

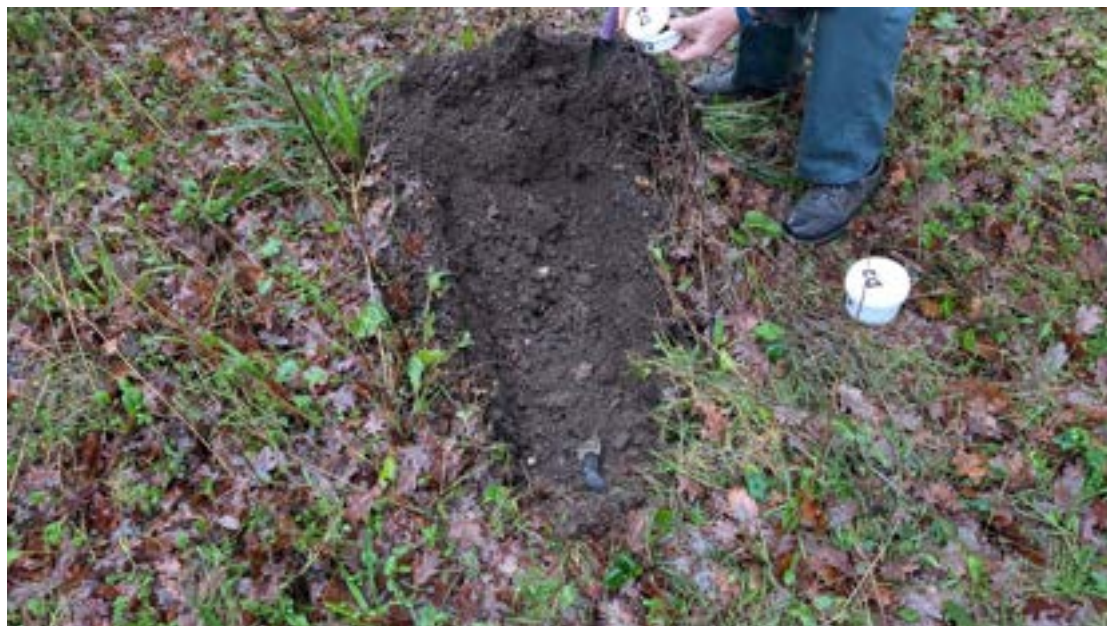
### **Trial Pit D2**

| <b>B1</b> | <b>B2</b> |
|---|---|
| Trial pit D1 was located to the east of the northeastern corner of Barn D on the vegetated grassland. The trial pit revealed a layer of topsoil of approximately 0.1 m over the natural clay strata. The sample consisted of brown clay and sand with vegetation and gravel. | Trial pit D2 was located to the east of the southeastern corner of Barn D on the vegetated grassland. The trial pit revealed a layer of topsoil of approximately 0.1 m over the natural clay strata. The sample consisted of brown clay and sand with vegetation and stones. |

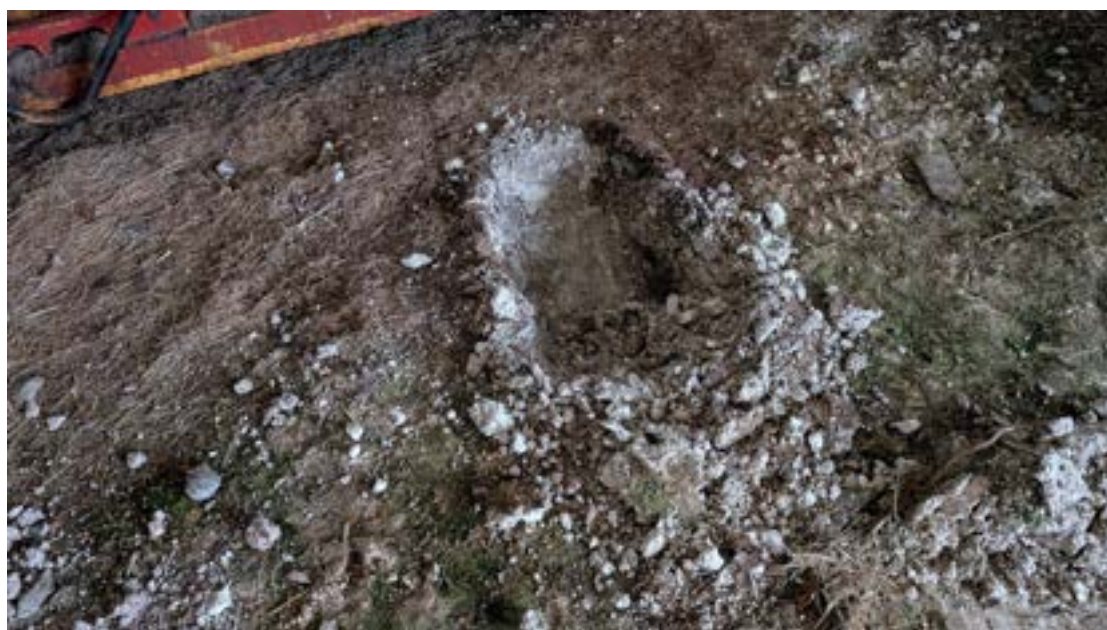
### **Trial Pit E1**

| <b>B1</b> | <b>B2</b> |
|---|---|
| Trial pit E1 was located to the northwestern corner of Barn E. The trial pit consisted of chalk floor made ground of approximately 0.2 m. The sample consisted of brown clay and sand with vegetation and stones. | Trial pit E2 was located to the southwestern corner of Barn E. The trial pit consisted of chalk floor made ground of approximately 0.2 m. The sample consisted of brown clay and sand with gravel and stones. |
