Aquatech Drain Services Ltd
Holmbush Lane, Woodmancote
Tel. 01273 933705
contact@aquatechdrains.co.uk

Completed section inspection

Town or Village:	Billingshurst	**Inspection Direction:**	Downstream	**Upstream Node:**	S135
Road:	Platts Corner	**Inspected Length:**	0.78 m	**Upstream Pipe Depth:**	1.600 m
Location:	Footway	**Total Length:**	0.78 m	**Downstream Node:**	AQUACELL
Surface Type:	Asphalt Footway	**Joint Length:**	1.00 m	**Downstream Pipe Depth:**	0.000 m

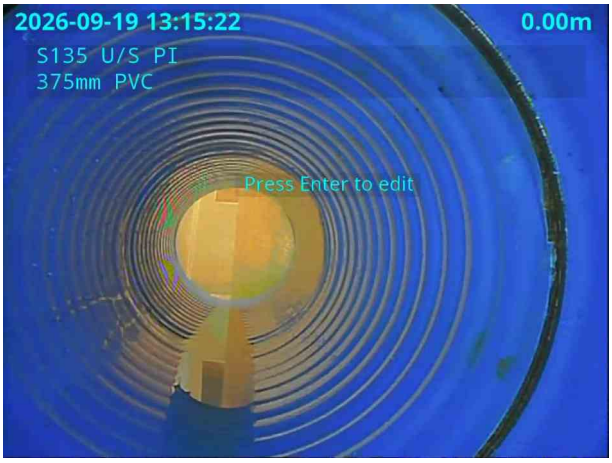
1, 00:00:00, 0.00 m
Start node, catchpit, reference: S135

2, 00:00:24, 1.65 m
Finish node, other special chamber, reference: PI01, PUMP TANK

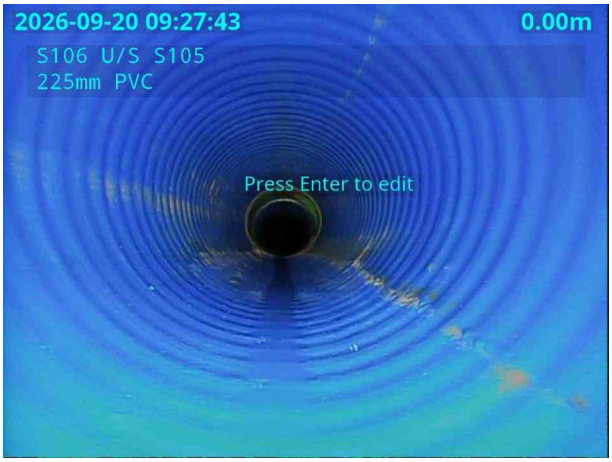
1, 00:00:00, 0.00 m
Start node, inspection chamber, reference: S106

2, 00:03:23, 31.67 m
Finish node, inspection chamber, reference: S105

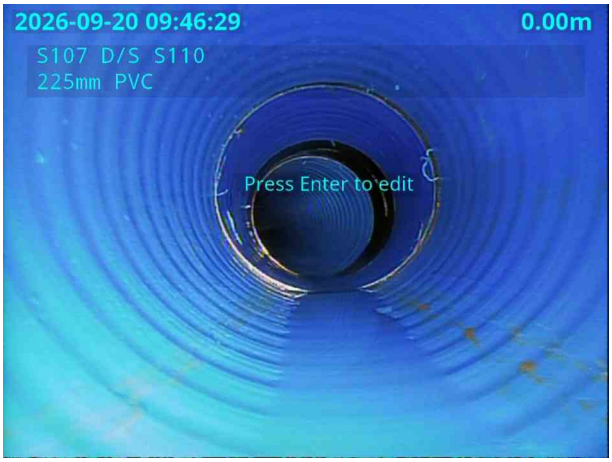
1, 00:00:00, 0.00 m
Start node, inspection chamber, reference: S107

2, 00:01:13, 11.25 m
Finish node, catchpit, reference: S110

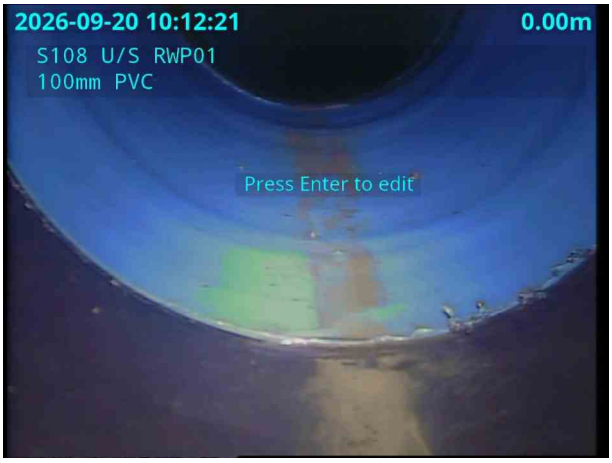
1, 00:00:00, 0.00 m
Start node, inspection chamber, reference: S108

2, 00:00:34, 2.09 m
Finish node, other special chamber, reference: RWP01, RAIN WATER PIPE

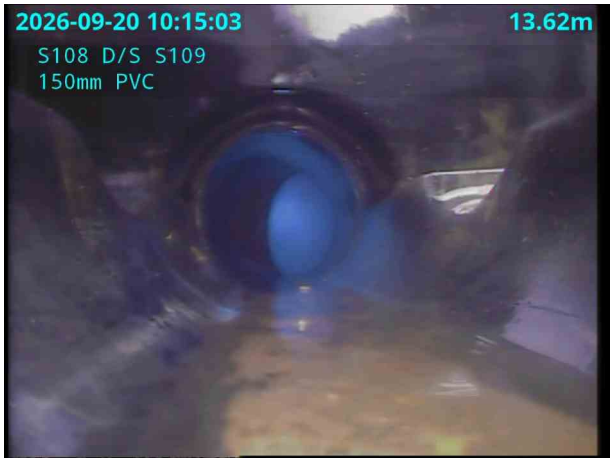
1, 00:00:00, 0.00 m
Start node, inspection chamber, reference: S108

2, 00:00:41, 13.62 m
Finish node, inspection chamber, reference: S109

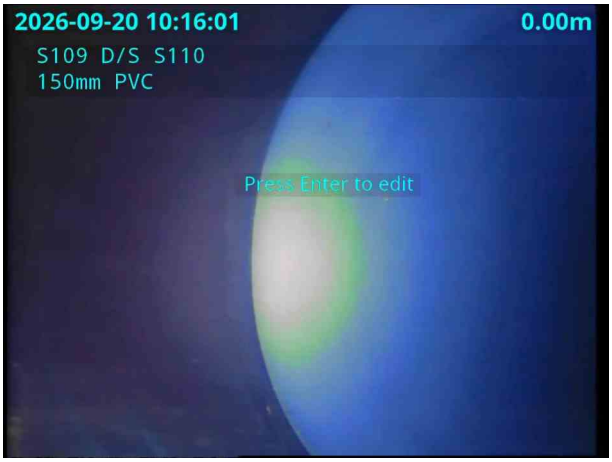
1, 00:00:00, 0.00 m
Start node, inspection chamber, reference: S109

2, 00:01:11, 11.61 m
Finish node, catchpit, reference: S110

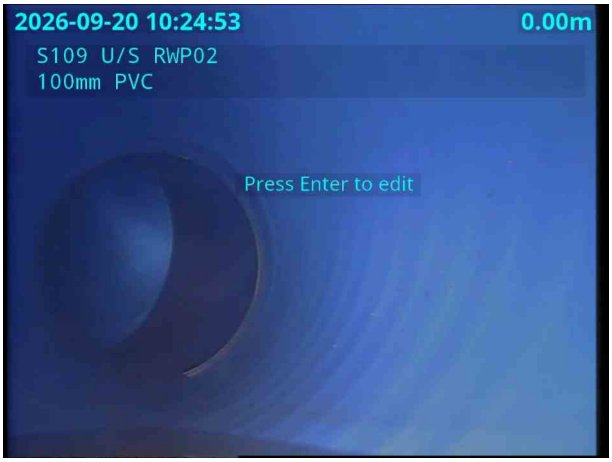
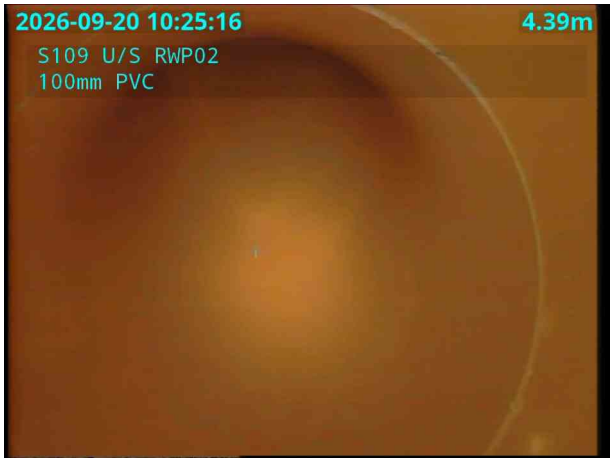
1, 00:00:00, 0.00 m
Start node, inspection chamber, reference: S109

2, 00:00:23, 4.39 m
Finish node, other special chamber, reference: RWP02, RAIN WATER PIPE

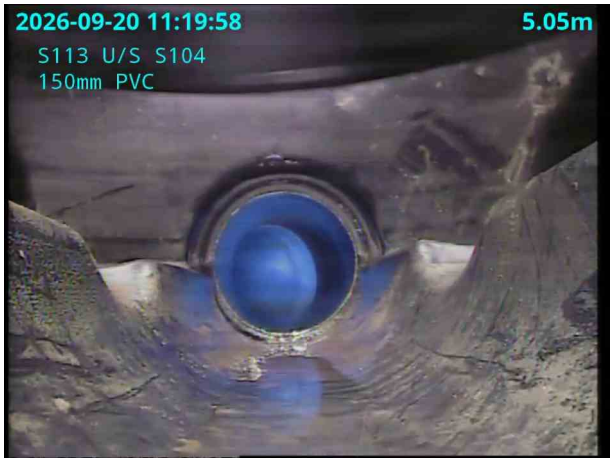
1, 00:00:00, 0.00 m
Start node, inspection chamber, reference: S113

2, 00:00:31, 5.05 m
Finish node, inspection chamber, reference: S104

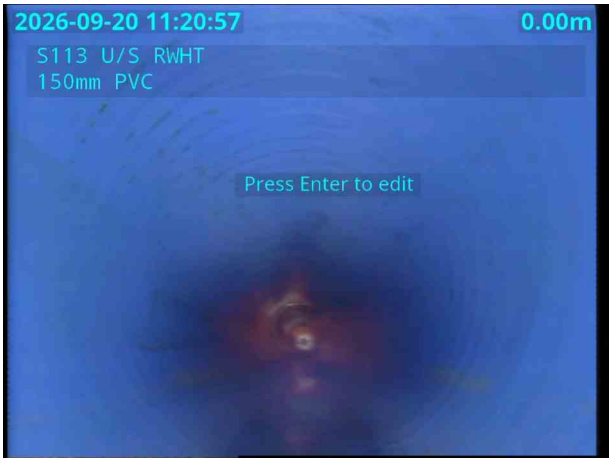
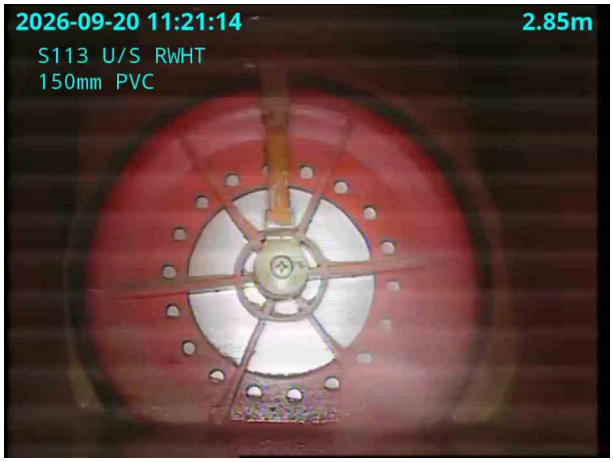
1, 00:00:00, 0.00 m
Start node, inspection chamber, reference: S113

2, 00:00:18, 2.85 m
Finish node, other special chamber, reference: RWHT, RAIN WATER HOLDING TANK

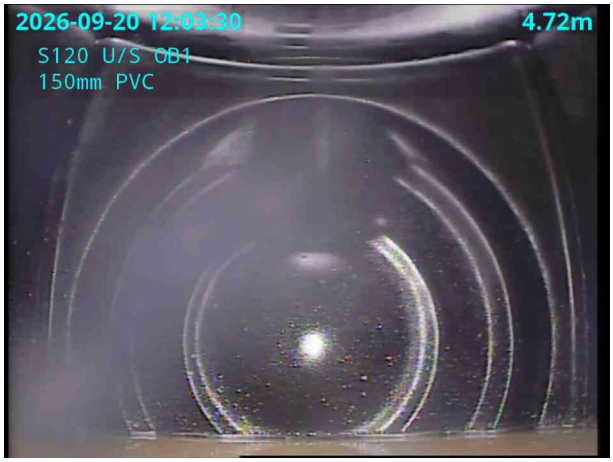
1, 00:00:00, 0.00 m
Start node, manhole, reference: S120

2, 00:00:39, 4.72 m
Finish node, gully, reference: OB1

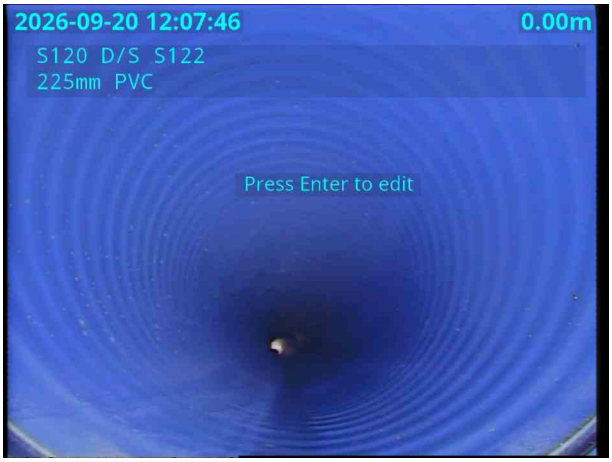
1, 00:00:00, 0.00 m
Start node, manhole, reference: S120

2, 00:00:47, 13.74 m
Finish node, manhole, reference: S122

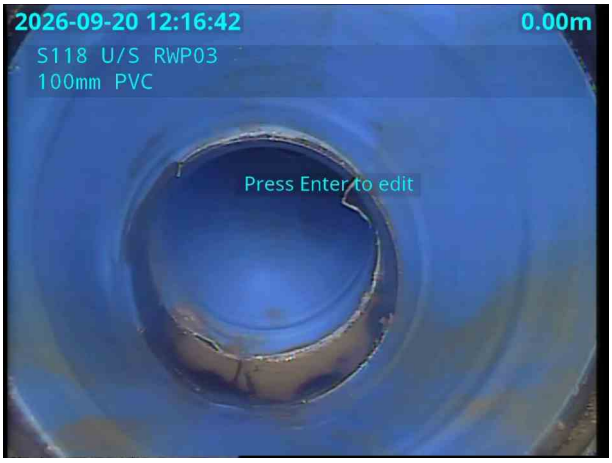
1, 00:00:00, 0.00 m
Start node, manhole, reference: S118

2, 00:01:02, 6.15 m
Finish node, other special chamber, reference: RWP03, RAIN WATER PIPE

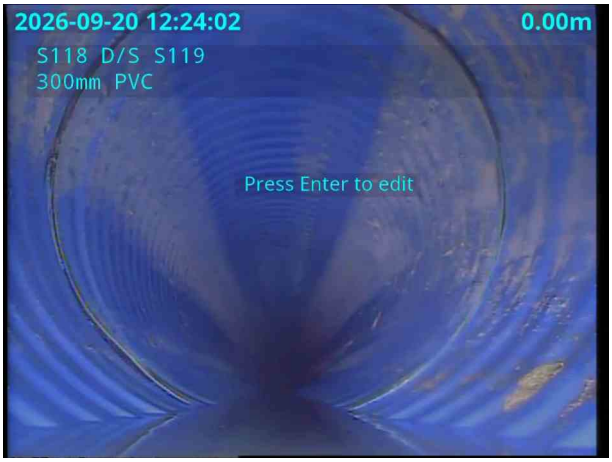
1, 00:00:00, 0.00 m
Start node, inspection chamber, reference: S118

2, 00:01:06, 17.38 m
Finish node, manhole, reference: S119

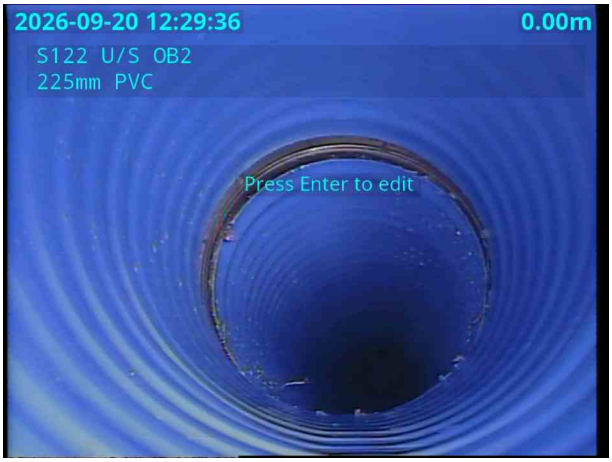
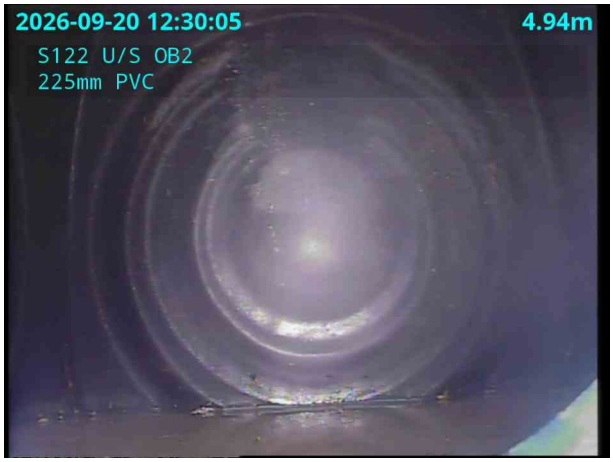
1, 00:00:00, 0.00 m
Start node, manhole, reference: S122

2, 00:00:26, 4.61 m
Line deviates right

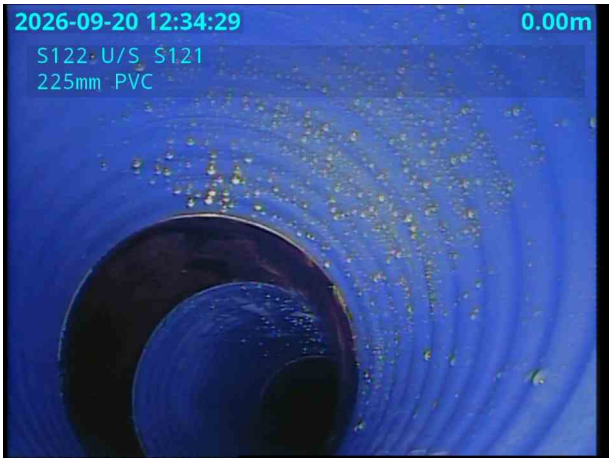
1, 00:00:00, 0.00 m
Start node, manhole, reference: S122

2, 00:00:45, 11.87 m
Finish node, manhole, reference: S121

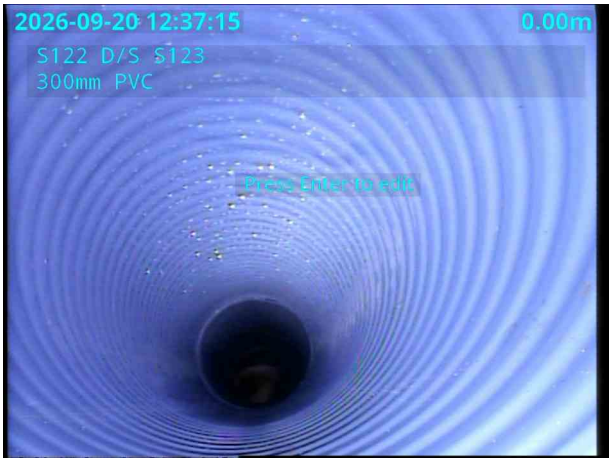
1, 00:00:00, 0.00 m
Start node, manhole, reference: S122

2, 00:00:24, 5.71 m
Finish node, manhole, reference: S123

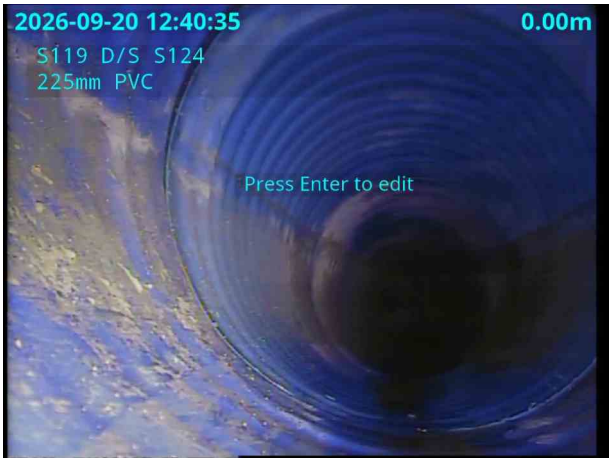
1, 00:00:00, 0.00 m
Start node, manhole, reference: S119

2, 00:00:31, 9.56 m
Finish node, manhole, reference: S124

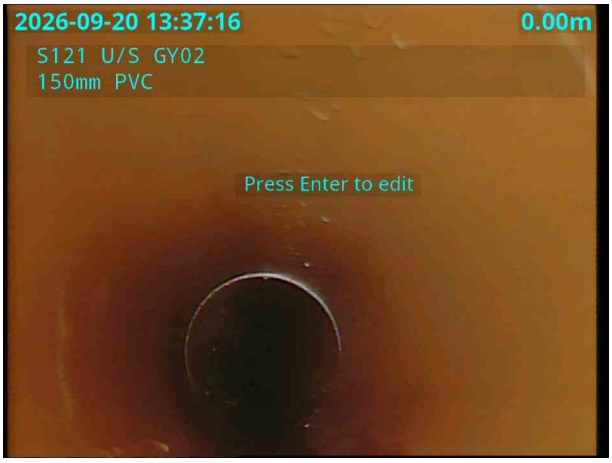
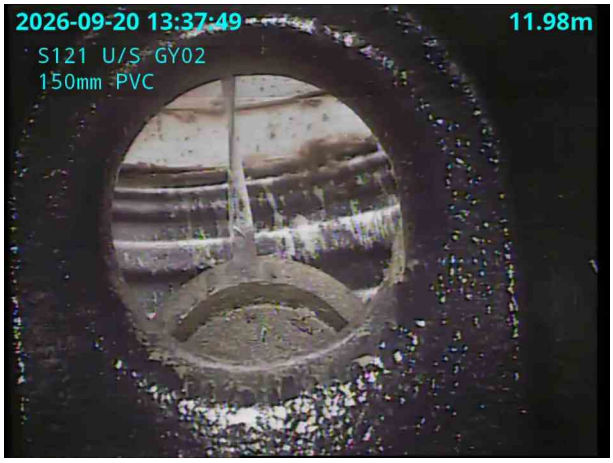
1, 00:00:00, 0.00 m
Start node, gully, reference: MH

2, 00:00:33, 11.98 m
Finish node, gully, reference: GY02

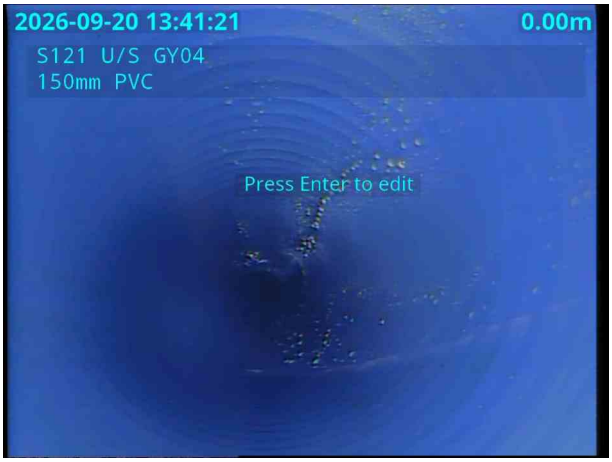
1, 00:00:00, 0.00 m
Start node, manhole, reference: S121

2, 00:00:35, 4.94 m
Finish node, gully, reference: GY04

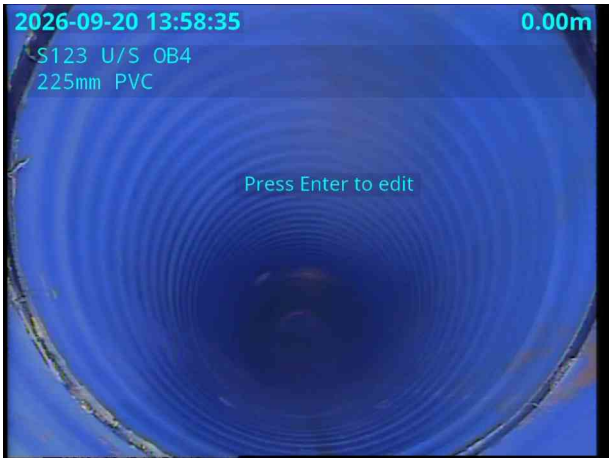
1, 00:00:00, 0.00 m
Start node, manhole, reference: S123

2, 00:00:23, 6.92 m
Finish node, gully, reference: OB4

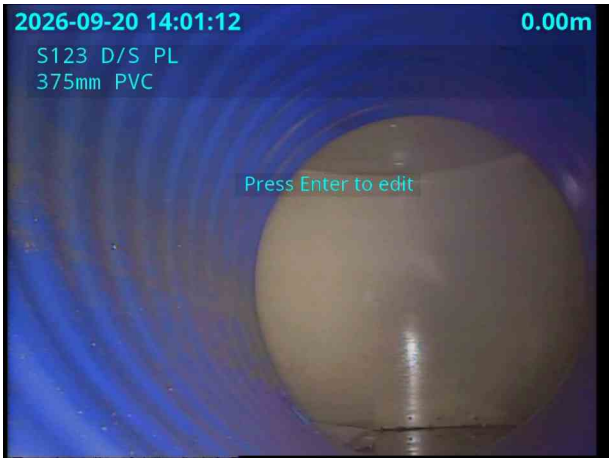
1, 00:00:00, 0.00 m
Start node, manhole, reference: S123

2, 00:00:15, 0.77 m
Finish node, other special chamber, reference: PI02, PUMP TANK

Comments: SURVEY ABANDONED - PIPE NOT FINISHED YET
Recommendations: None

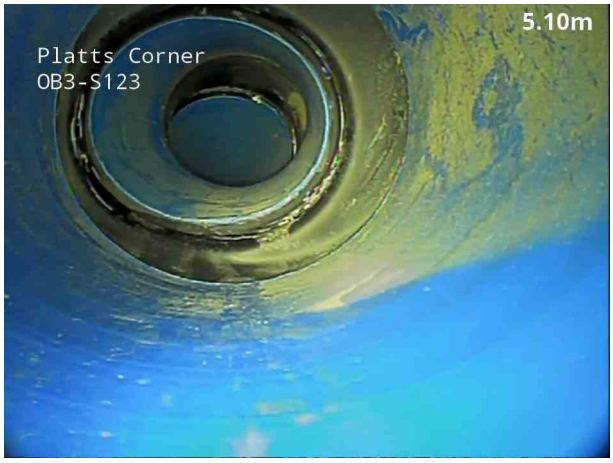
1, 00:00:04, 0.00 m
Water level, 0% of the vertical dimension

2, 00:00:41, 5.40 m
Pipe size changes, new size(s), 150mm high

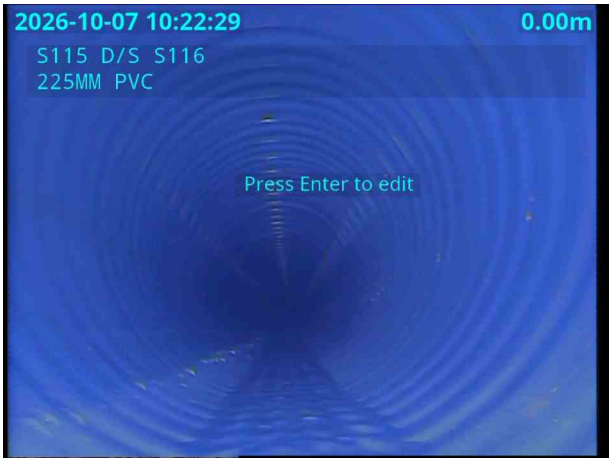
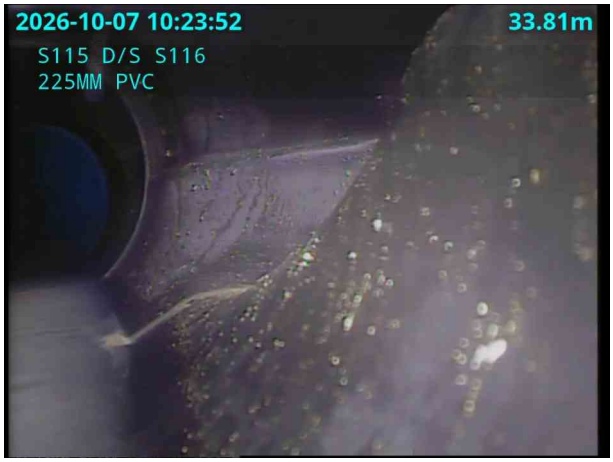
1, 00:00:00, 0.00 m
Start node, inspection chamber, reference: S115

2, 00:01:25, 33.81 m
Finish node, inspection chamber, reference: S116

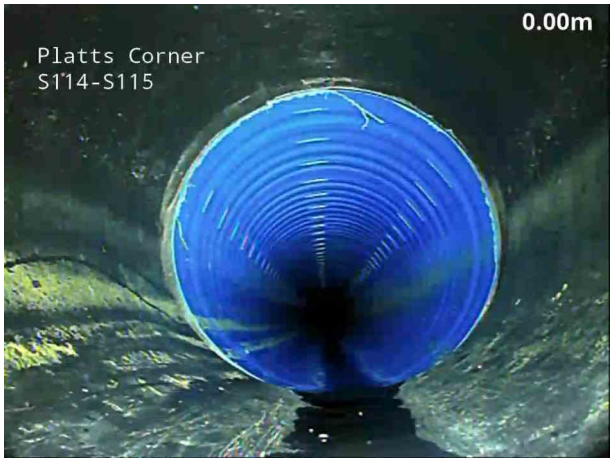
1, 00:00:00, 0.00 m
Start node, inspection chamber, reference: S114

2, 00:00:02, 0.00 m
Water level, 0% of the vertical dimension

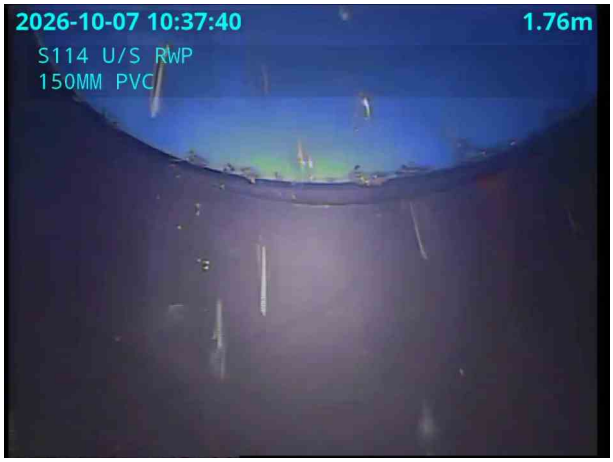
1, 00:00:00, 0.00 m
Start node, inspection chamber, reference: S114

2, 00:00:24, 1.76 m
Finish node, other special chamber, reference: RWP04, RAIN WATER PIPE

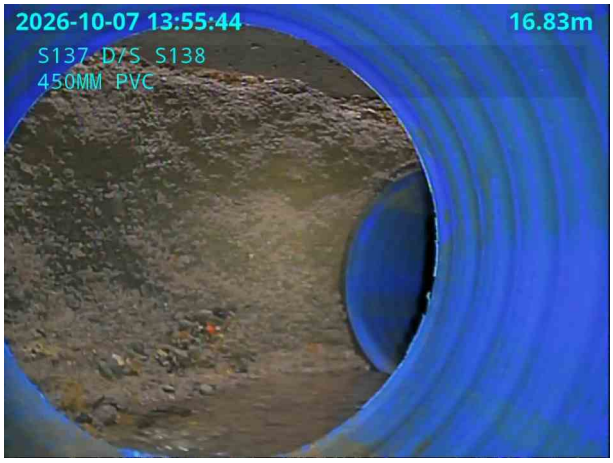
1, 00:00:00, 0.00 m
Start node, manhole, reference: S137

2, 00:01:23, 16.83 m
Finish node, manhole, reference: S138

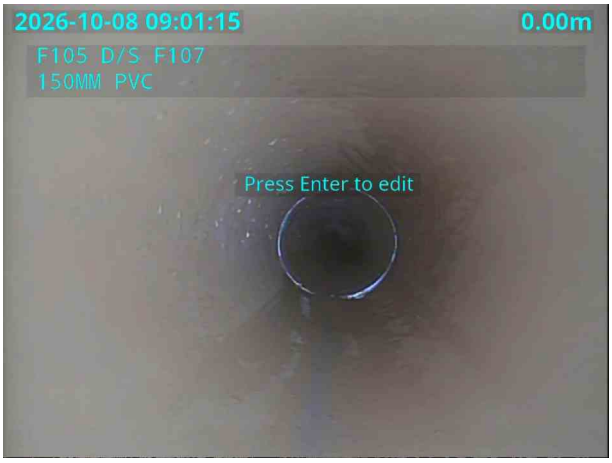
1, 00:00:00, 0.00 m
Start node, inspection chamber, reference: F105

2, 00:03:41, 40.50 m
Finish node, inspection chamber, reference: F107

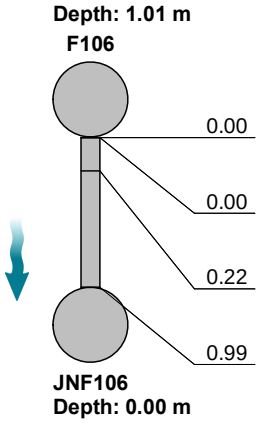
Position [m]	Code	Observation	MPEG	Photo	Grade
0.00	IC	Start node, inspection chamber, reference: F106	00:00:00		
0.00	WL	Water level, 5% of the vertical dimension	00:00:01		
0.22	LD	Line deviates down	00:00:08		
0.99	BRF	Finish node, major connection without manhole, reference: JNF106	00:00:16

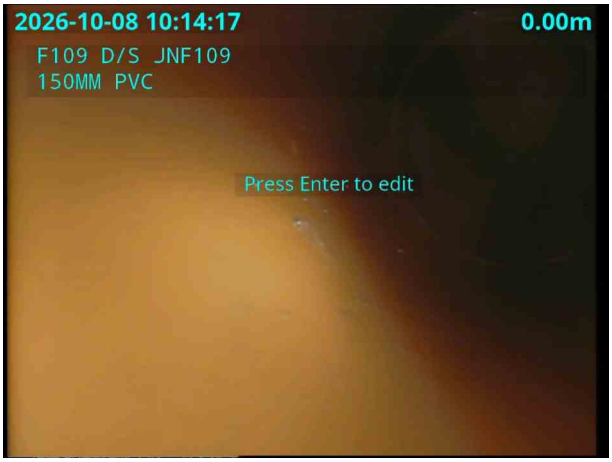
Section Pictures - 10/8/2026 - F109X

2, 00:00:09, 0.20 m
Line deviates right

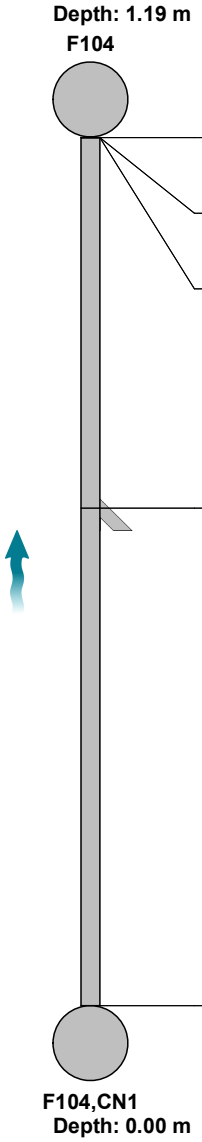
Position [m]	Code	Observation	MPEG	Photo	Grade
0.00	IC	Start node, inspection chamber, reference: F104	00:00:00		
0.00	WL	Water level, 5% of the vertical dimension	00:00:00		
0.00	REM	General remark: INCORRECT ID F104 AND F104.CN1	00:00:00		
4.17	JN	Junction at 9 o'clock, 150mm dia	00:00:12		
9.76	OCF	Finish node, other special chamber, reference: F104,CN1: OTHER	00:00:27

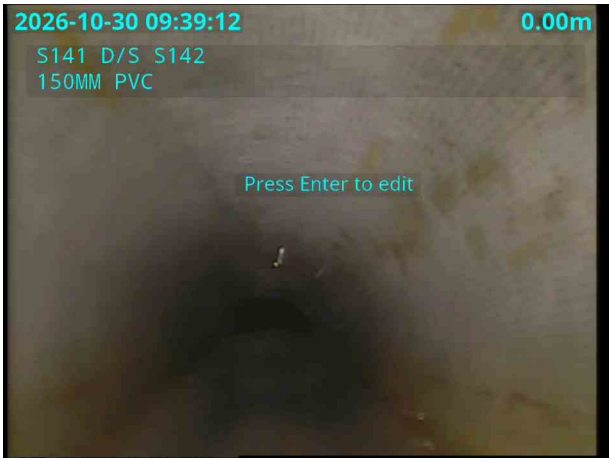
1, 00:00:00, 0.00 m
Start node, manhole, reference: S141

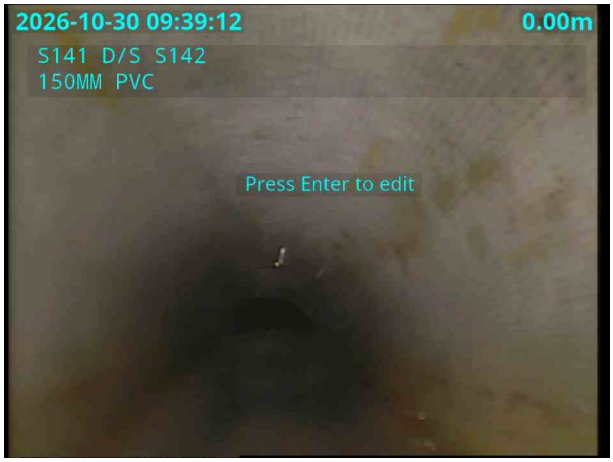
Position [m]		Code	Observation	MPEG	Photo	Grade
0.00		MH	Start node, manhole, reference: S141	00:00:00		
0.00		WL	Water level, 10% of the vertical dimension	00:00:00		
0.00	S01	RPL	Point repair, localised lining from 12 o'clock to 12 o'clock, start	00:00:00		
27.08		LR	Line deviates right	00:01:30		
27.08	F01	RPL	Point repair, localised lining from 12 o'clock to 12 o'clock, finish	00:01:30		
27.54		LL	Line deviates left	00:01:34		
28.46		MHF	Finish node, manhole, reference: S142	00:01:57

2, 00:00:00, 0.00 m
Point repair, localised lining from 12 o'clock to 12 o'clock, start

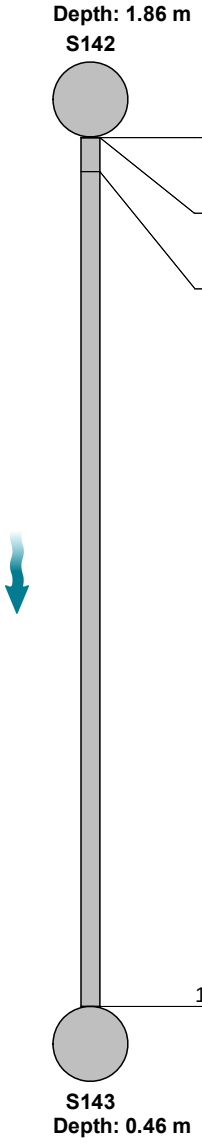
Position [m]	Code	Observation	MPEG	Photo	Grade
0.00	MH	Start node, manhole, reference: S142	00:00:00		
0.00	WL	Water level, 10% of the vertical dimension	00:00:00		
0.77	LR	Line deviates right	00:00:07		
19.54	MHF	Finish node, manhole, reference: S143	00:00:59
