Project

Project Name:	Storrington Squash Club
Project Description:	CCTV Survey, trace & map
Project Status:	Complete
Project Date:	7/14/2026
Inspection Standard:	MSCC5 Sewers & Drainage GB (SRM5 Scoring)

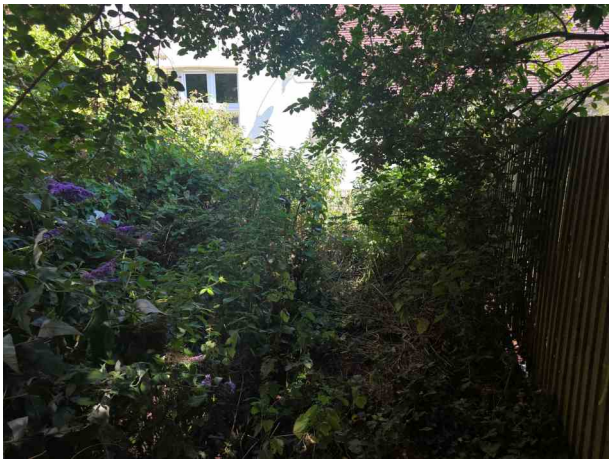
General site photo

Unable to trace and locate MH1 refer to general site photo

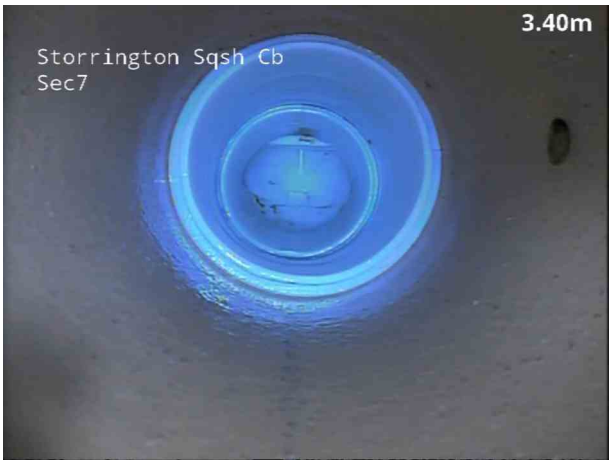
7-1-3A, 00:00:20, 3.20 m
Line deviates up

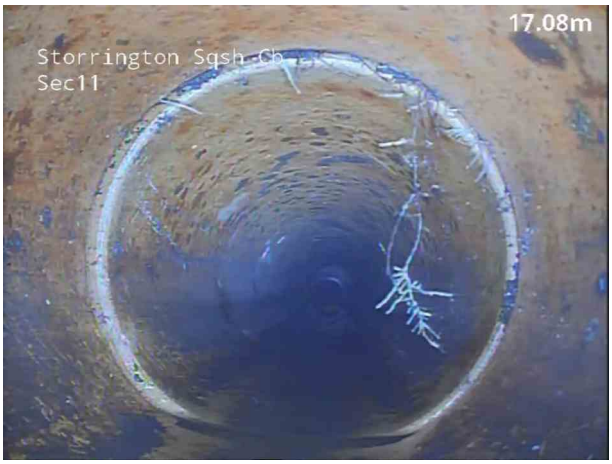
11-1-3A, 00:00:21, 6.70 m
Roots, fine at joint
