Post Installation Report

Russell Leisure Ltd

Moat Road Play Area

Inspection Ref: 2390397 Site Ref: 110382

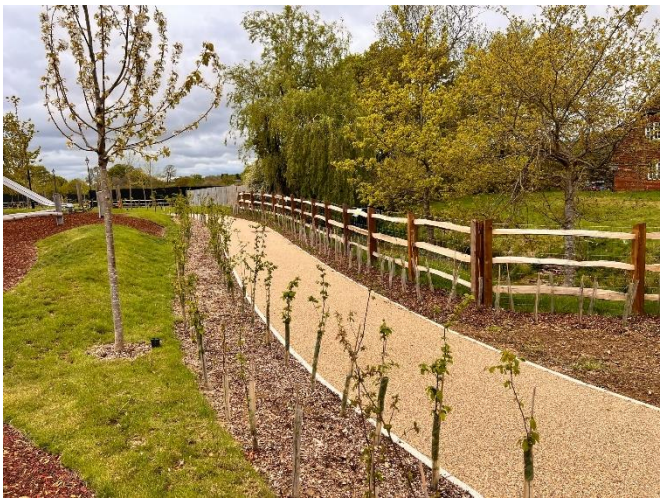
Finding: The design of the fencing may encourage climbing leading to falls from height (1200mm) onto the surrounding surfaces; the open design will also not prevent animals from entering the area

FIGURE 1: DOG PROOF FENCING HAS BEEN INSTALLED TO STOP ANIMALS AND CHILDREN CLIMBING THROUGH.

Action: Refer to the designer for a design risk assessment

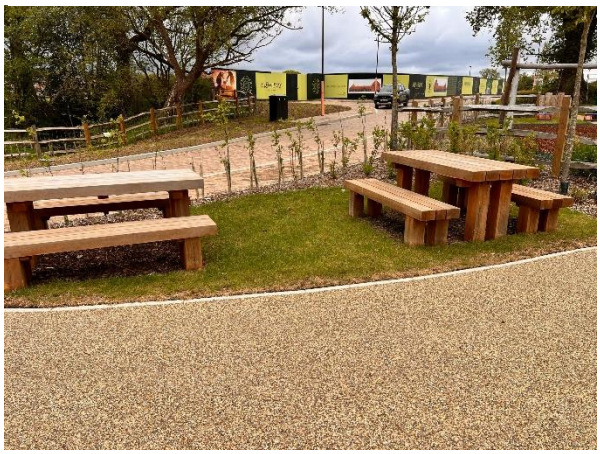
Finding: NOTE - There is a body of water or a water basin in close proximity to the playground. Risk assessment of this is a specialist field and outside the scope of our inspection.

FIGURE 2: DOG PROOF FENCING AND CHESTNUT FENCING HAS BEEN INSTALLED TO STOP CHILDREN FALLING INTO WATER.

Action: Contact our official water safety partner the RLSS (Royal Life Saving Society) at www.rlss.org.uk and / or ensure that the appropriate risk assessment is in place
