LEVEL MONITORING

for SMS (AXA)

Birchwood, The Street, Slinforld, Horsham, RH13 0RP

Client:	SMS (AXA)
Client Contact:	Refer to iSubs
Claim Number:	12687256K
Client Reference:	IFS-AXA-SUB-25-0125280
Policy Holder:	Mr Senthil Rajan-Edge
Report Date:	4 September 2026
Our Ref:	M25989

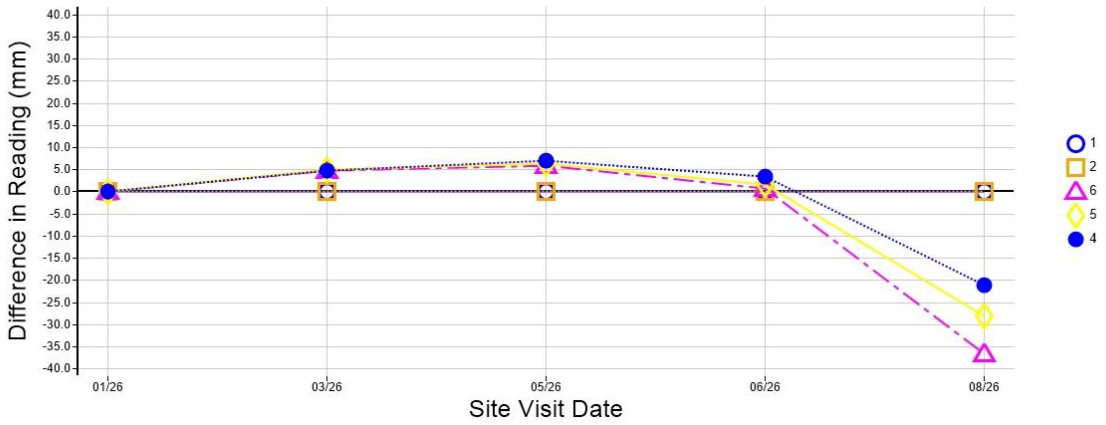
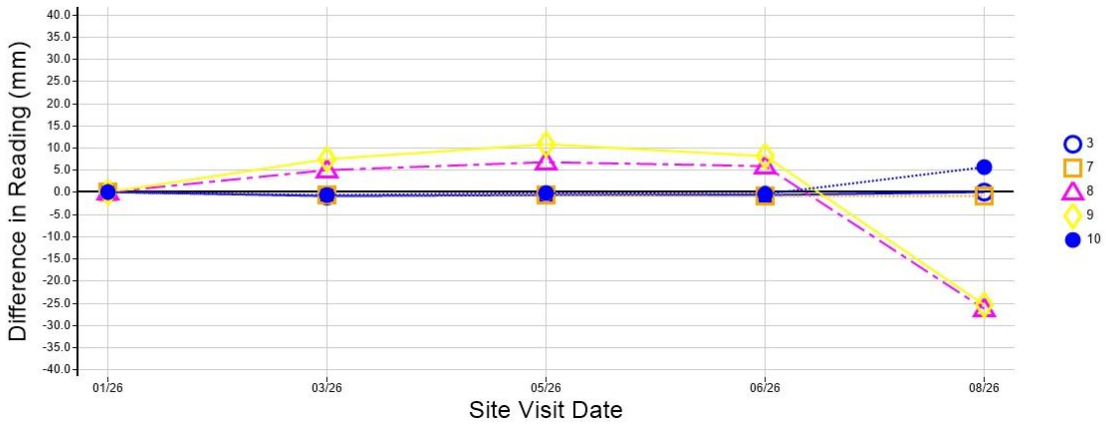
Level Monitoring Difference Graphs

The following graphs display the progressive movement that each Level Monitoring Station recorded at each separate site visit date to give an overall look at how much the property is moving.

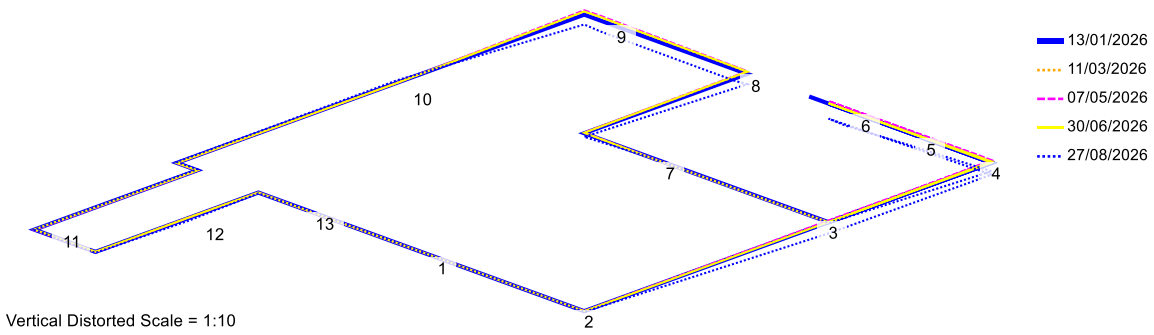
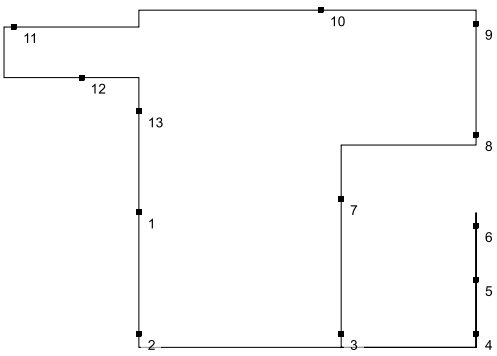
Level Monitoring Displacement Map

The following image shows an isometric representation of the movement of the property, based on the Level Monitoring Stations that were installed.
