OREHAM MANOR FARM, OREHAM COMMON, HENFIELD,
WEST SUSSEX, BN5 9SB

Preliminary Contamination Risk Assessment

February 2023

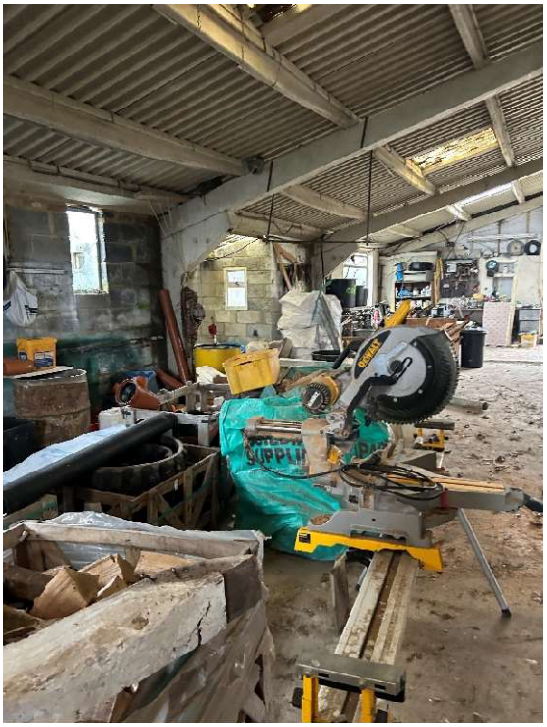
Photo 2: Dumper and excavator stored within the eastern section of the warehouse.

Photo 3: Table saw and storage of wood and various materials within the eastern warehouse section.
