Tudor Cottage, Maplehurst, RH13 6RD
Timber repairs to SE elevation

Greenman Carpentry Co. Ltd.
Tudor Cottage
Frame Repair.
April 2025

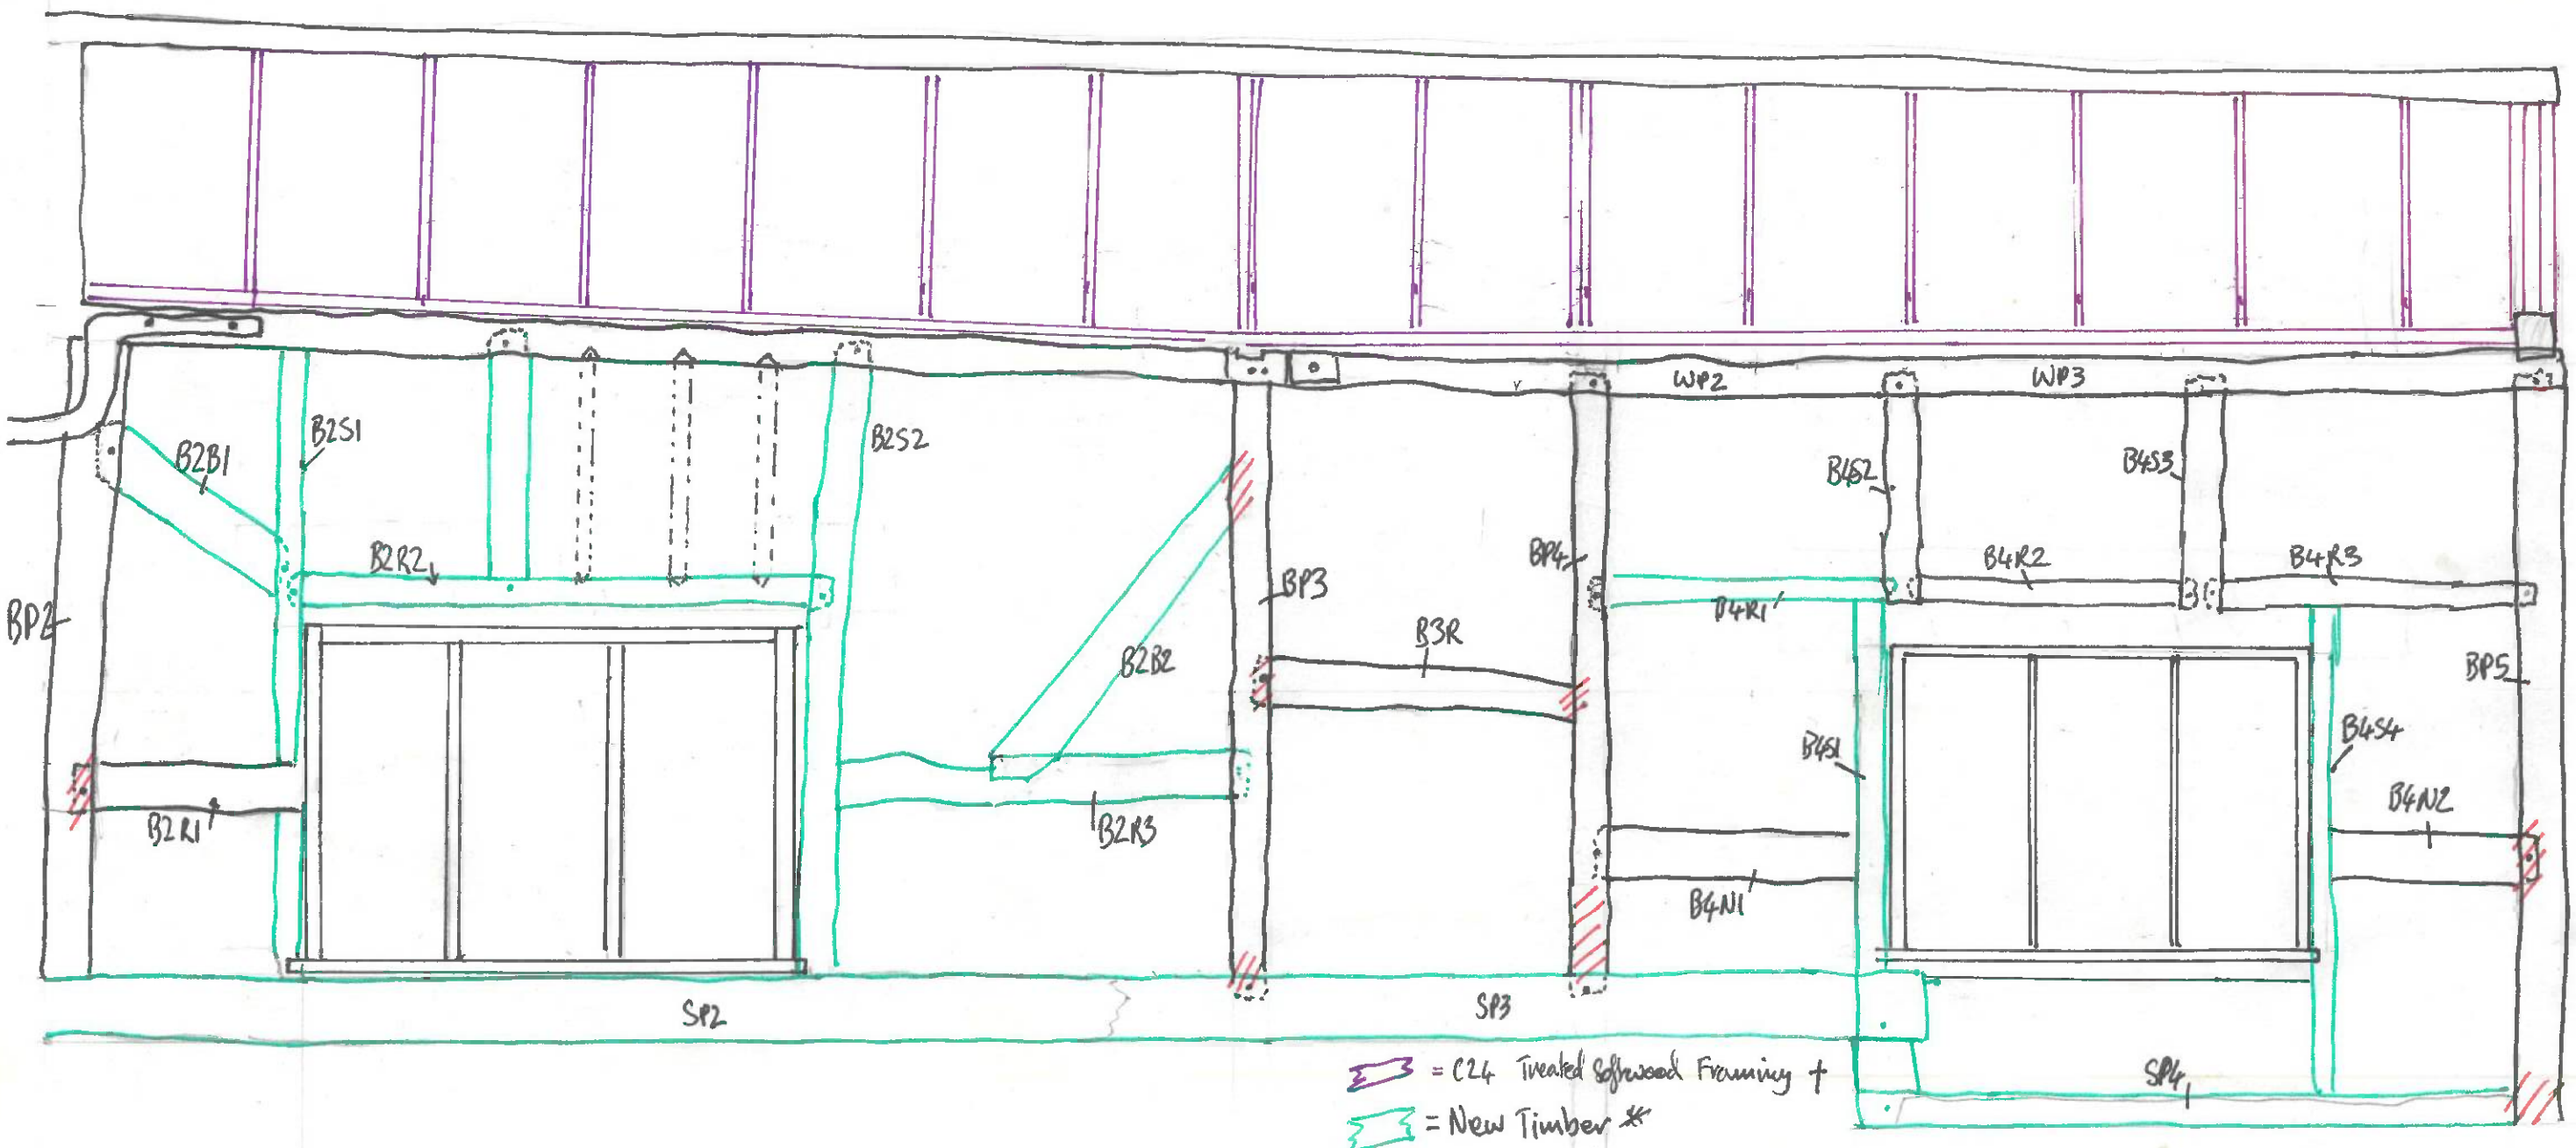
* Repairs/replacements made using air dried oak stock.
† framing above original wall plate using construction grade s/w.
