From: Amy.Furness [redacted]
Sent: Wednesday, October 8, 2025 6:15 pm
To: Kate.Turner [redacted]
Subject: DISC/25/0226 - Condition 10 and 6

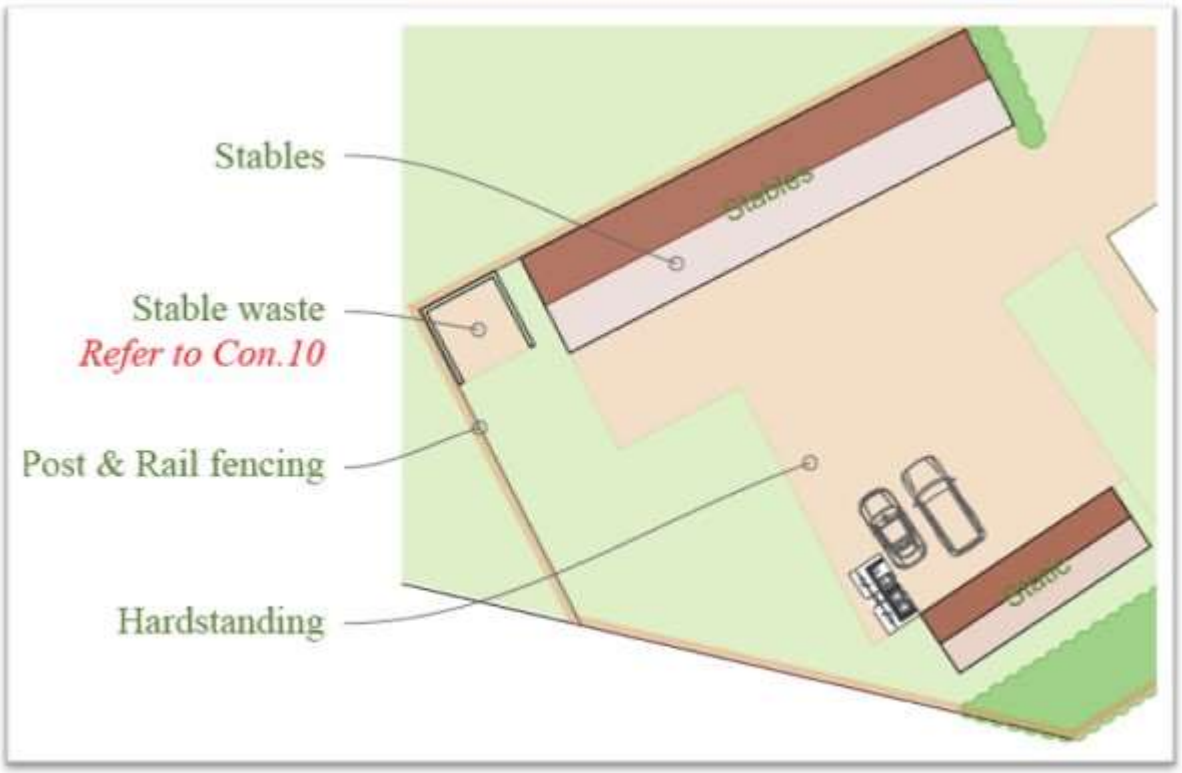
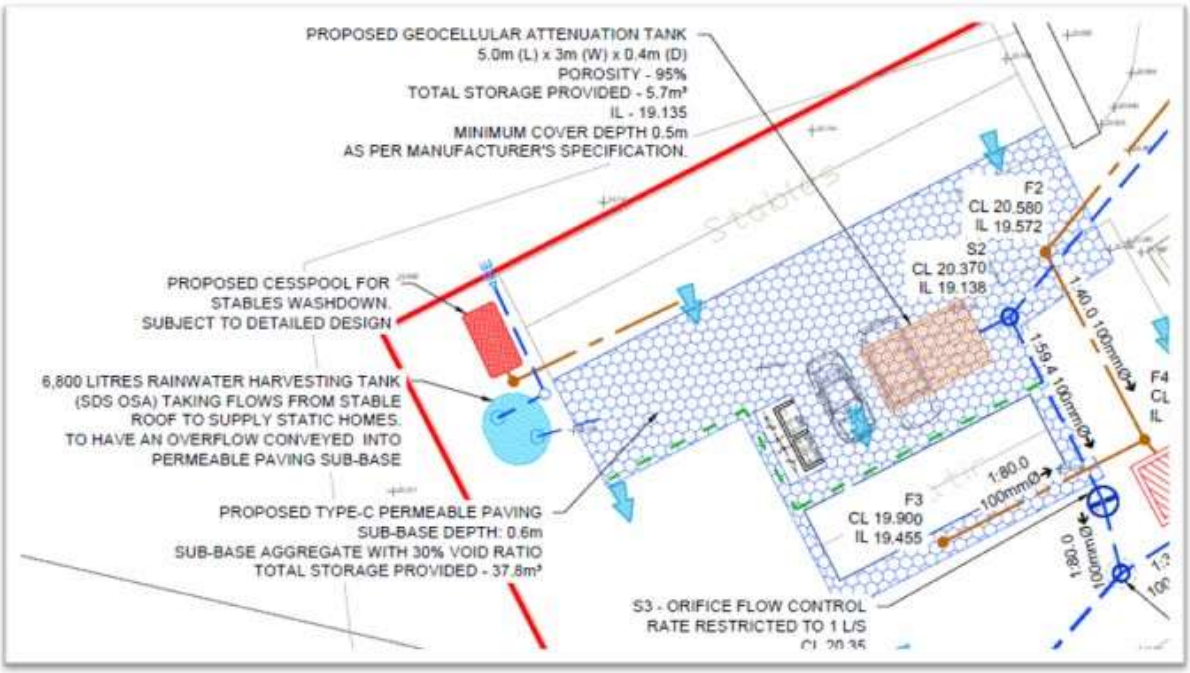
Drawing No: Con. 6. Drawn on 03.07.2025. Drawing No: CIV-100, Revision A02, Updated: 11.06.25 (Provided within Letter "prepared in response to Lead Local Flood Authority comments dated 09.04.2025…').

- The stable waste block was not included within the Drainage Strategy and as such, surface water runoff from this stable waste block has not been considered within the drainage strategy.

- The proposed location of the stable block is on top of the proposed location for the cesspool for the stables washdown area. This is not appropriate – there is concern here regarding accessibility to empty and maintain the cesspool, as well as the cumulative load bearing down onto it from the stable waste above. Should the cesspool be compromised, the resulting runoff from the stables washdown area may flow towards the ditch or into the permeable paving, resulting in contaminated water ultimately making its way into the ditch at the outfall location. This poses an environmental health concern regarding contamination to the resulting watercourse. **I therefore recommend that the stable waste block be moved to a different location.**

- I note that the proposed drainage layout plan stated *'Proposed cesspool for stables washdown. Subject to detailed design.'* It was believed by HDC Drainage that this information would be provided separately to discharge condition 10. **It is crucial that the cesspool is sized appropriately and emptied frequently**. Should the cesspool overflow, the resulting runoff from the stables washdown area may flow towards the ditch or into the permeable paving, resulting in contaminated water ultimately making its way into the ditch at the outfall location. This poses an environmental health concern regarding contamination to the resulting watercourse.

- The proposed location of the rainwater harvesting tank lies beneath the route which would be taken to empty waste into the stable waste block. The plans do not indicate the depth of the proposed rainwater harvesting tank nor plans to reinforce the surface above to stabilise the ground should a vehicle drive over, which may be the case to empty the stable waste storage block. I do NOT advise that vehicles are allowed to drive over the area of the rainwater harvesting tank, including those accessing the

- **The proximity of the proposed cesspool to the rainwater harvesting tank has been highlighted as a concern by Environmental Health – please consult Environmental Health – a revision of the location of the rainwater harvesting tank may be necessary to put more distance between the rainwater harvesting tank and the cesspool.**

stable waste block. **I therefore recommend that the stable waste block be moved to a different location.**

In light of this information, I highly recommend a revision to the layout of the stable waste block, the rainwater harvesting tank and the cesspool, considering access to and maintenance of the cesspool and stable waste block.
