**BS5837: 2012 Tree Survey,
Arboricultural Impact Assessment
and preliminary Tree Protection Plan**

**Site: The Lodge at Wineham Place, Wineham Lane, Henfield,
BN5 9AZ**

Report Date: 03/11/25

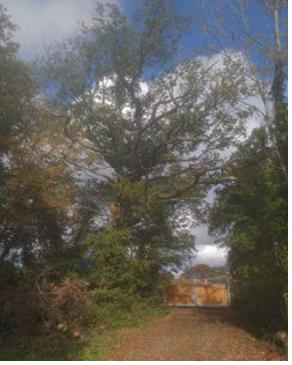
| Ref. | Species | Full Structure | Measurements | Survey Notes | Retention Category | RPA | Condition | Recommendations | Photo |
|---|--|---|--|---|---|---|---|--|---|
| T023 | Oak (<i>Quercus sp.</i>) | Tree | Height (m): 17 Stem Diam(mm): 550 Spread (m): 10N, 10E, 8S, 7W Crown Clearance (m): 6 Lowest Branch (m): 5(E) Life Stage: Early Mature Rem. Contrib.: 20+ Years | Tree is showing signs of physiological stress with major dead limbs on the south and east quadrants up to 10m. There has been a recent branch failure at 6m on the south west side of the trunk of a large limb approx. 300mm diameter at union. Upper crown is sparse at tips with epicormic growth throughout upper crown. Given target of driveway and road remedial action for the large deadwood is advised. Additionally monitoring the crown health and further detailed investigation of the base of the tree is recommended at the next safety survey. Given the size and age of the tree it still qualifies as a B despite the physiological stresses. | B1 | Radius: 6.6m. Area: 137 sq m. | Physiological Condition: Fair Structural Condition: Fair | 1) Remove large deadwood over access road and gate. 2) Monitor crown health and carry out detailed basal assessment as part of next safety survey. | |
