**Arboricultural Report**  
**composed of**  
**Arboricultural Impact Assessment**  
**Arboricultural Method Statement**  
**& Tree Protection Plan**

Bowood  
Bashurst Copse  
Itchingfield  
West Sussex  
RH13 0NZ

Written by  
Barry Holdsworth Ltd

10th April 2025

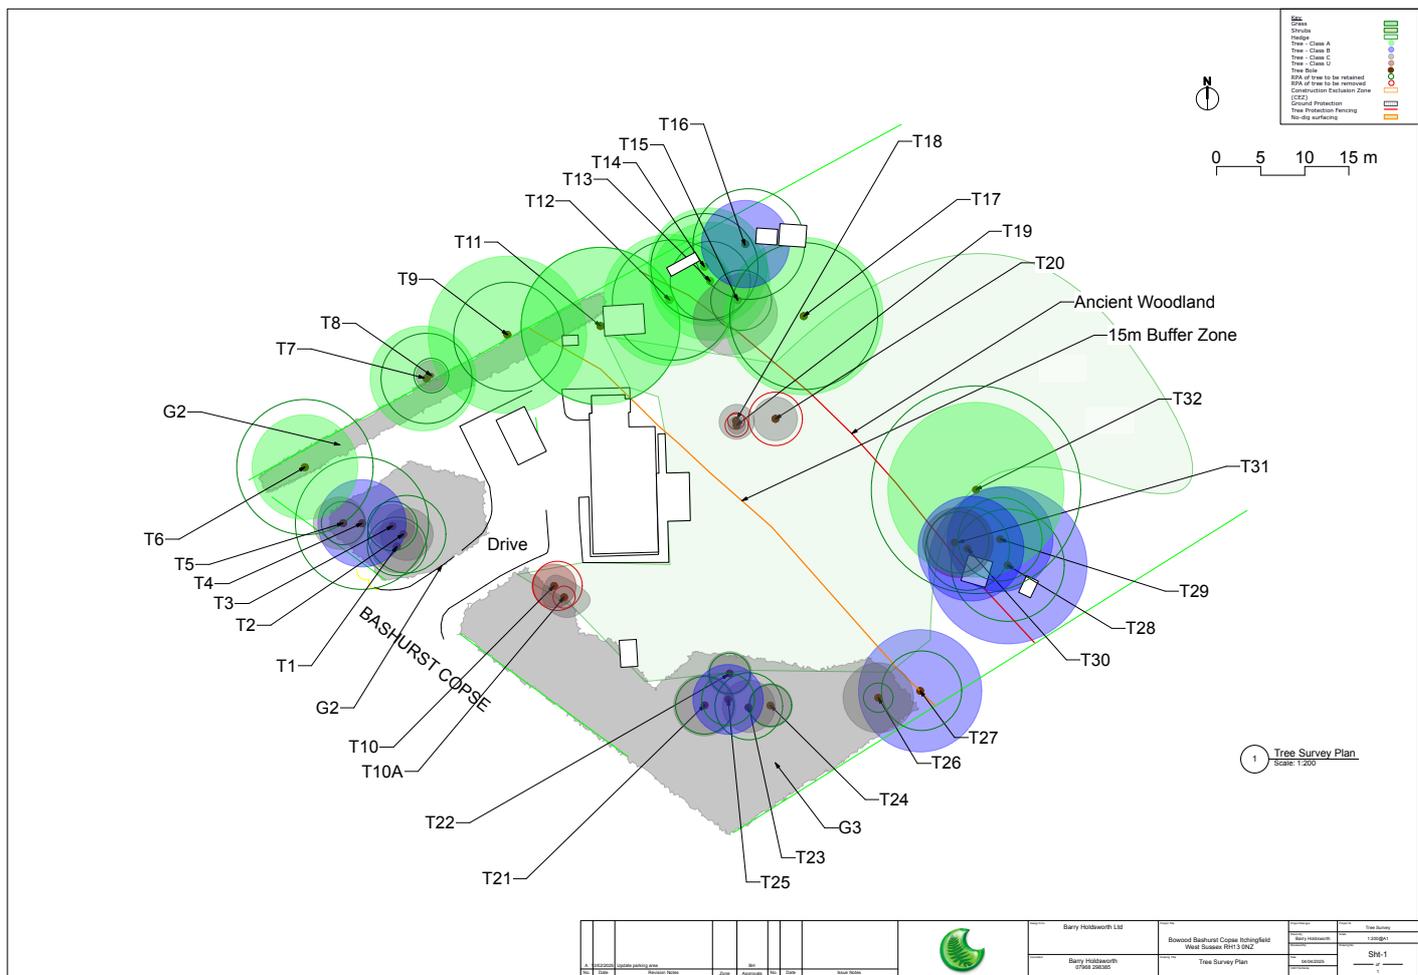
Appendix 2 Tree Survey Plan

No	Species	Height	Ø at 1.5m	Spread	Crown clearance	Age	Condition and Recommendations	Removal	ERC	BS	RPA
G1	Holly/Hornbeam/Hazel	8-12	50-120	6.00	1m	SM	Physiological Condition: Fair	N	>10	C2	1.44
	Cherry+Portuguese Laurel						Structural Condition: Fair				
	Ash						Public Amenity Value: Low				
	<i>Ilex aquifolium</i>						Inspection Limitations: None				
	<i>Carpinus betulus</i>						Unmanaged screen along roadside				
	<i>Corylus avellana</i>						<b>Recommend:</b> Reduce and trim back				
	<i>Prunus lusitanica</i>										
<i>Prunus laurocerasus</i>											
G2	Cherry+Portuguese Laurel	5-6	50-120	6.00	g/l	SM	Physiological Condition: Fair	N	>10	C2	1.44
	<i>Prunus lusitanica</i>						Structural Condition: Fair				
	<i>Prunus laurocerasus</i>						Public Amenity Value: Low				
							Inspection Limitations: None				
							Unmanaged hedge				
							<b>Recommend:</b> Reduce and trim back				
G3	Holly/Yew/Hazel	8-14	50-120	6.00	g/l	SM	Physiological Condition: Fair	N	>10	C2	1.44

Public Amenity Value: Low				
							Inspection Limitations: None				
T4	Oak	20	630	10.00	6mS	M	Physiological Condition: Fair	N	>40	B2	7.56
	<i>Quercus robur</i>						Structural Condition: Fair				
							Public Amenity Value: Moderate				
							Inspection Limitations: None				
							Poor pruning cuts to allow electricity cables to pass through Large wound 0.5-2.5mNW partially occluded with wound wood				
T5	Portuguese Laurel	9	125+165	6.00	g/l	SM	Physiological Condition: Fair	N	>10	C2	2.48
	<i>Prunus lusitanica</i>						Structural Condition: Fair				
							Public Amenity Value: Low				
							Inspection Limitations: None				
T6	Oak	24	645	18.00	13mN	M	Physiological Condition: Good	N	>40	A2	7.74
	<i>Quercus robur</i>						Structural Condition: Good				
							Public Amenity Value: Moderate				
							Inspection Limitations: None				
							<b>Recommend:</b> Remove ivy				
T7	Hornbeam	25	430	10.00	10mN	M	Physiological Condition: Good	N	>40	A2	5.16

Bifurcates @g/l				
							<b>Recommend:</b> Remove for development				
<b>T10A</b>	Birch <i>Betula pendula</i>	17	105	2/2/3/3	2mW	SM	Physiological Condition: Fair Structural Condition: Fair Public Amenity Value: Low Inspection Limitations: None	Y Fell	>10 B	C2	1.26
							Leans 10°E <b>Recommend:</b> Remove for development				
<b>T11</b>	Hornbeam <i>Carpinus betulus</i>	24	750	18.00	8mE	M	Physiological Condition: Good Structural Condition: Good Public Amenity Value: Moderate Inspection Limitations: None	N	>40	A2	9.00
							Bifurcates @1.5m - co-dominant				
<b>T12</b>	Hornbeam <i>Carpinus betulus</i>	24	345+135 240+245 130+200 260	15.00	8mE	M	Physiological Condition: Good Structural Condition: Good Public Amenity Value: Moderate Inspection Limitations: None	N	>40	A2	6.88
							m/s from g/l				
<b>T13</b>	Hornbeam <i>Carpinus betulus</i>	24	355+265 185	14.00	6mE	M	Physiological Condition: Good Structural Condition: Good Public Amenity Value: Moderate Inspection Limitations: None	N	>40	A2	4.55

m/s from g/l <b>Recommend:</b> Remove for development				
<b>T21</b>	Cupressus <i>x Cuprocypris leylandii</i>	20	275	7.00	g/l	EM	Physiological Condition: Fair Structural Condition: Fair Public Amenity Value: Low Inspection Limitations: None	N	>10	C2	3.3
							Slightly reduced thin canopy				
<b>T22</b>	Portuguese Laurel <i>Prunus lusitanica</i>	2	115x2 75x3	5.00	g/l	SM	Physiological Condition: Fair Structural Condition: Fair Public Amenity Value: Low Inspection Limitations: None	Y Fell	>10 B	C2	2.32
							Has been reduced to 2m <b>Recommend:</b> Remove for development

<b>T23</b>	Birch <i>Betula pendula</i>	18	320	6.00	5mW	M	Physiological Condition: Fair Structural Condition: Fair Public Amenity Value: Low Inspection Limitations: None <b>Recommend:</b> Remove ivy	N R/1	>10 B	C2	3.84
<b>T24</b>	Holly <i>Ilex aquifolium</i>	10	200	5.00	g/l	SM	Physiological Condition: Fair Structural Condition: Fair Public Amenity Value: Low Inspection Limitations: None	N	>10	C2	2.4
<b>T25</b>	Hornbeam <i>Carpinus betulus</i>	15	250	8.00	6mW	EM	Physiological Condition: Good Structural Condition: Good Public Amenity Value: Moderate Inspection Limitations: None <b>Recommend:</b> Remove ivy	N R/1	>20 B	B2	3.0
<b>T26</b>	Hornbeam <i>Carpinus betulus</i>	12	140	8.00	5mW	SM	Physiological Condition: Fair Structural Condition: Fair Public Amenity Value: Low Inspection Limitations: None	N	>10	C2	1.68
<b>T27</b>	Hornbeam <i>Carpinus betulus</i>	24	360+260 125+90 140+160 2x150	14.00	7mW	M	Physiological Condition: Good Structural Condition: Good Public Amenity Value: Moderate Inspection Limitations: None	N	>20	B2	4.55
