### DRAINAGE CCTV REPORT

# CCTV survey report

**Project Name** – Novartis site Horsham - CCTV Survey

**Project Number** – 60950

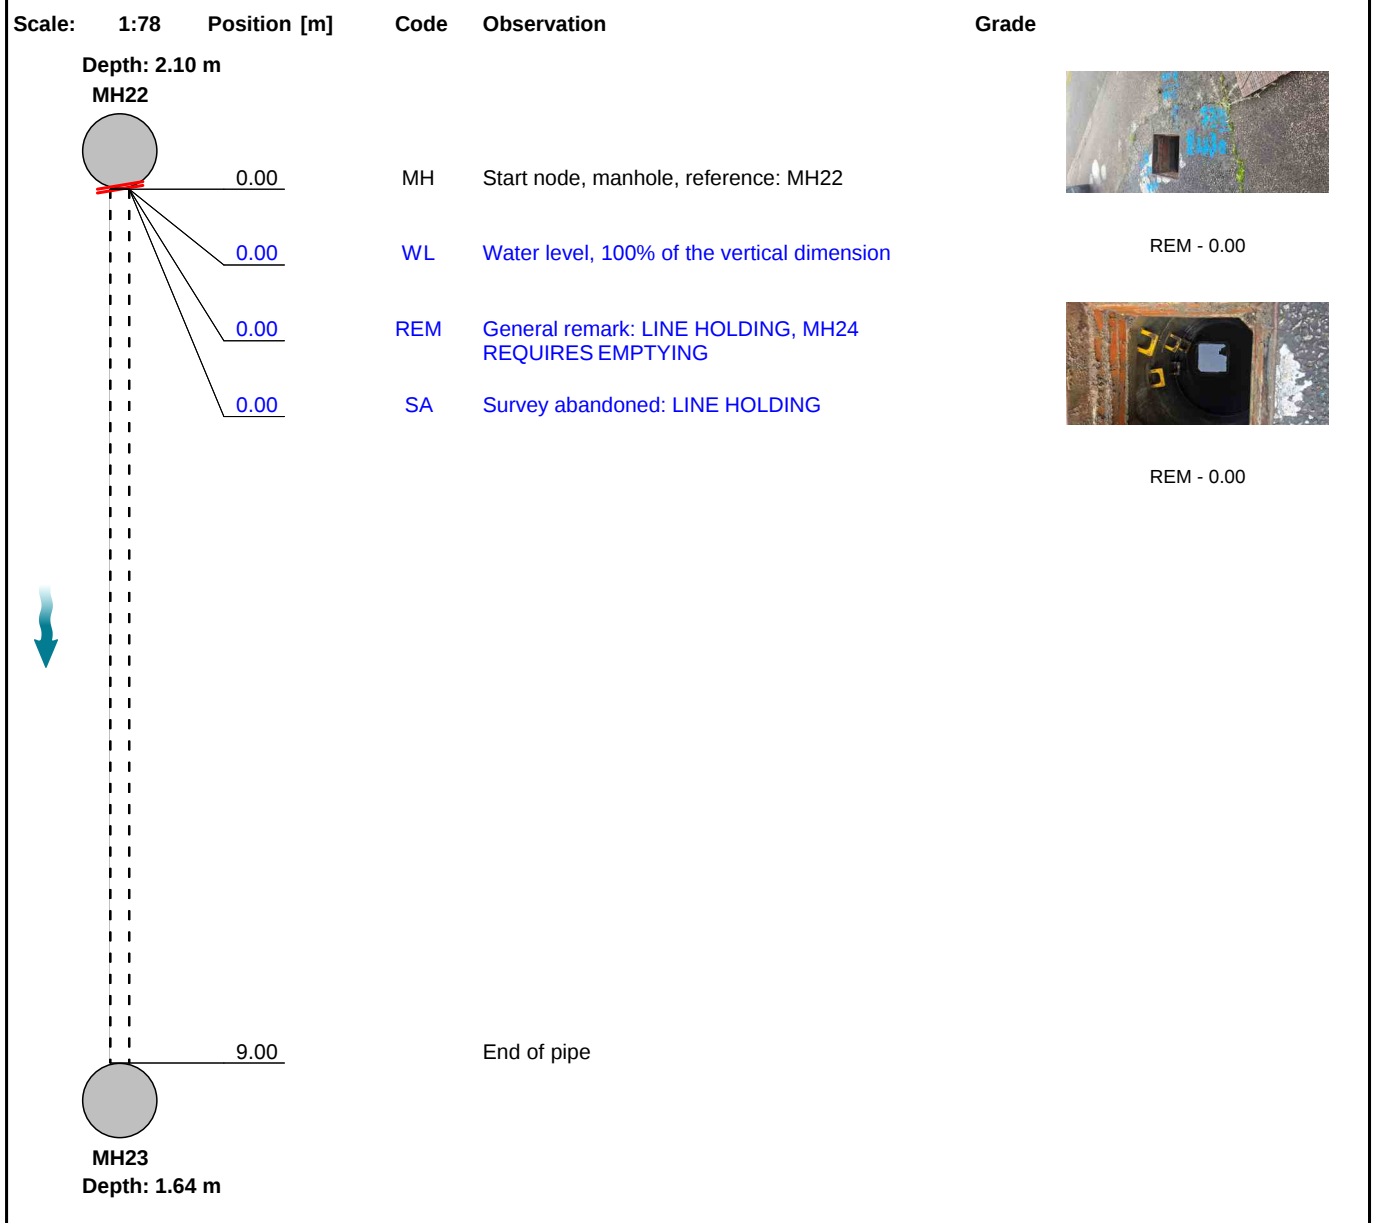
| <b>Comments:</b> | LINE HOLDING FROM INTERCEPTOR - MH24 | | | | |

| <b>Recommendations:</b> | INTERCEPTOR REQUIRES EMPTYING TO CLEAN | | | | |

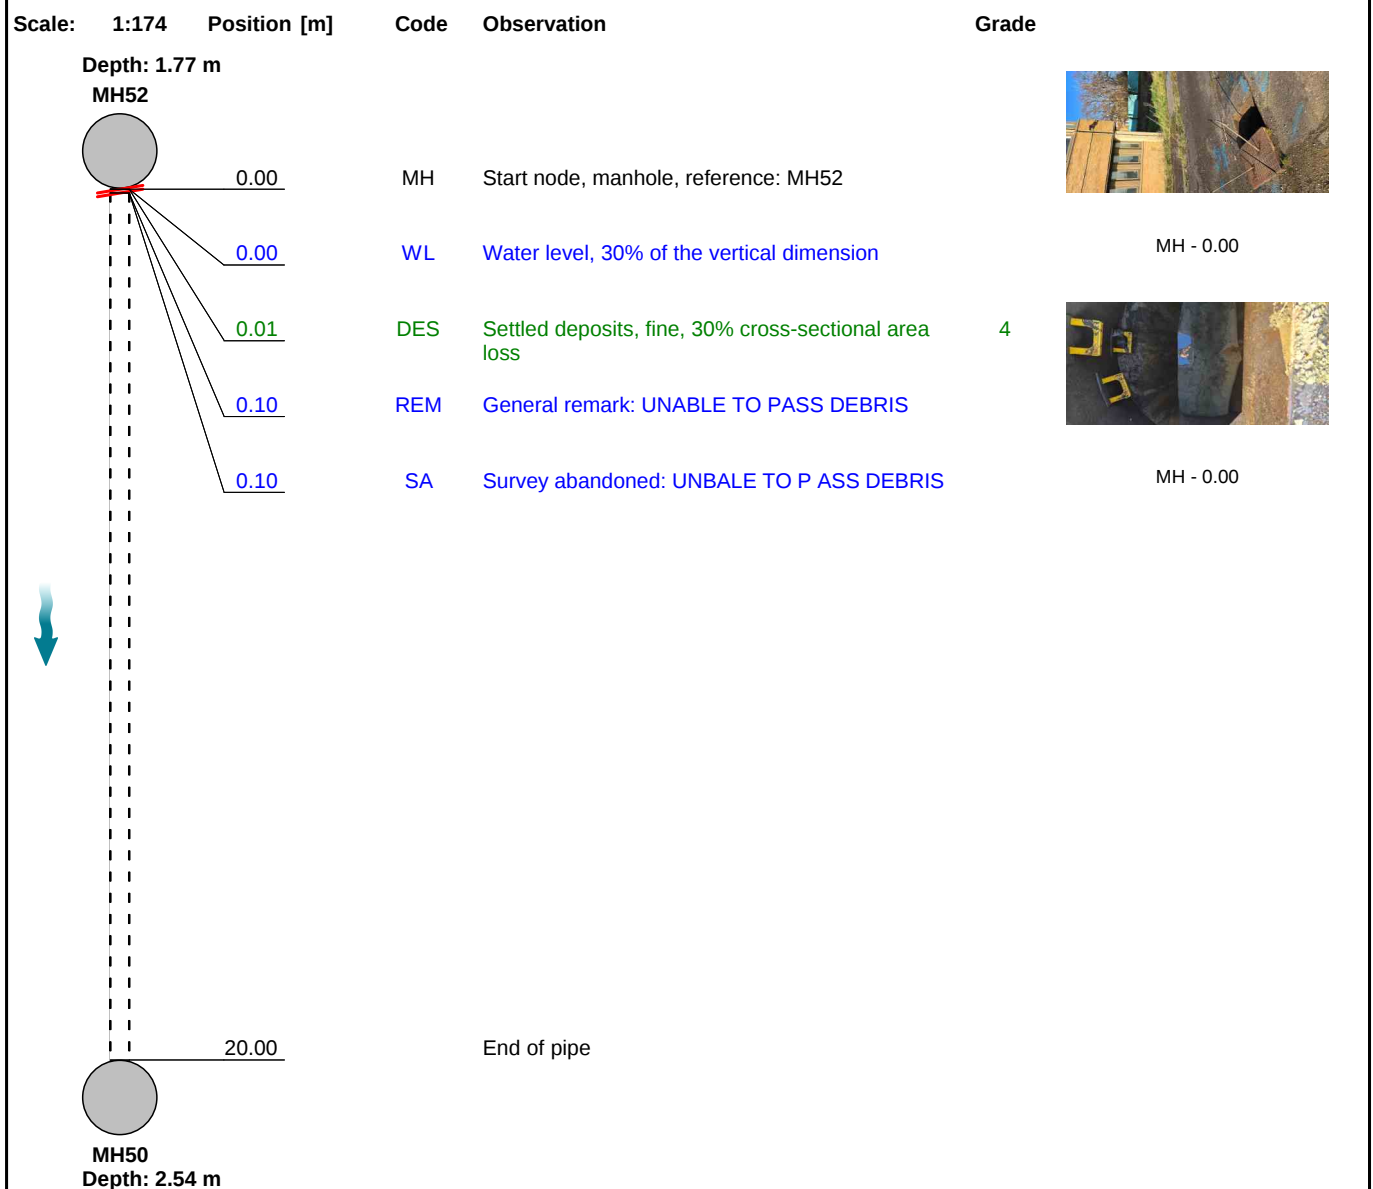
| Comments: | REQUIRES HEAVY JETTING TO SURVEY | | | | |

| Recommendations: | REQUIRES HEAVY JETTING | | | | |
