### DRAINAGE CCTV REPORT

# CCTV survey report

**Project Name** – Novartis site Horsham - CCTV Survey

An investigative CCTV survey was carried out at Novartis site, Horsham in order to assist in the redevelopment of the site.

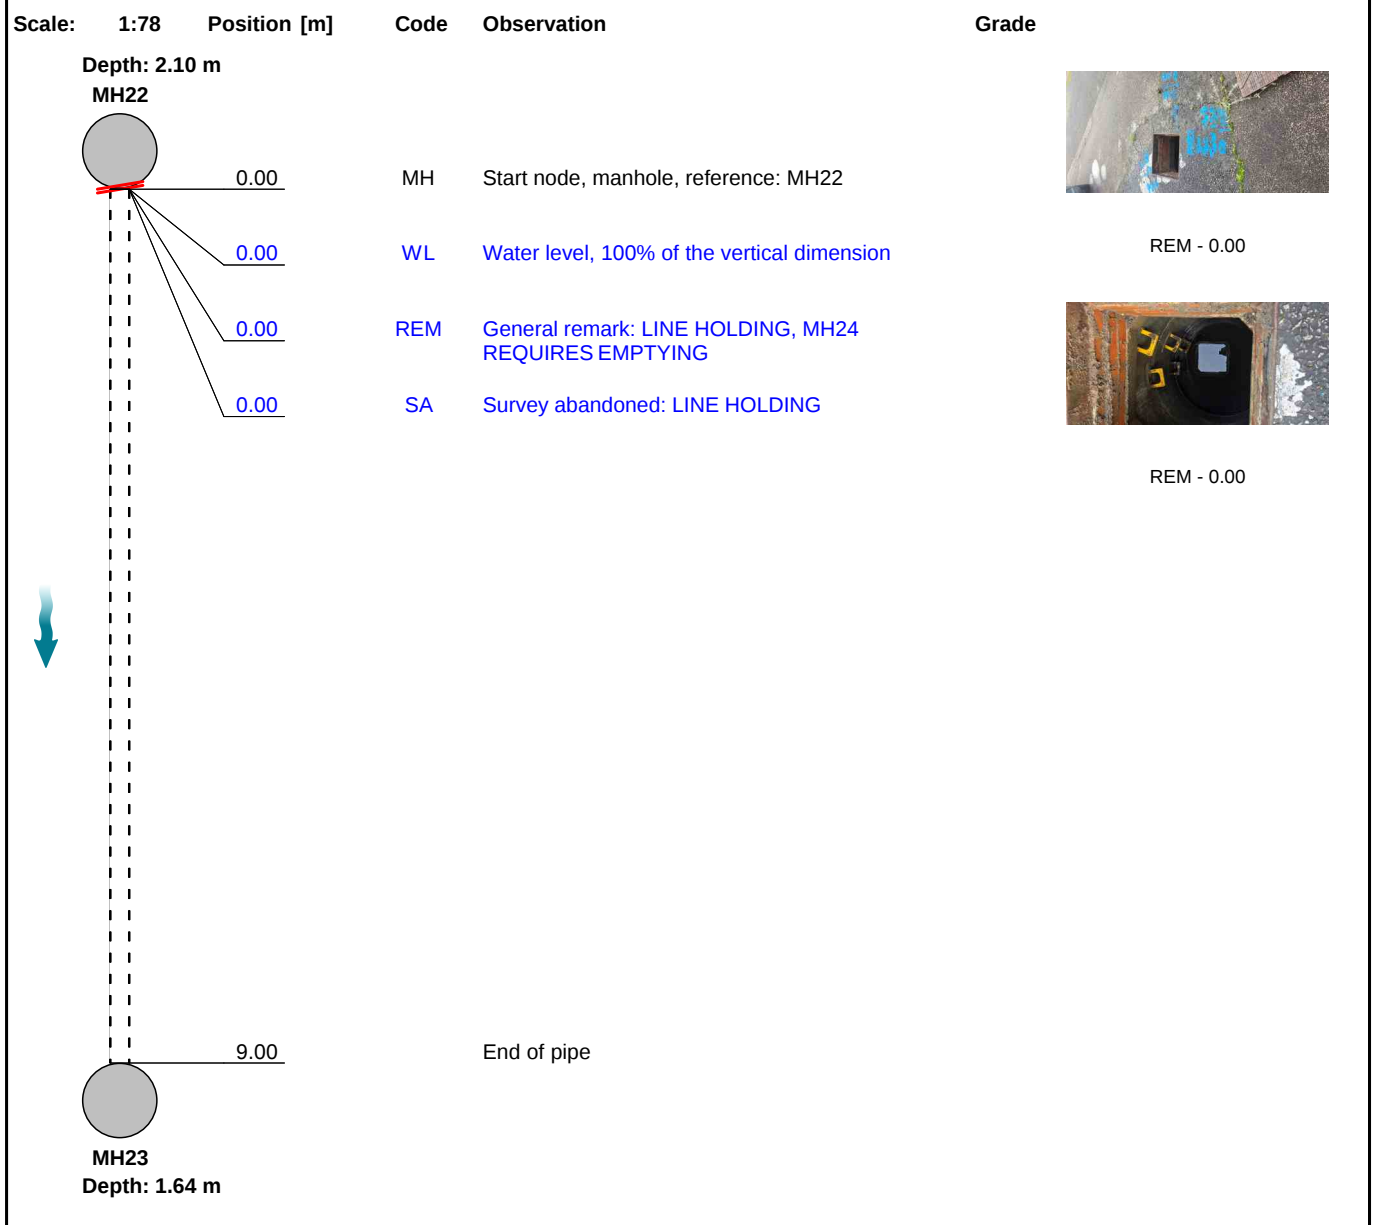
| <b>Comments:</b> | LINE HOLDING FROM INTERCEPTOR - MH24 | | | | |

| <b>Recommendations:</b> | INTERCEPTOR REQUIRES EMPTYING TO CLEAN | | | | |

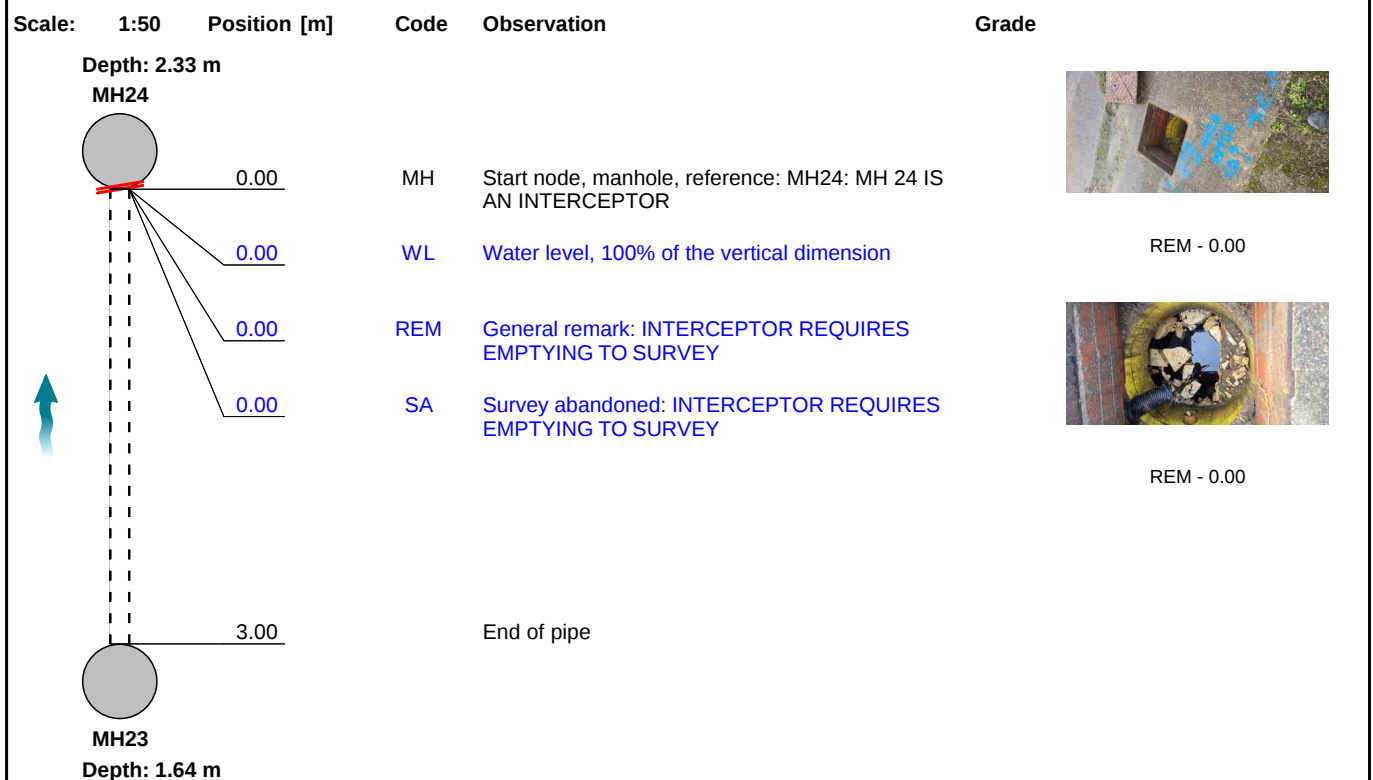
| <b>Comments:</b> | REQUIRES SUCKING OUT TO SURVEY | | | | |

| <b>Recommendations:</b> | REQUIRES SUCKING OUT TO EMPTY | | | | |

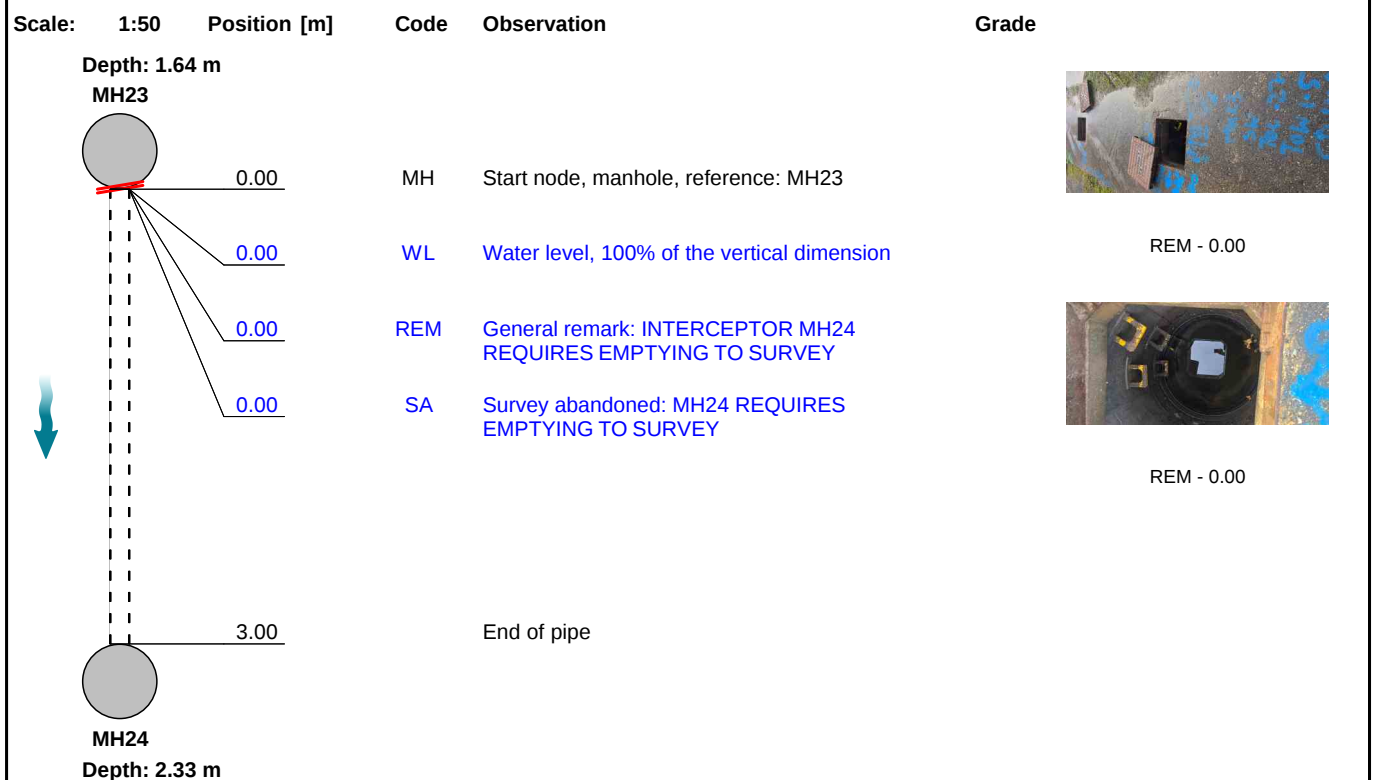
| <b>Comments:</b> | INTERCEPTOR - MH24 REQUIRES EMPTYING TO SURVEY | | | | |

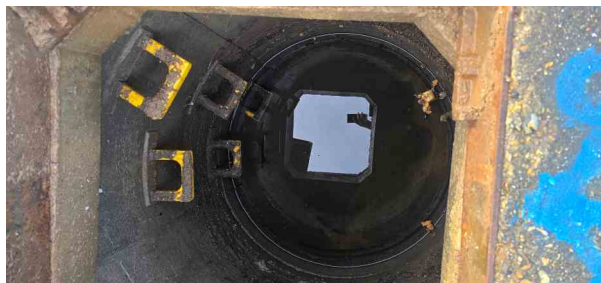
MH23X\_6dcffdca-c3d8-4f4e-adff-02b165a218c5\_20241125\_100841.jpg, 00:00:03, 0.00 m  
 General remark, INTERCEPTOR MH24 REQUIRES EMPTYING TO SURVEY

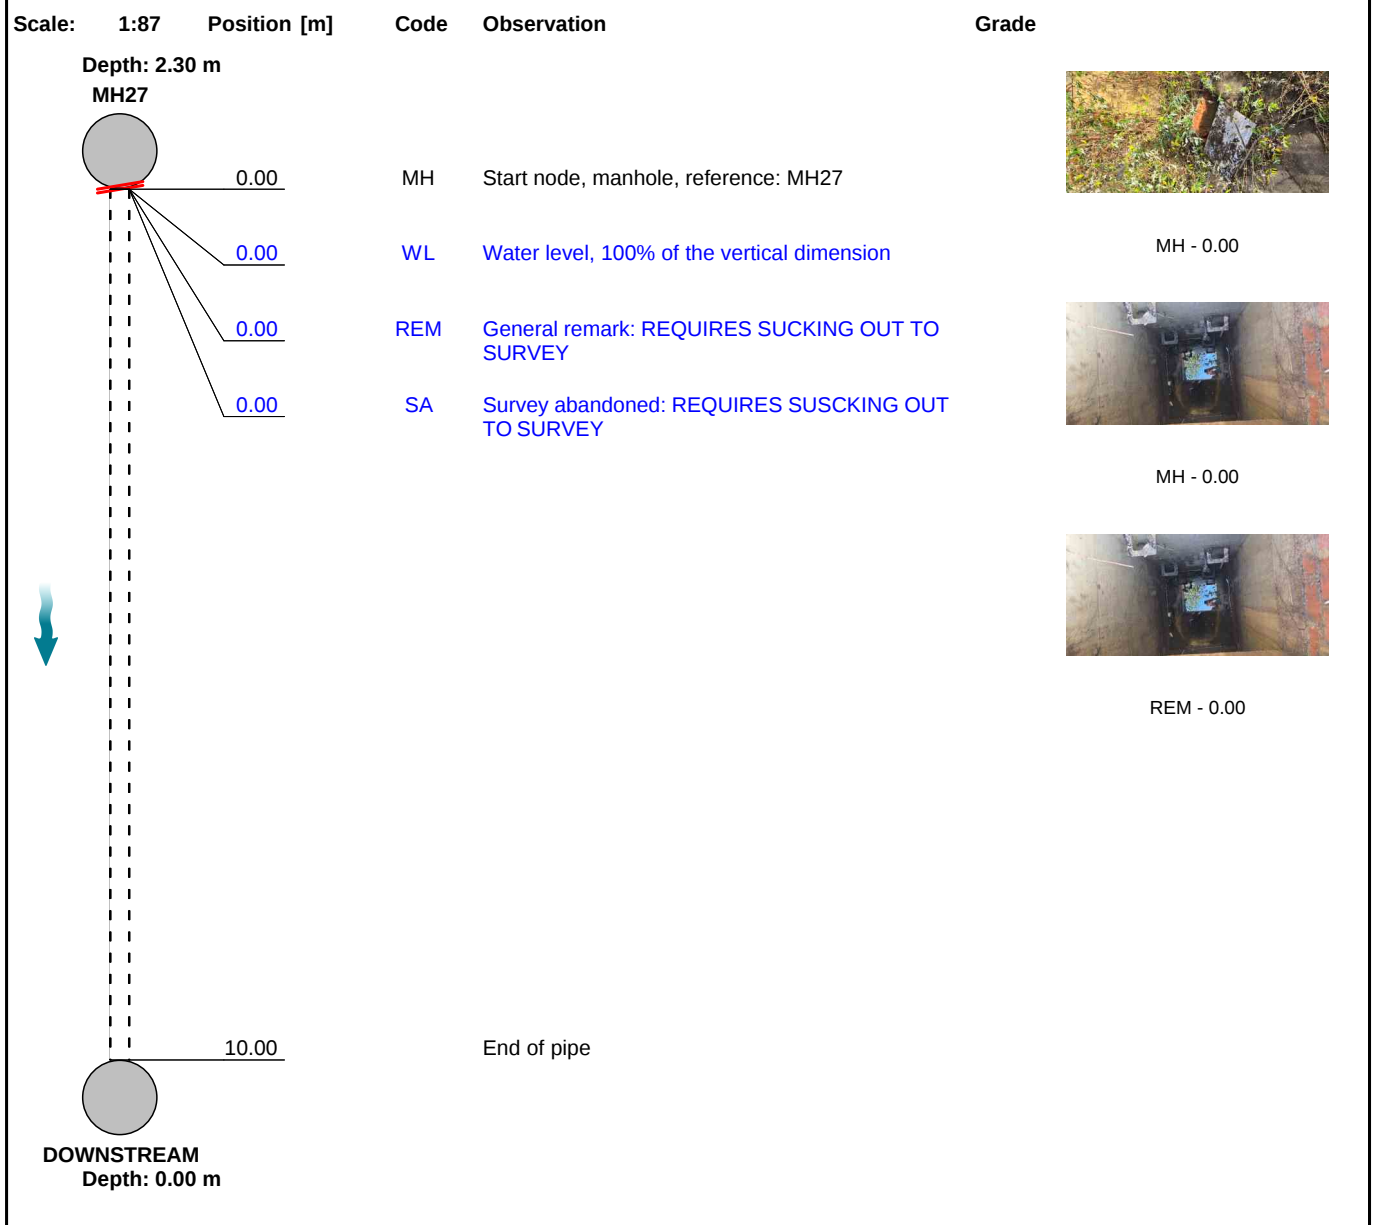
| <b>Comments:</b> | LINE HOLDING WATER, REQUIRES SUCKING OUT TO SURVEY | | | | |

| <b>Recommendations:</b> | REQUIRES SUCKING OUT | | | | |

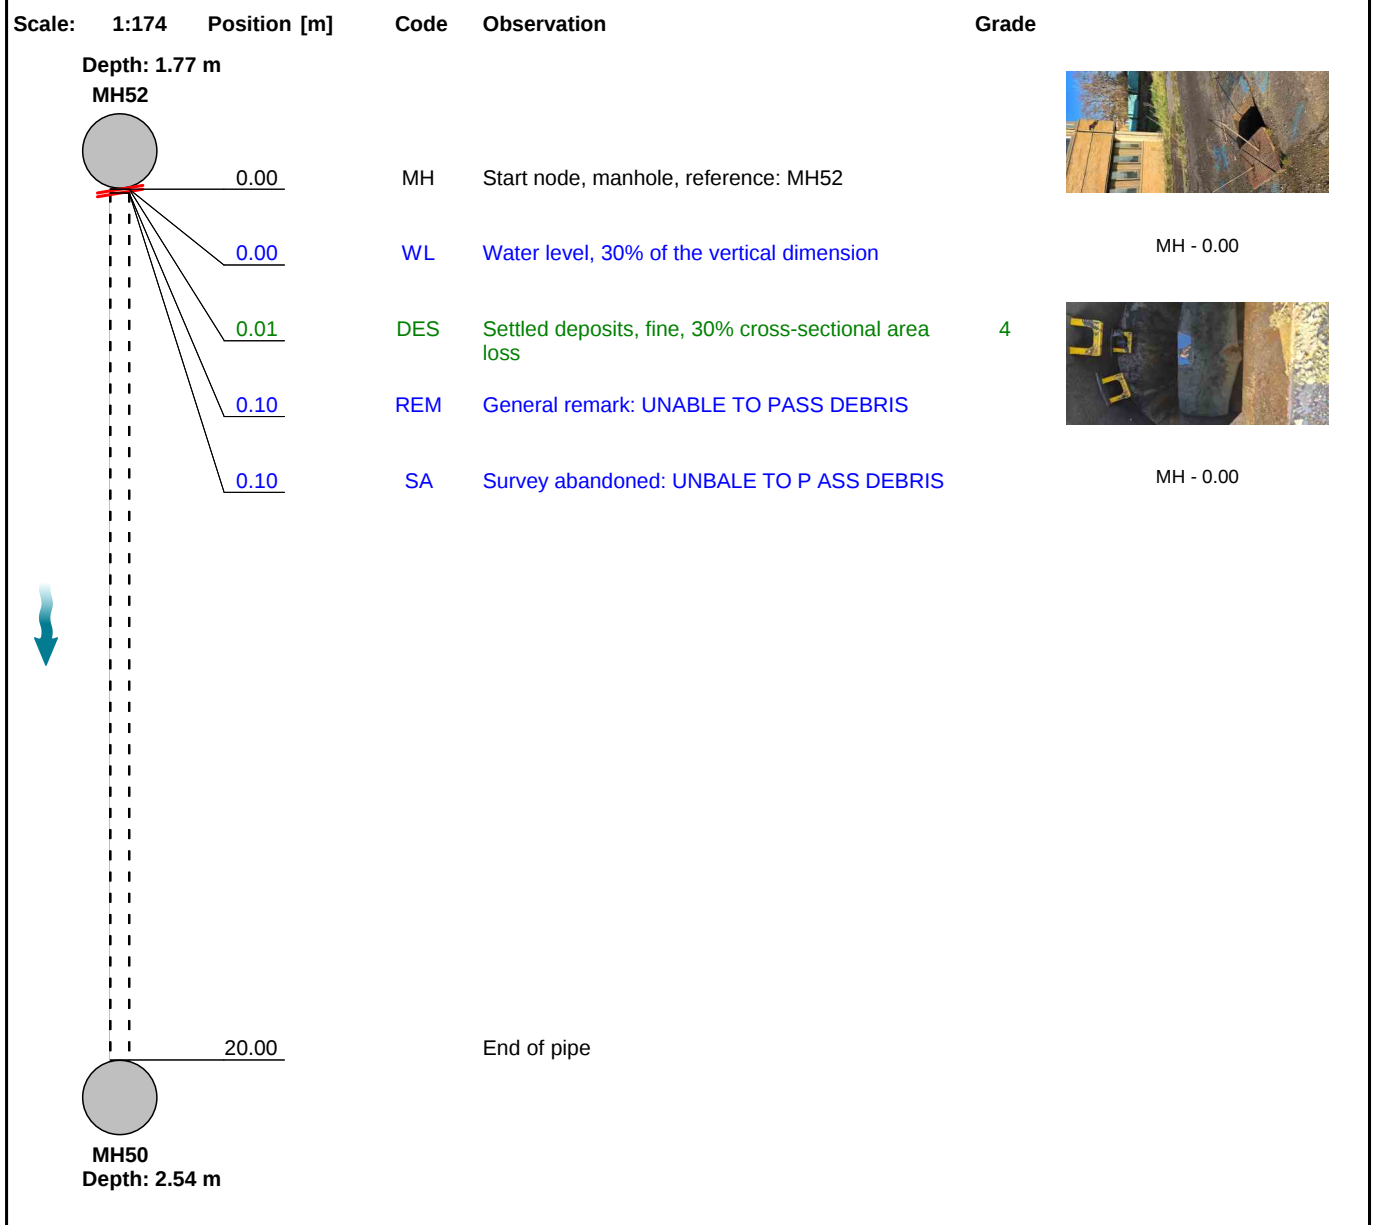
| <b>Comments:</b> | REQUIRES HEAVY JETTING TO SURVEY | | | | |

| <b>Recommendations:</b> | REQUIRES HEAVY JETTING | | | | |

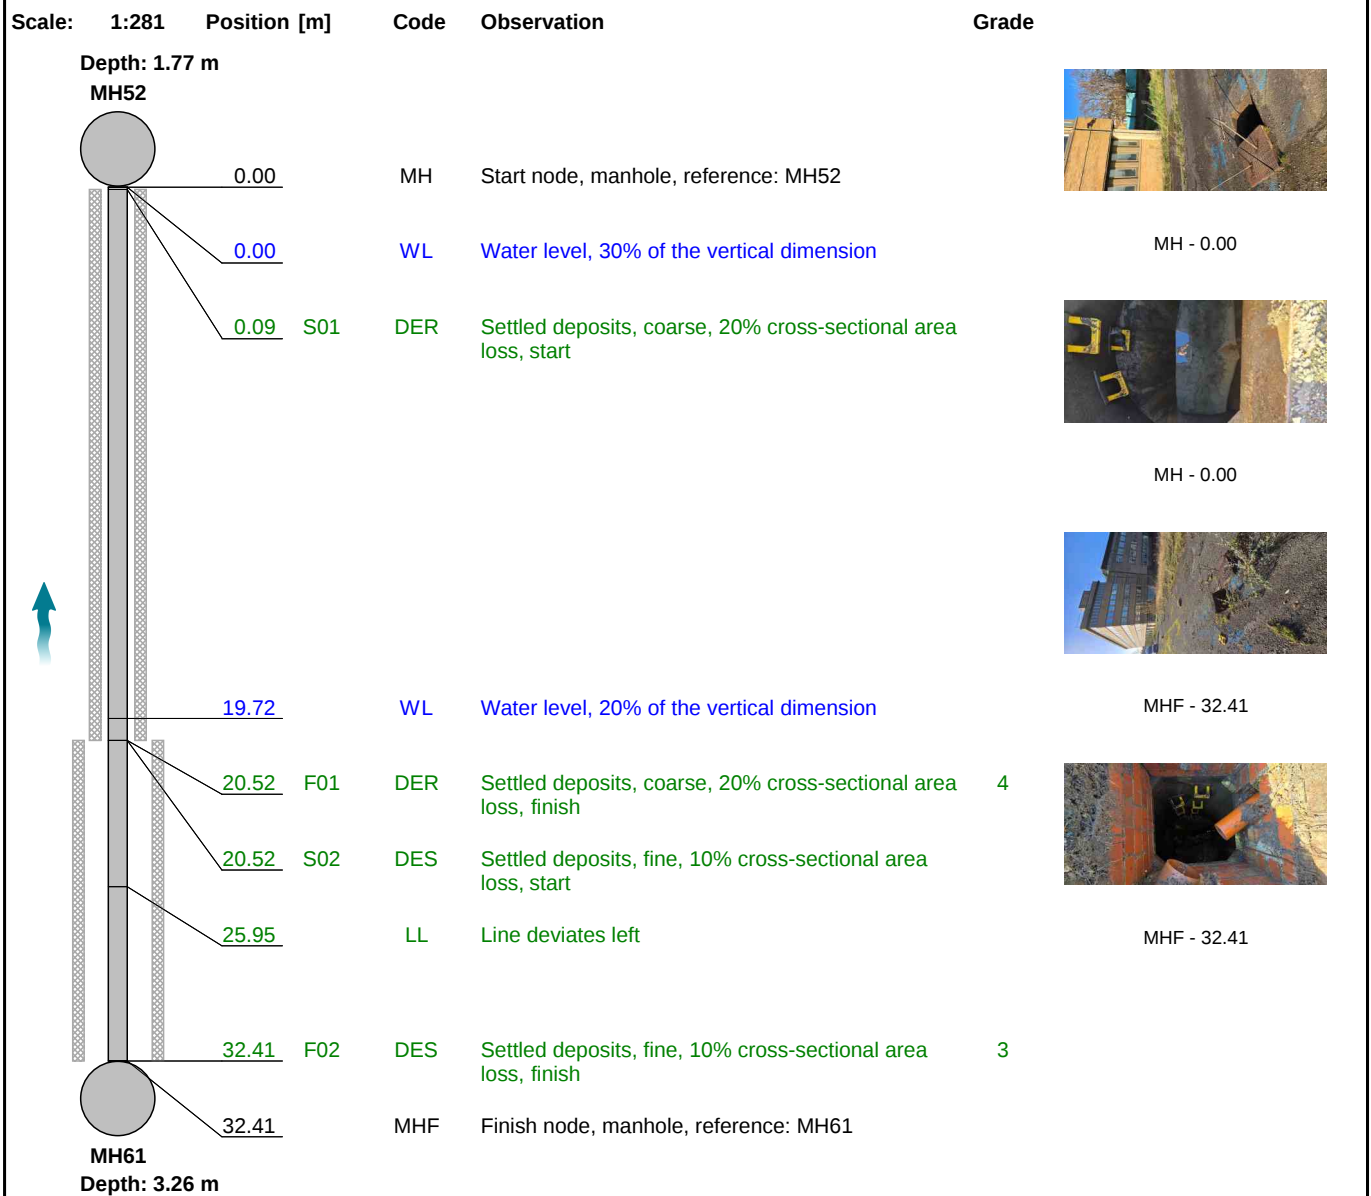
| <b>Comments:</b> | SURVEY COMPLETE | | | | |

| <b>Recommendations:</b> | REQUIRES HEAVY JETTING TO CLEAN | | | | |

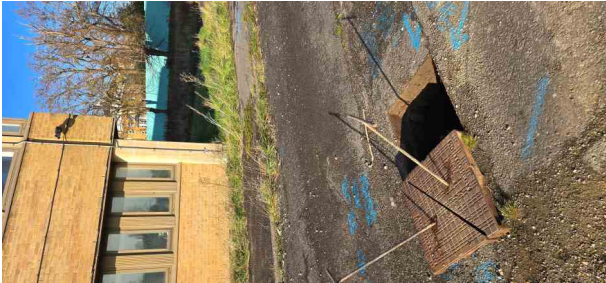
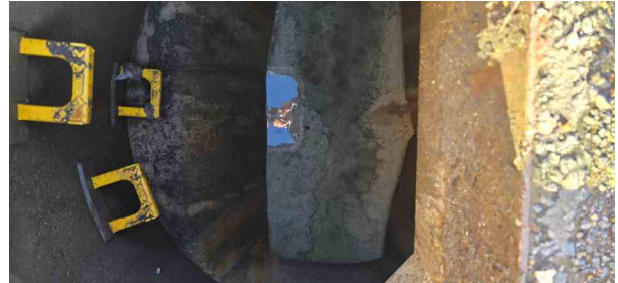
MH61X\_e9efd8cd-0511-4080-8fd8-b2573383b329\_20241125\_135532.jpg, 00:00:01, 0.00 m  
 Start node, manhole, reference: MH52

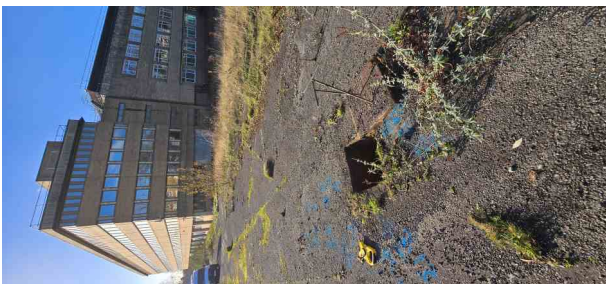
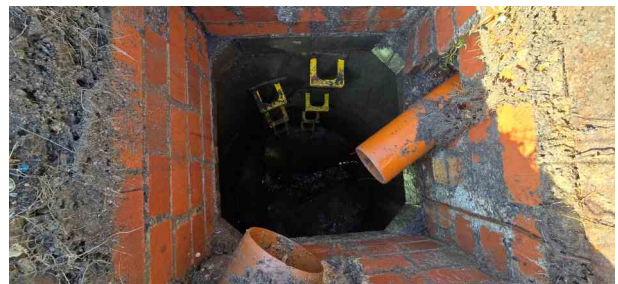
MH61X\_272adc5c-e3b7-4cf9-9421-c9fd14ab4772\_20241125\_135430.jpg, 00:03:38, 32.41 m  
 Finish node, manhole, reference: MH61

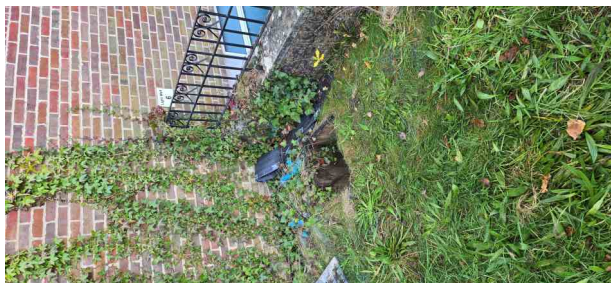
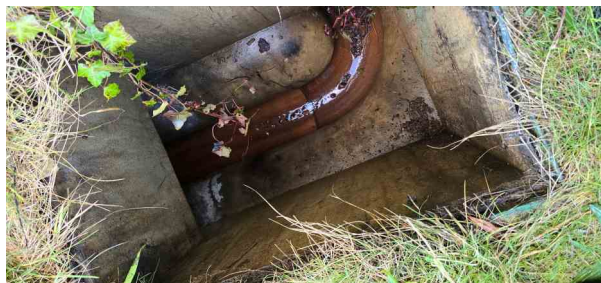
MH64X\_c13aa89b-c7d0-4460-9c15-158c411df083\_20241125\_142620.jpg, 00:00:01, 0.00 m  
 Start node, manhole, reference: MH64

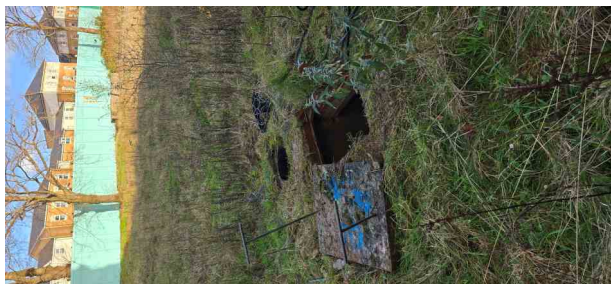
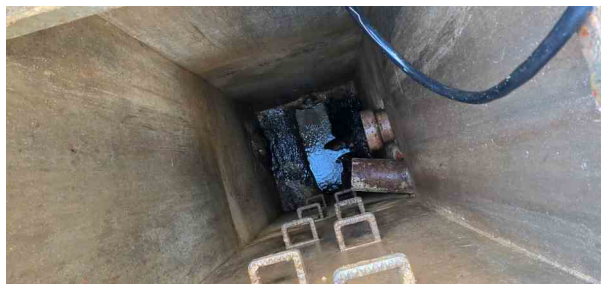
MH64X\_d30f4c3b-6a8c-4047-97a1-0165e4aa9c35\_20241125\_142601.jpg, 00:00:50, 12.02 m  
 Finish node, manhole, reference: MH69

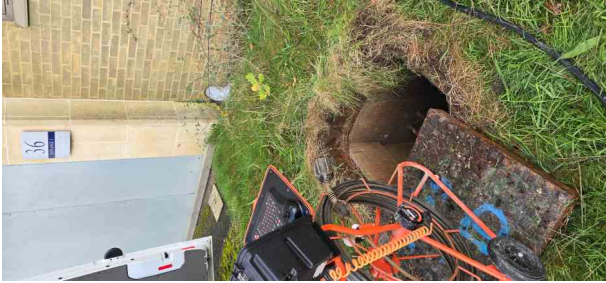
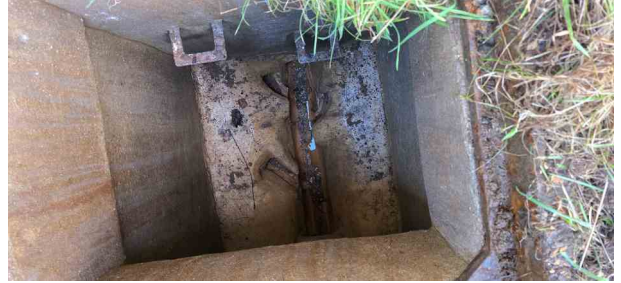
MH63X\_84e43519-7d21-40aa-bcb9-b75b2af84fb4\_20241125\_142650.jpg, 00:00:01, 0.00 m  
 Start node, manhole, reference: MH63

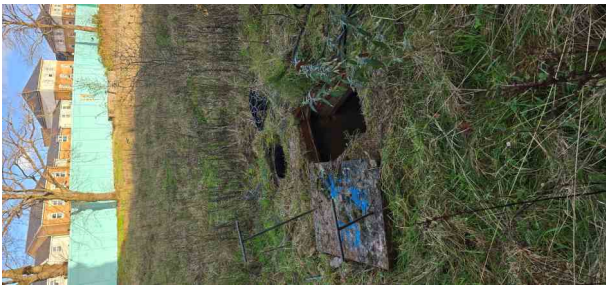
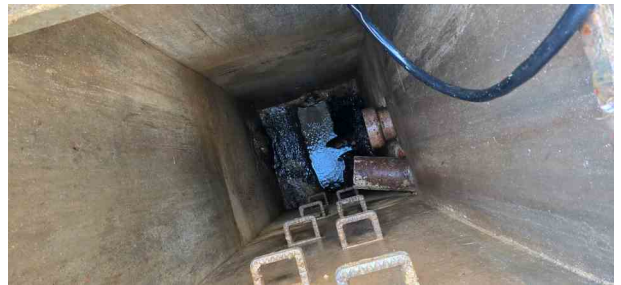
MH63X\_d33e356d-36db-4550-8fac-a52281a523c4\_20241125\_142801.jpg, 00:00:41, 7.64 m  
 Finish node, manhole, reference: MH69

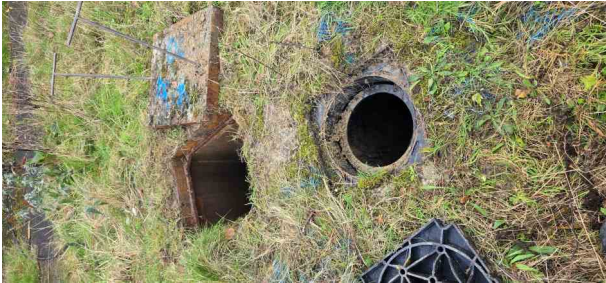
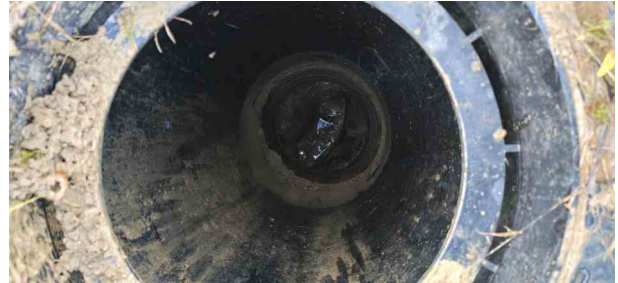
MH70X\_952ce354-e7cf-4cab-a660-69bb7fe629e2\_20241125\_142811.jpg, 00:00:01, 0.00 m  
 Start node, manhole, reference: MH70

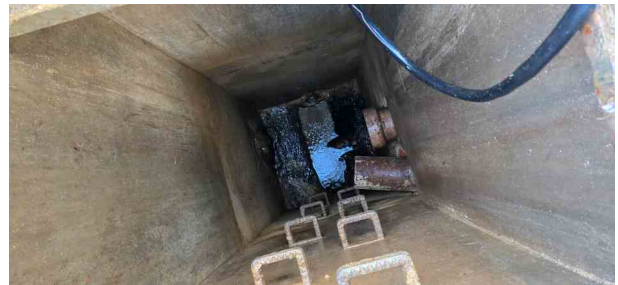
MH70X\_482b3a68-3968-4f9b-934f-2755644c4826\_20241125\_142839.jpg, 00:00:26, 0.50 m  
 Finish node, manhole, reference: MH69

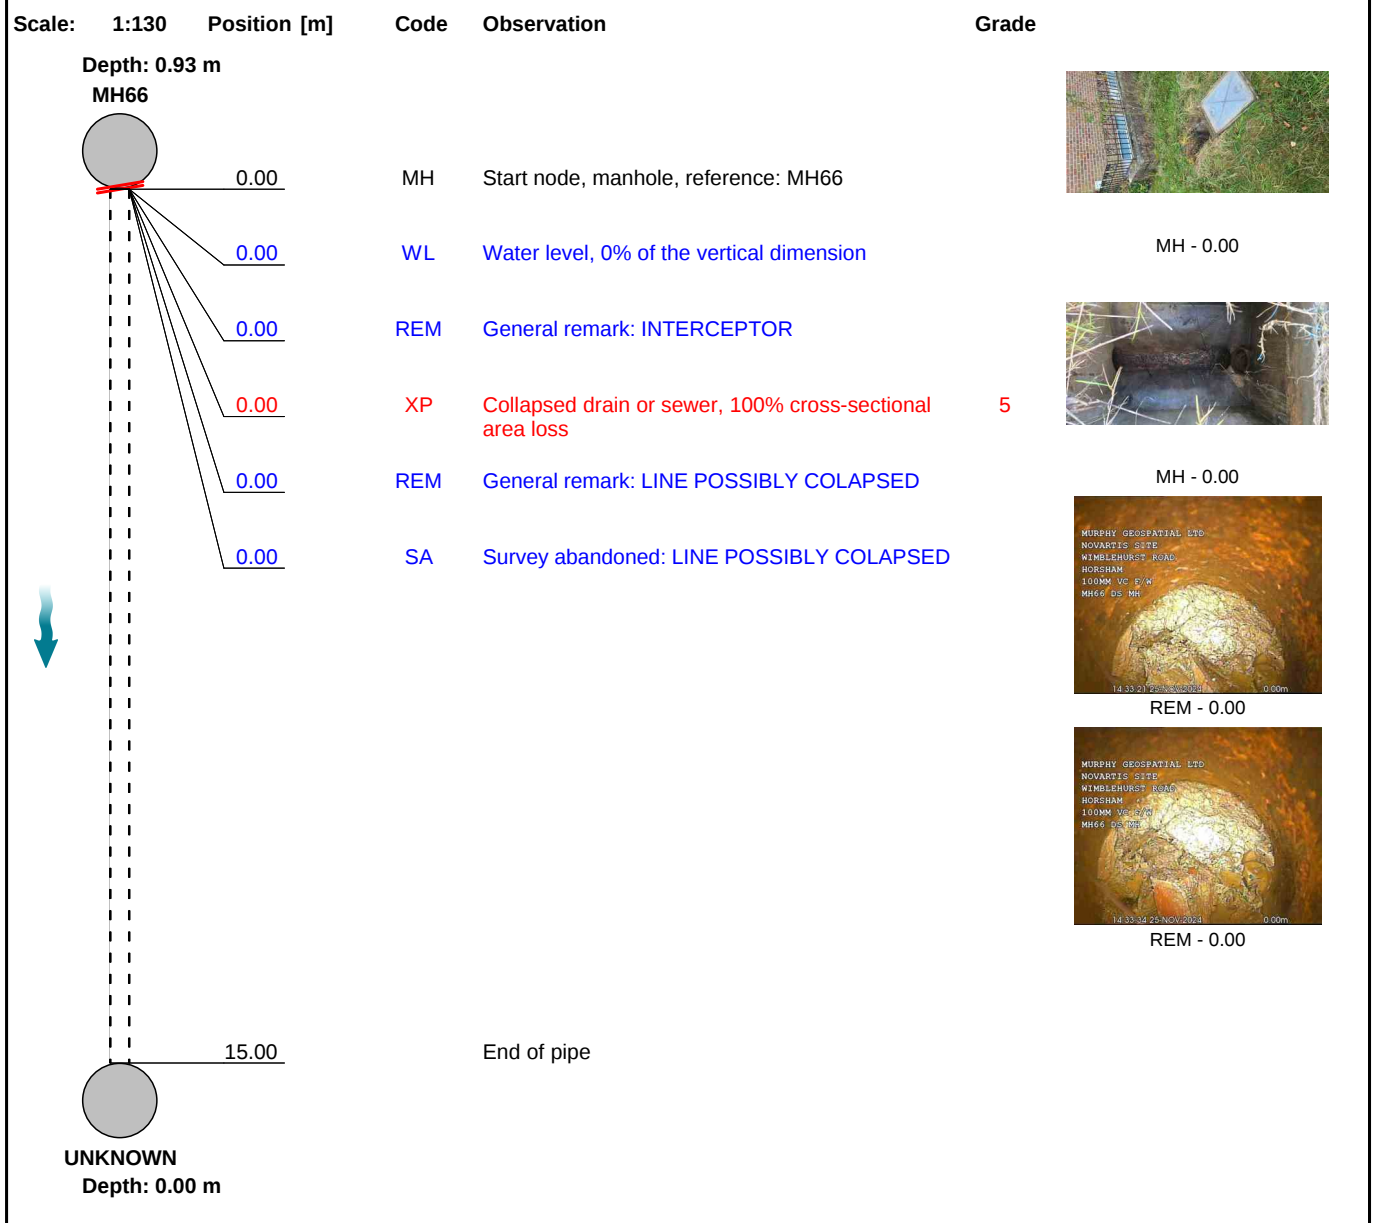
| Item No. | Inspection Direction | PLR | Client's Job Ref | Contractor's Job Ref |
|---|---|---|---|---|
| 15 | Downstream | MH66X | NOVARTIS SITE | NOVARTIS SITE |

| <b>Comments:</b> | LINE POSSIBLY COLLAPSED | | | | |

| <b>Recommendations:</b> | LINE REQUIRES DIG UP TO REPAIR | | | | |

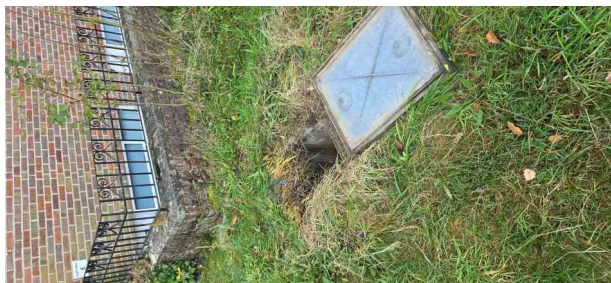
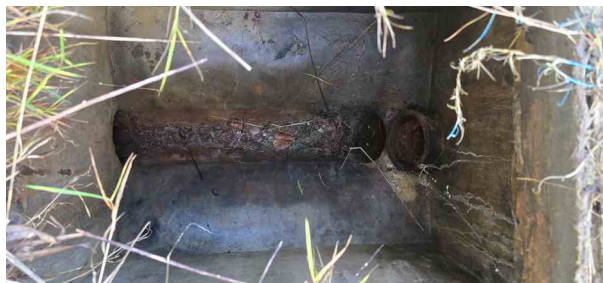
MH66X\_af767249-9a80-4ee8-a502-89d04811b755\_20241125\_143053.jpg, 00:00:01, 0.00 m  
 Start node, manhole, reference: MH66

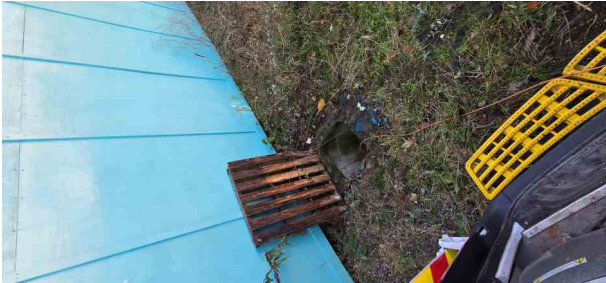
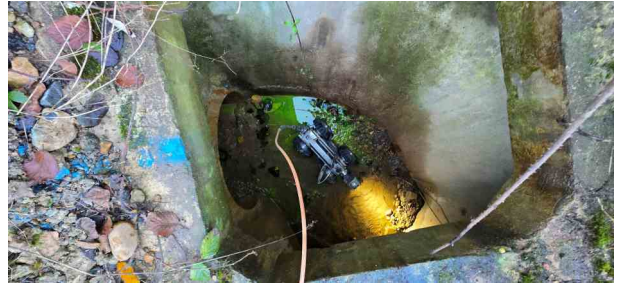
X\_2586be45-4d85-47f3-9d48-08431449bb65\_20241125\_144824.jpg, 00:00:01, 0.00 m  
 Start node, manhole, reference: MH92

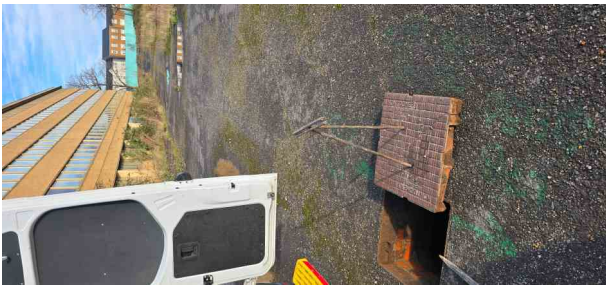
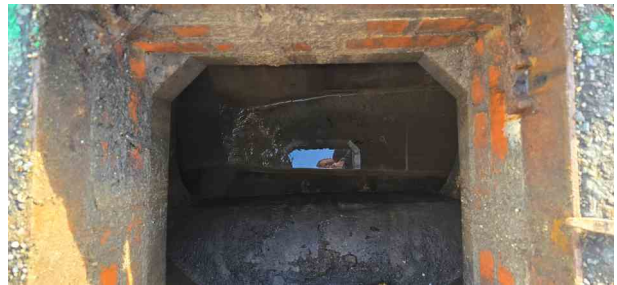
MH33X\_2ca10918-82b4-4f2f-bf51-7afa06732a2f\_20241125\_145333.jpg, 00:03:02, 29.66 m  
 Finish node, manhole, reference: MH33
