Flood Risk Assessment and Surface Water Drainage Strategy for Planning

January 2026

Units 4 to 5

Redkiln Close

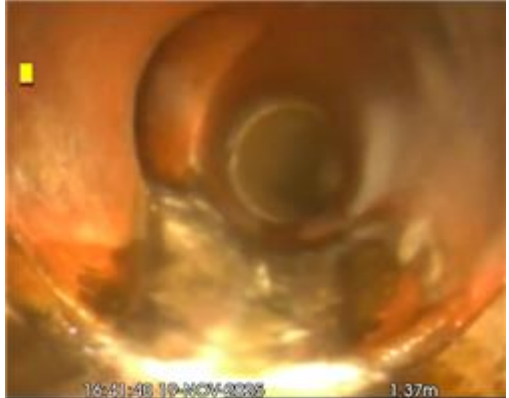
00.00m	0:00:00	WL	Water level: 0% Height/Diameter	
01.37m	0:00:05	JN	Junction at 09 o'clock: 0mm Diameter	Image Provided - Ref: 5_2

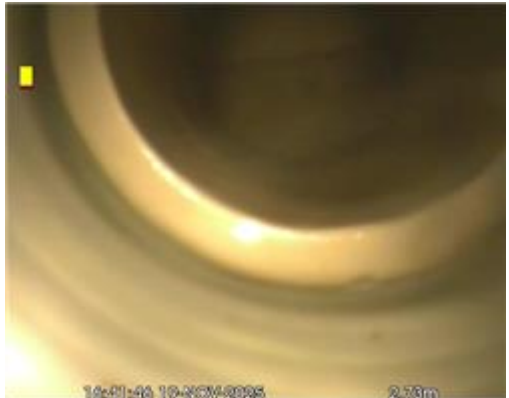
02.73m		WRF	Finish node type, major connection without manhole LINE 6 ENTERS W.C	Image Provided - Ref: 5_9999

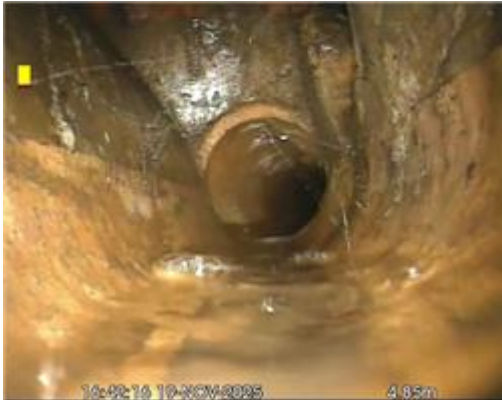
00.00m	0:00:00	WL	Water level: 0% Height/Diameter	
04.85m		MHF	Finish node type, manhole LINE 7 ENTERS MH3	<p>Image Provided - Ref: 6_9999</p>

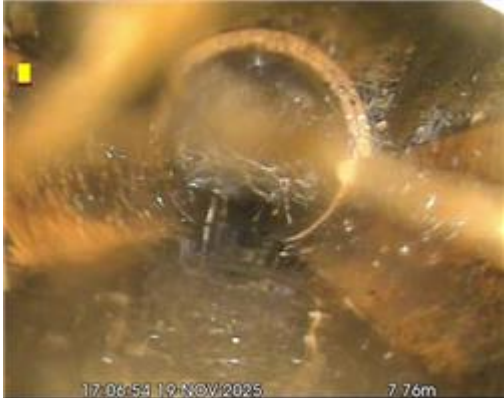
00.00m	0:00:00	WL	Water level: 0% Height/Diameter	
07.76m	0:00:22	REM	General remark ENTERS SW4	Image Provided - Ref: 13_2

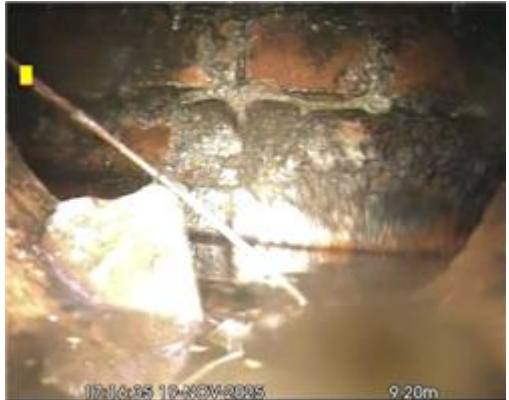
00.00m	0:00:00	WL	Water level: 0% Height/Diameter	
09.20m		GYF	Finish node type Gully LINE 16 ENTERS ROAD GULLY	Image Provided - Ref: 15_9999

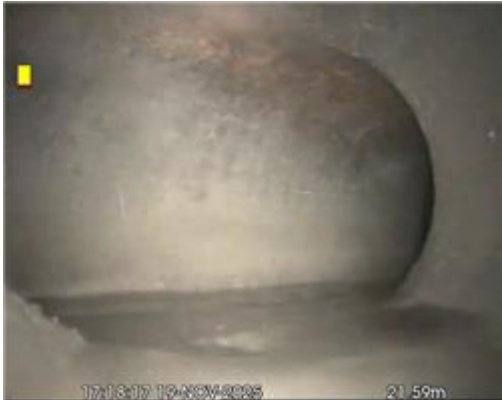
00.00m	0:00:00	WL	Water level: 0% Height/Diameter	
21.59m		MHF	Finish node type, manhole LINE 17 ENTERS LINE 13	Image Provided - Ref: 16_9999
