WARNHAM PARISH COUNCIL CONSULTATION COMMENTS

TO:	Horsham District Council – Planning Dept
SITE ADDRESS:	Land East of Tilletts Lane Warnham
PROPOSAL:	Erection of 59 dwellings with associated open space, landscaping, parking, access, and drainage infrastructure.
REFERENCE:	DC/25/1155
RECOMMENDATION:	Objection

RDPO Investigation Report

RDPO Temp Confirm No.	None Raised
RDPO Officer	SW
Date Investigation Complete	11 July 2025
Road Name/No.	Tilletts Lane
Area/Town	Warnham
Riparian Issue?	Yes
Highway Flooding?	Yes

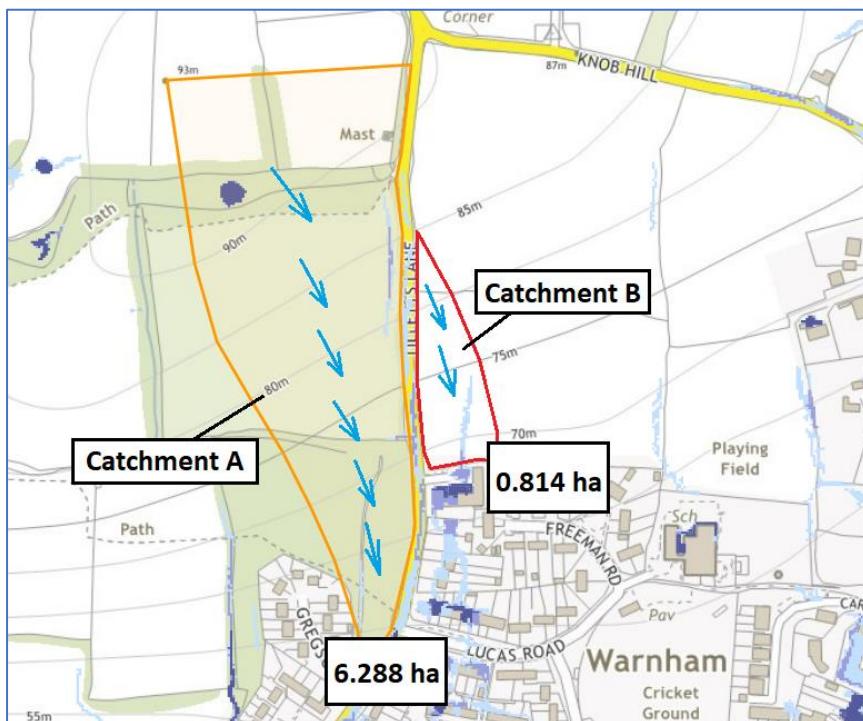
The area of land that contributes to the surface water flood risk at the road (Catchment A) is approximately 6.288 Hectares (image 3).

There is an additional catchment (Catchment B) from part of the open field north of Freeman Road. This appears to contribute to an over land surface water flood flow route that will drain into the lower residential area (Images 3 and 4). Both catchments are separated by Tilletts Lane.

Image 3. Catchment A area of Tilletts Lane surface water flood risk—approximately 6.288 Hectares, and Catchment B area of Freeman Road surface water flood risk—approximately 0.814 Hectares. Source: OS mapping overlaid with Environment Agency surface water flood mapping (extent) and measuring tool annotation. Accessed 07/07/2025

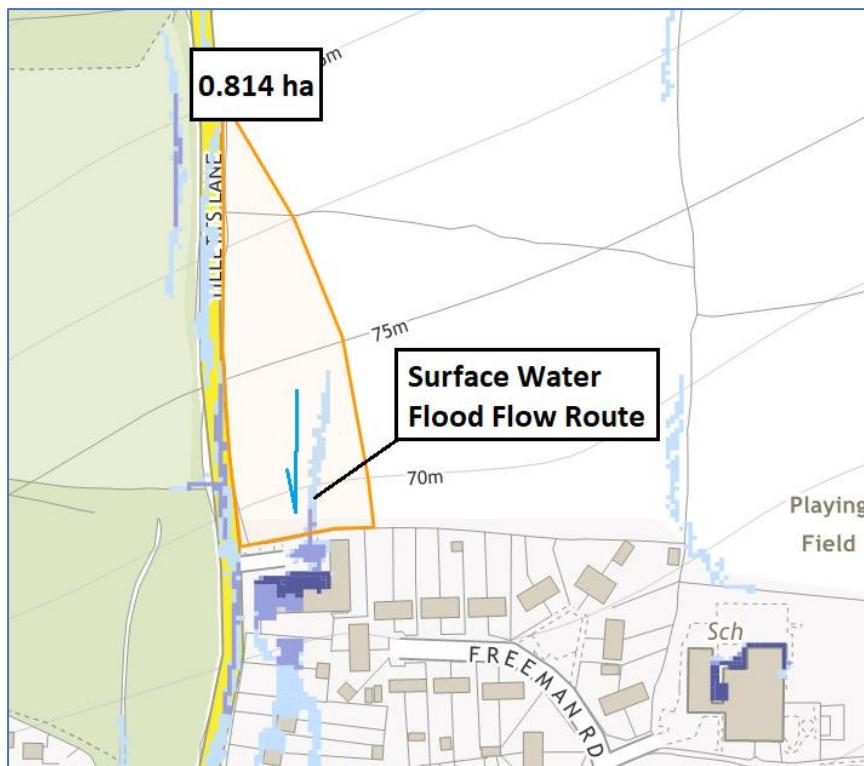
Topographic flow directions have been marked with blue arrows.

Image 4. Detail of Catchment B area of Freeman Road surface water flood risk—approximately 0.814 Hectares. Source: OS mapping overlaid with Environment Agency surface water flood mapping (extent) and measuring tool annotation. Accessed 07/07/2025

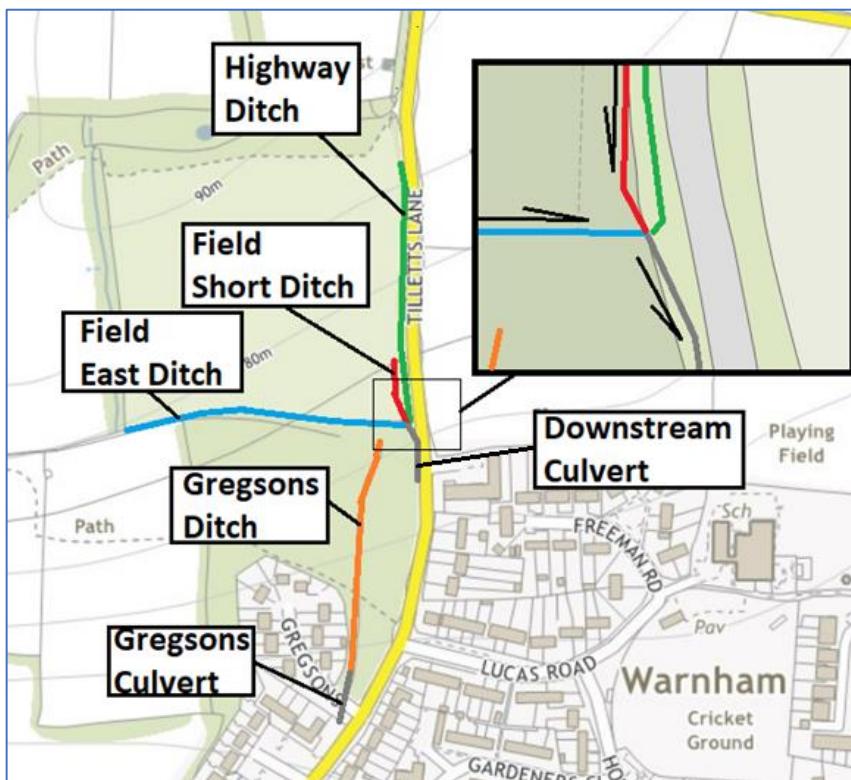
A small system of watercourses flow at Tilletts Lane (image 6). These have been separated into individual sections and labelled as:

1. Highway ditch
2. Field short ditch
3. Field east ditch
4. Downstream culvert
5. Gregors ditch
6. Grgors culvert

Image 6. Ordinary watercourse systems at Tilletts Lane area. Source: OS mapping with annotation.

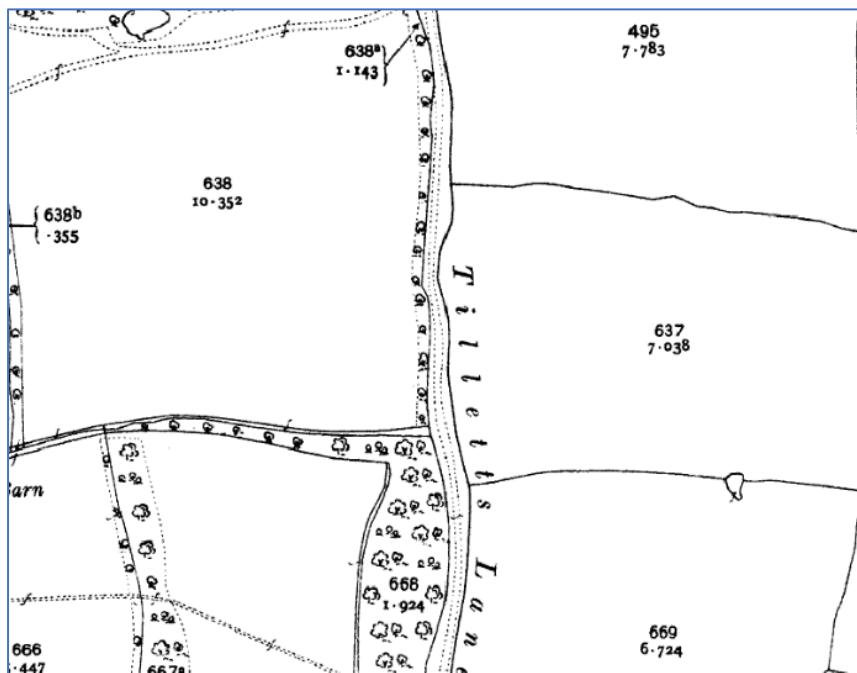
Image 8. Historic map showing location of watercourses west and south of Tilletts Lane. Source: OS mapping historic Epoch 4 (1922-1969). Accessed: 07/07/2025

This informs that a system of watercourses at Tilletts Lane area appear historic and have been in place since at least 1922 to 1969. The maps suggest it is likely that the highway drained to open ditch systems between fields and highway.
