*Project ref: TV260608*

SITE: Land Northwest of Southwater

# ***CCTV Survey Report***

*Sewer Inspection, Cleaning and Repair*

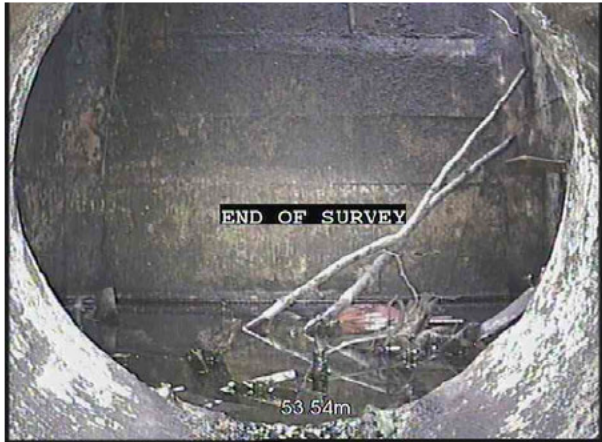
1, 00:03:53, 53.54 m  
Finish node, manhole, reference: IC2
