**Arboricultural Report**  
**composed of**  
**Arboricultural Impact Assessment**  
**Arboricultural Method Statement**  
**& Tree Protection Plan**

Land adjacent 1 Woodcot New Road Billingshurst RH14 9DS

6th May 2026

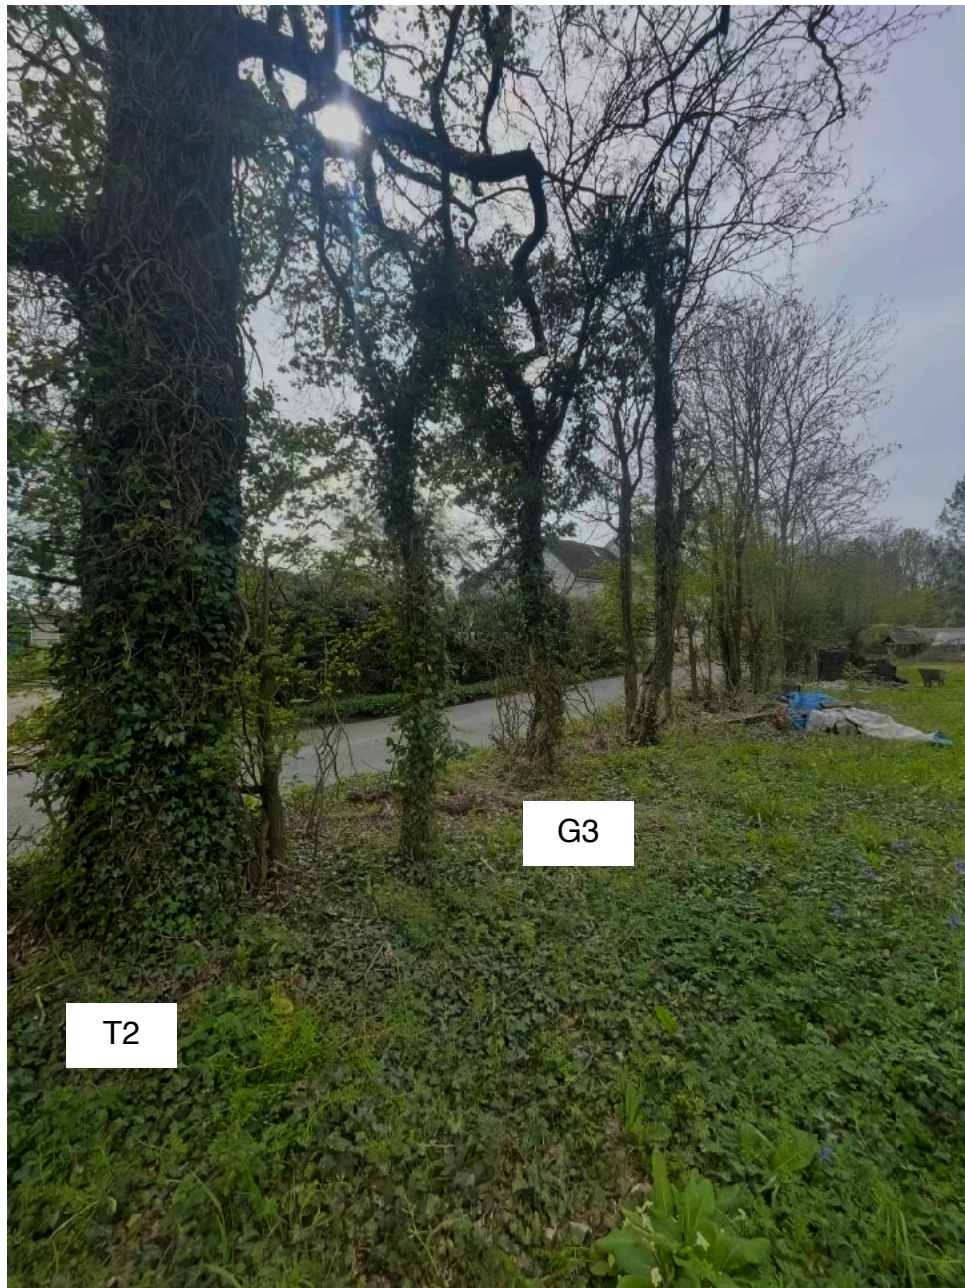
Removal of G3 group of Ash trees will allow for replanting using native hedging to reinforce screening along the roadside

| No | Species | Height | Ø at 1.5m | Spread | Crown | Age | Condition and Recommendations | Removal | ERC | BS | RPA |
|---|---|---|---|---|---|---|---|---|---|---|---|
| | | | | | | | <b>Recommend:</b> Remove as poor specimens and this will allow for new native planting to bolster and reinvigorate the boundary hedge | | | | |
