# Gale Tree Consultancy

## Tree Condition Report

Wildwood, Mannings Heath, RH13 6LZ

November 2025

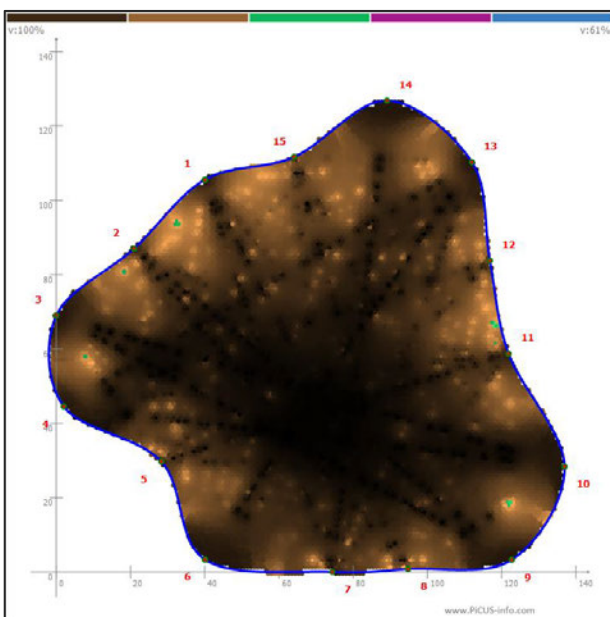
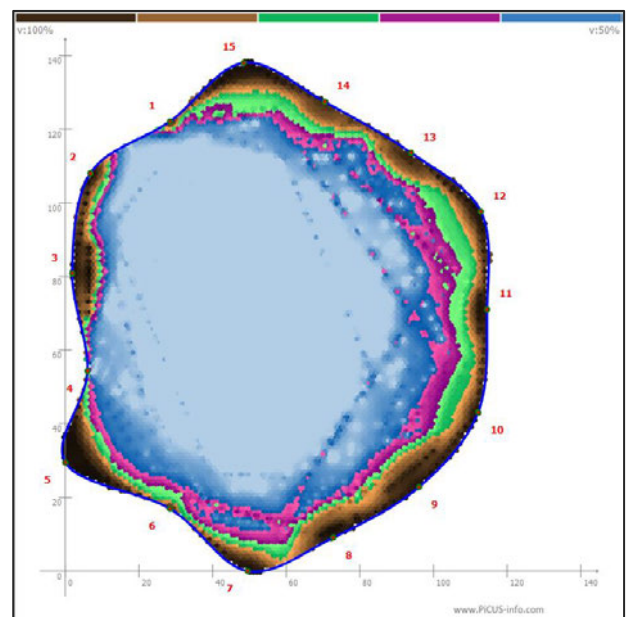
- On the examples below, the tomogram on the left indicates a sound tree and the tomogram on the right, a tree with significant decay or hollowing:

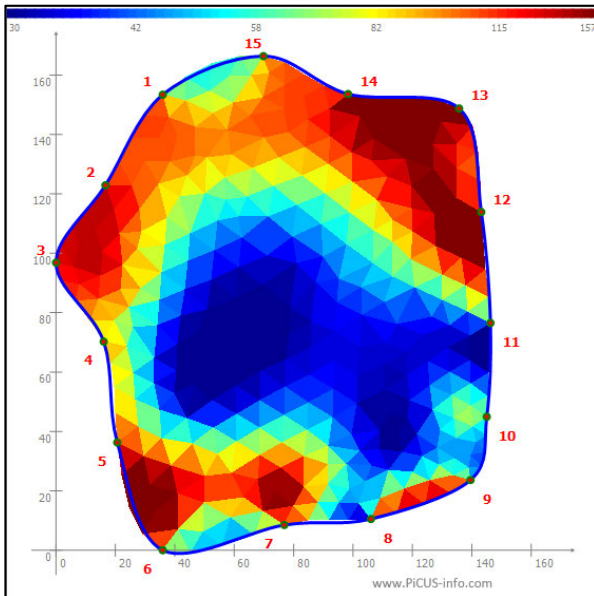
- The PiCUS 2 ERT unit produces an electrical current to assess the condition of the wood within the tree. Changes in the water content, cell composition and chemical elements will change according to the condition of the wood – see to the left
- The blue colouration in the tomogram indicates an area of high conductivity suggesting advancing decay
- The ERT system can test below the assessed plane which helps with the early diagnosis of changes to the wood structure

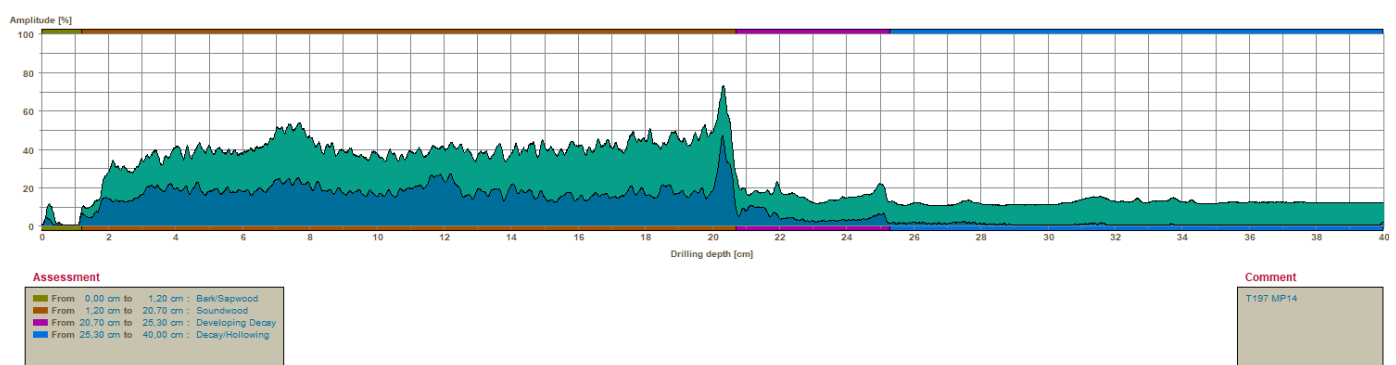
- An IML Resi PD400 microdrill, which measures the resistance of a very fine drill bit to a depth of 400mm, can be used for further confirmation. Significant drops in drilling resistance are indicative of decay or hollowing
- On the example below, sound wood is present to a depth of c.20.7cm before the needle drill enters an area of developing decay; at c.25.3cm the needle drill enters a cavity which extends to the end of the assessment
- Please note, the colours of the Resi Drill Traces have been colour-coded to match those of the PiCUS 3 Sonic Tomography unit

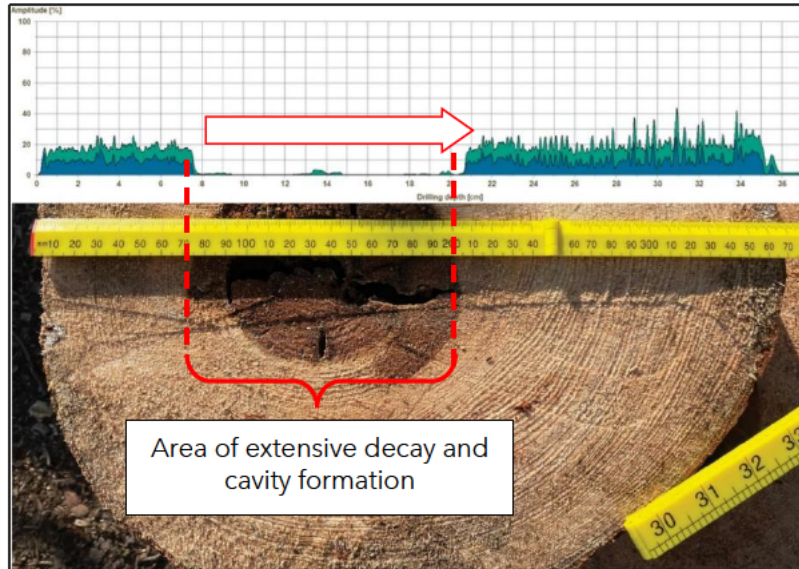
- On the image below, you can see where the drill entered the area of extensive decay and cavity at c.7.5cm and re-entered the sound wood at c.20.8cm; the drill exited the stem at c.35.4cm
