# GEOTECHNICAL

## for Subsidence Management Services

22 Princess Anne Road, Horsham, RH12 3HR

## Drainage Investigation Report

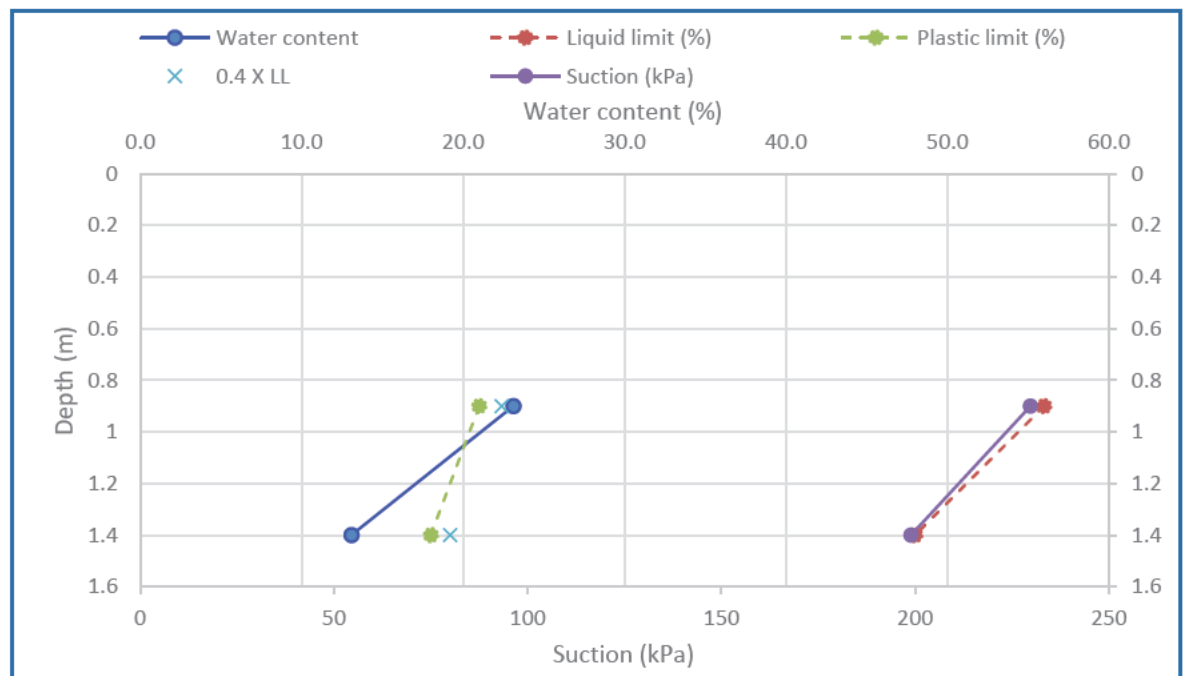
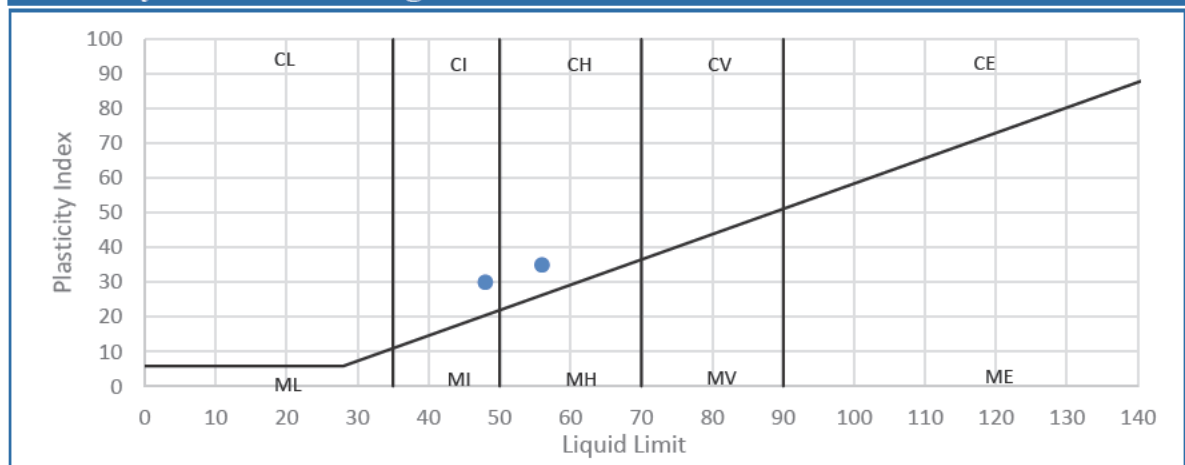
| Lab Ref | Depth (m) | WC (%) | LL (%) | PL (%) | PI (%) | .425 mm(%) | mod. PI (%) | Av. Suc. (kPa) | Description |
|---|---|---|---|---|---|---|---|---|---|
| 1 | 0.9 | 23.1 | 56 | 21 | 35 | 88 | 31 | 230 | Firm dark brown/grey silty CLAY with rare gravel and sand. Gravel is fine |
| 2 | 1.4 | 13.1 | 48 | 18 | 30 | 86 | 26 | 199 | Friable olive-brown/grey slightly sandy silty CLAY with rare gravel. Gravel is fine and medium. |

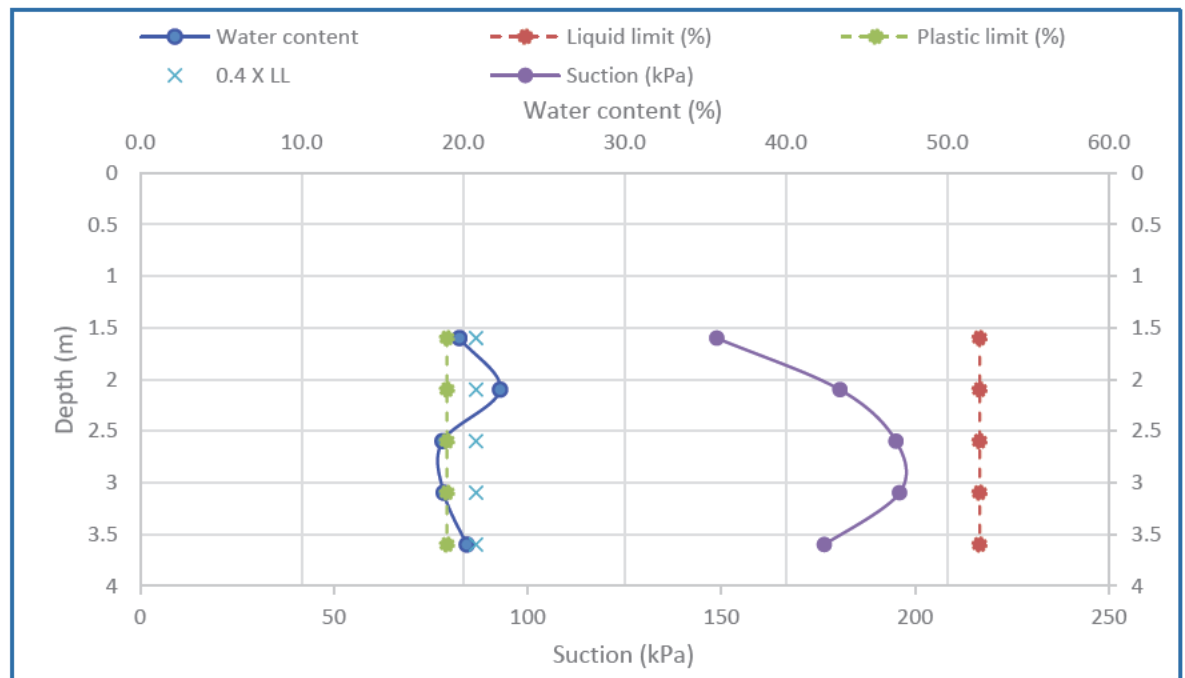
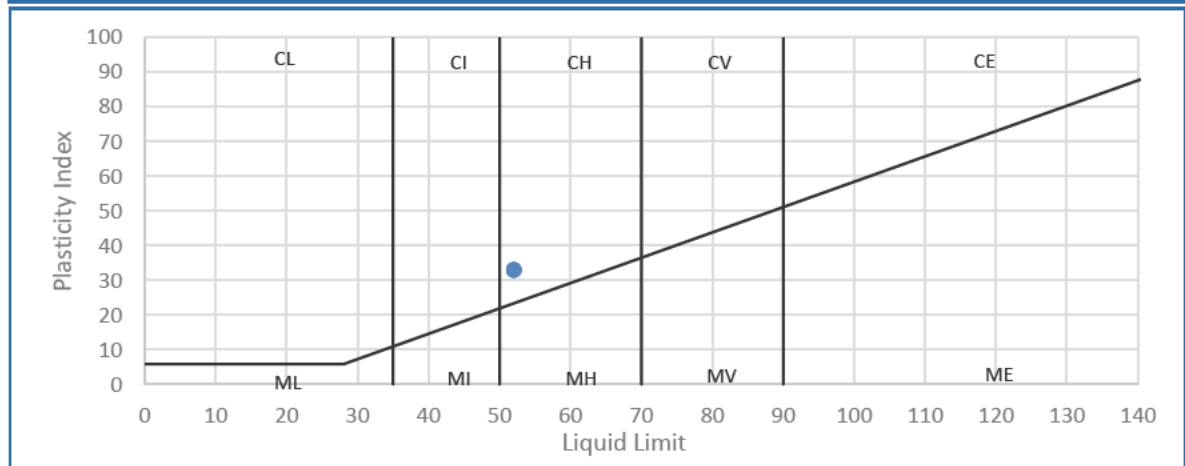
## Samples from BH2

| Lab Ref | Depth (m) | WC (%) | LL (%) | PL (%) | PI (%) | .425 mm(%) | mod. PI (%) | Av. Suc. (kPa) | Description |
|---|---|---|---|---|---|---|---|---|---|
| 6 | 3.1 | 18.8 | 52 | 19 | 33 | 68 | 22 | 196 | Firm olive-brown/grey silty CLAY with rare gravel and sand. Gravel is fine and medium. |
| 7 | 3.6 | 20.2 | 52 | 19 | 33 | 68 | 22 | 177 | Firm olive-brown/grey silty CLAY with rare gravel and sand. Gravel is fine |
