## B PHASE I – DESK STUDY

### 6.1 Site Location and Description

## C PHASE II - INTRUSIVE INVESTIGATION

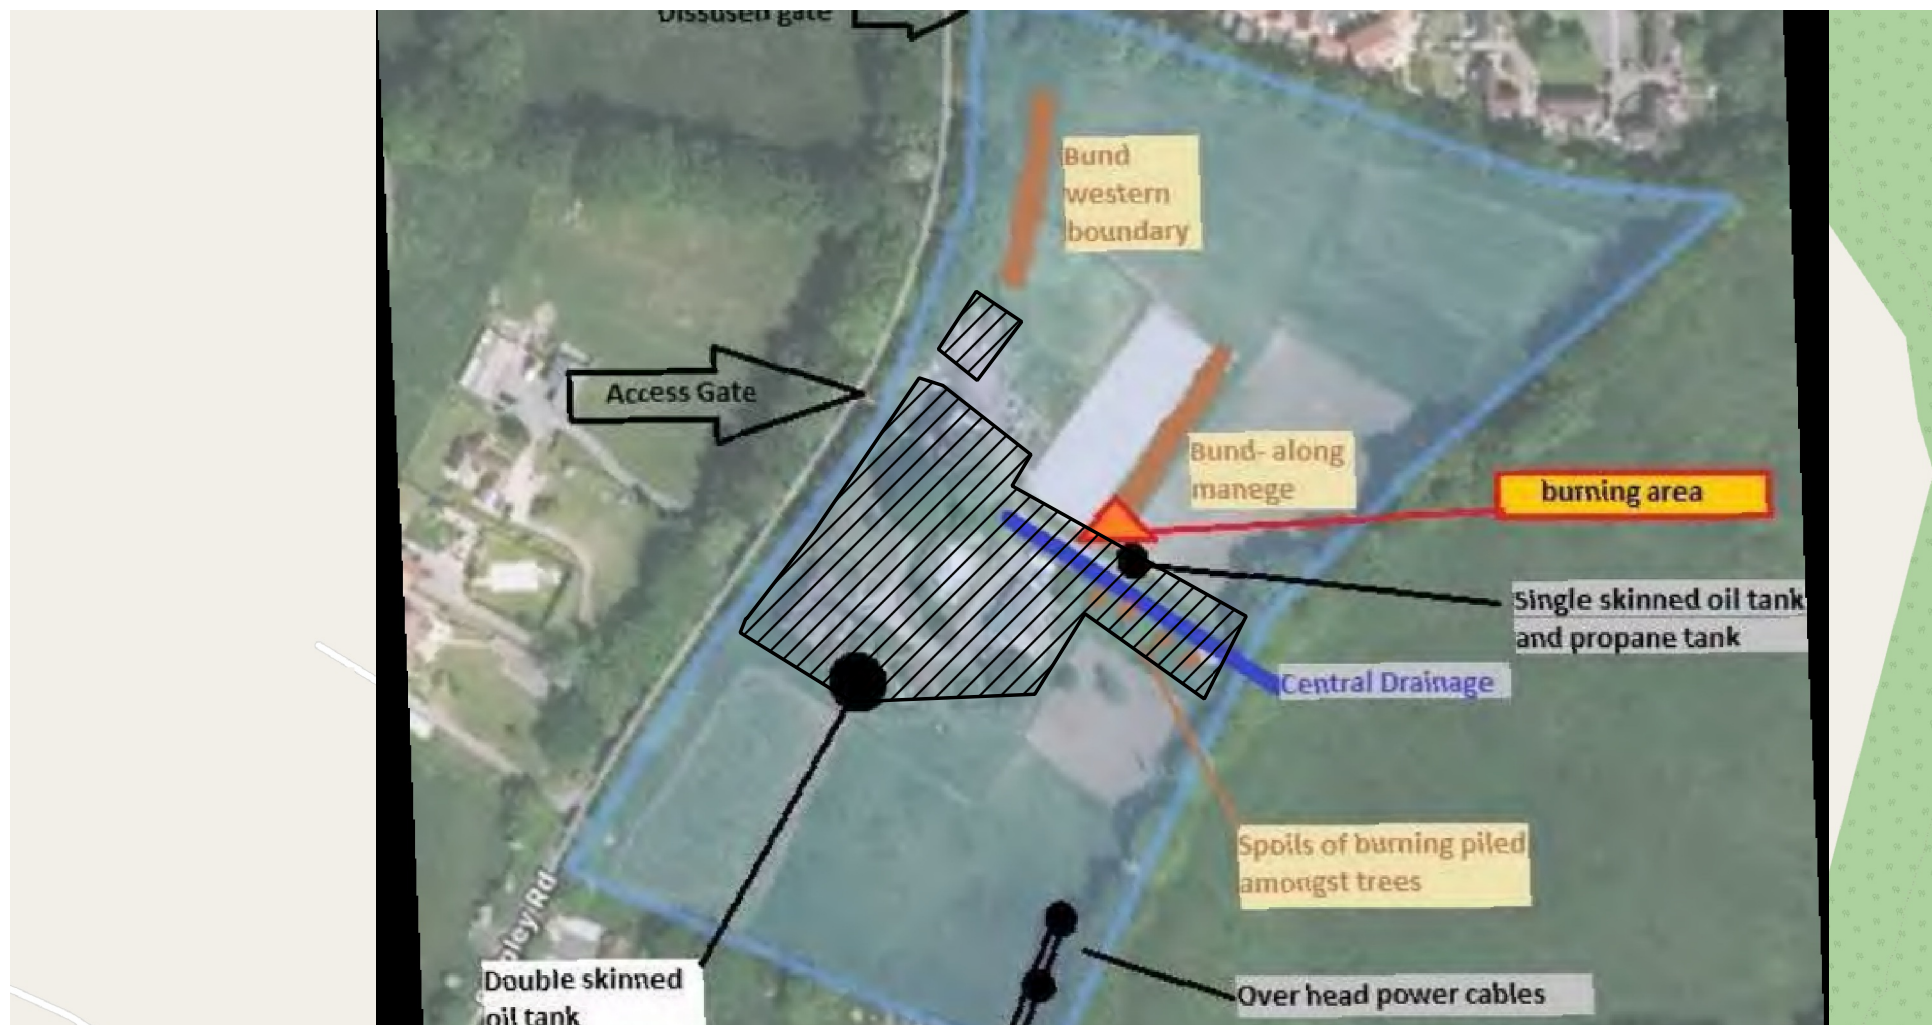
| | Project: | Woodfords, Shipley Road, Southwater | Date: | 23/02/22 | Figure No. | 4 |

| | Client: | Reside Developments | Title: | Site Investigation Locations | Project ID: | LP2826 |
