# Arboricultural Consultancy for Lloyds Bank

| Insured | | Address | Montrose House, Twittenside, Steyning, BN44 3TW | | |

# GEOTECHNICAL

## Drainage Investigation Report

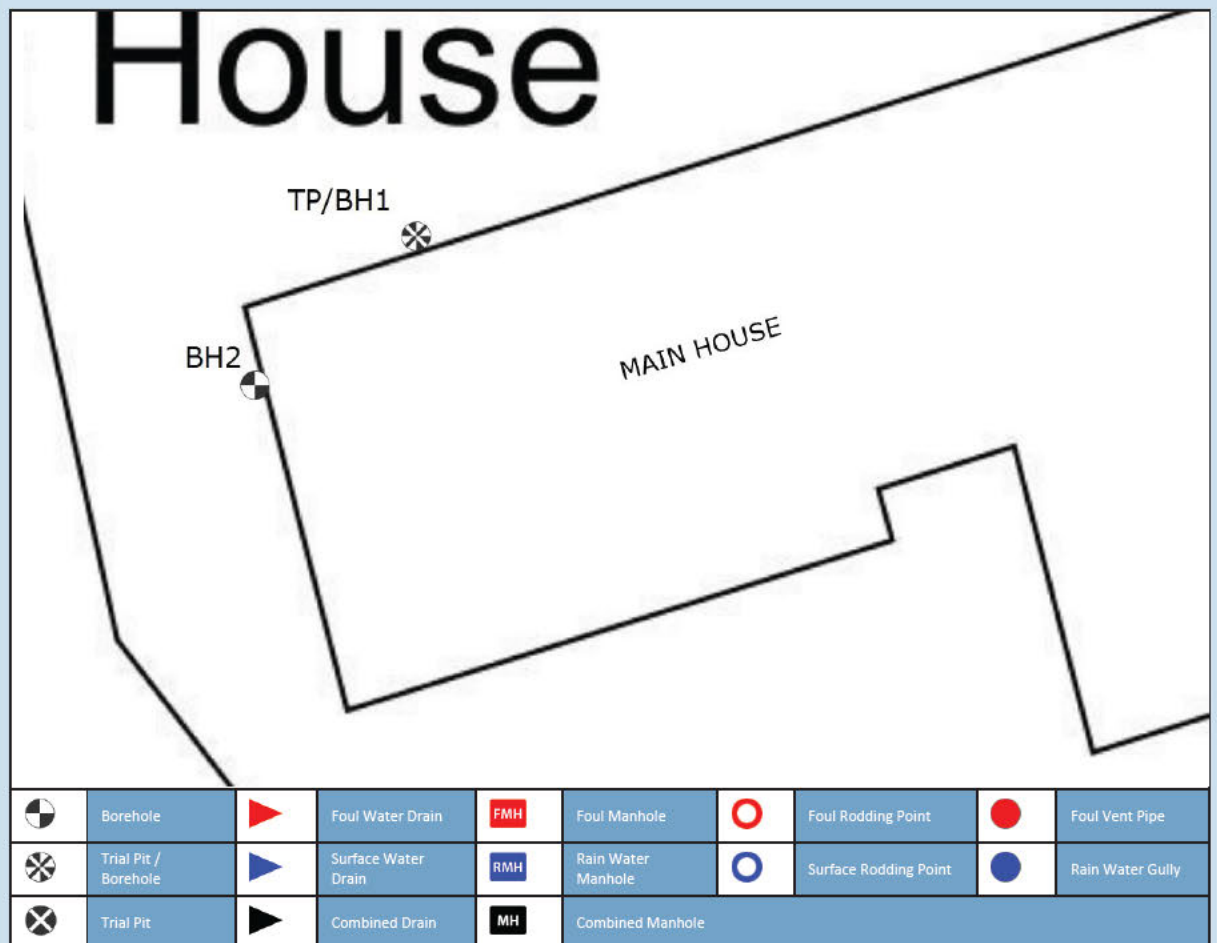
### Site Plan

House foundation comprised of brick wall to 400mm bgl, bearing on stepped concrete to 1300mm bgl, with a total projection of 450mm from the elevation. Underside of foundation (USF) was exposed to 100mm back from the face of the foundation and probed 500mm back from the face of the foundation.

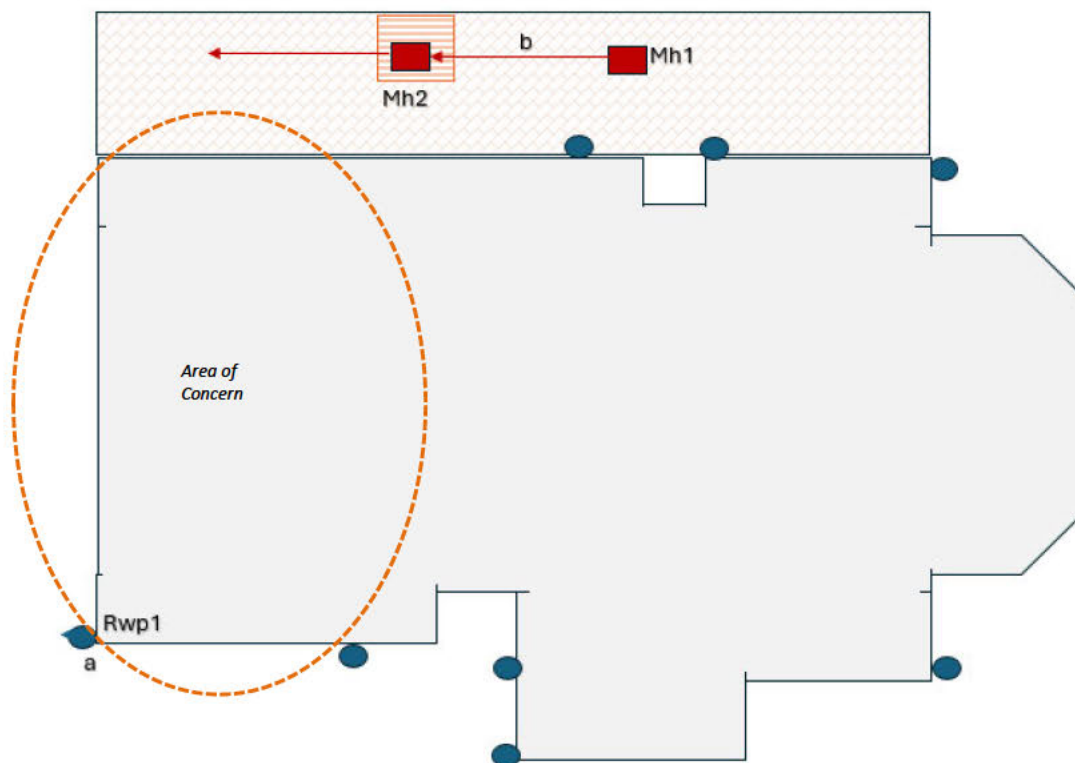
**CCTV Survey Result:** No structural damage. Unable to pass bend

To excavate and replace existing Rest bend at base of RWP including 1m of adjacent pipework
