## HERITAGE IMPACT ASSESSMENT

**Property Address:** Park Farm House, Wheatsheaf Road, Woodmancote,  
Henfield, West Sussex, BN5 9BA

**Inspection Date:** 23<sup>rd</sup> July 2024

**Prepared by** Richard Pocock MSc MRICS

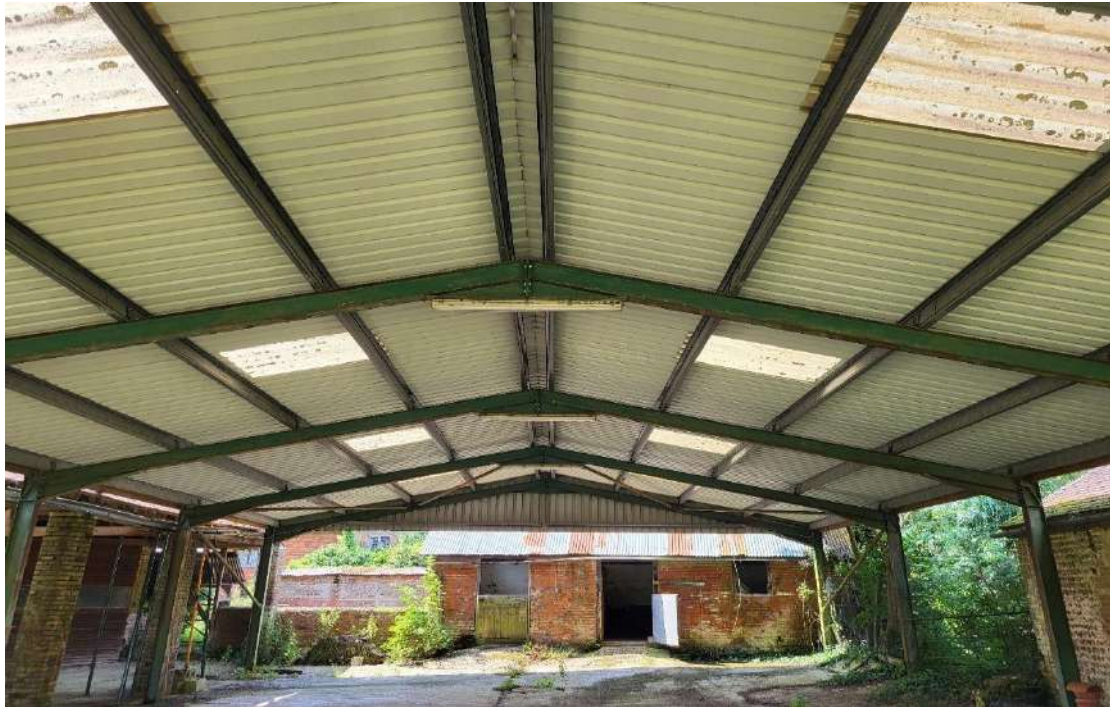
### **8.3 Open Steel Portal Framed Barn**

A further modern structure now covering the remainder of the formerly open farmyard. Again, no heritage value can be ascribed to it.

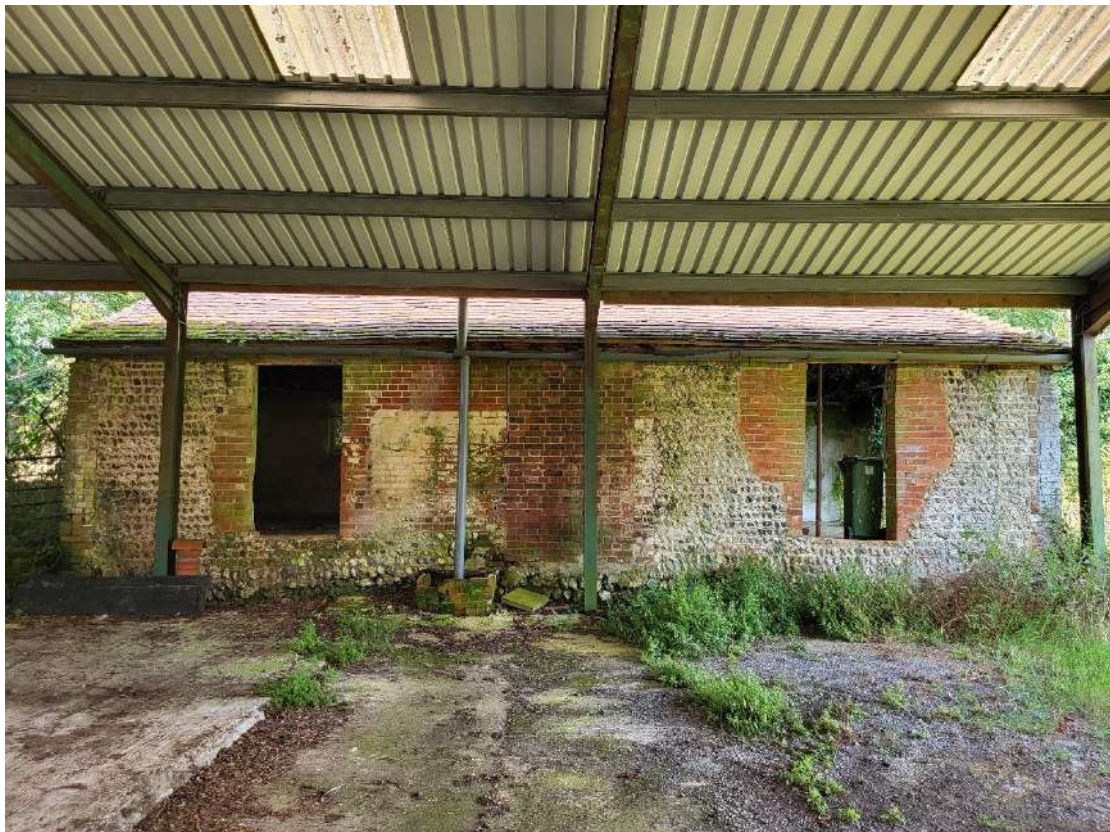
### **8.4 Garage/Store**

This is an intriguing unit, that once faced towards the farmyard but has been repurposed to face out east with the flank wall removed to allow it to become an open 'garage' structure.

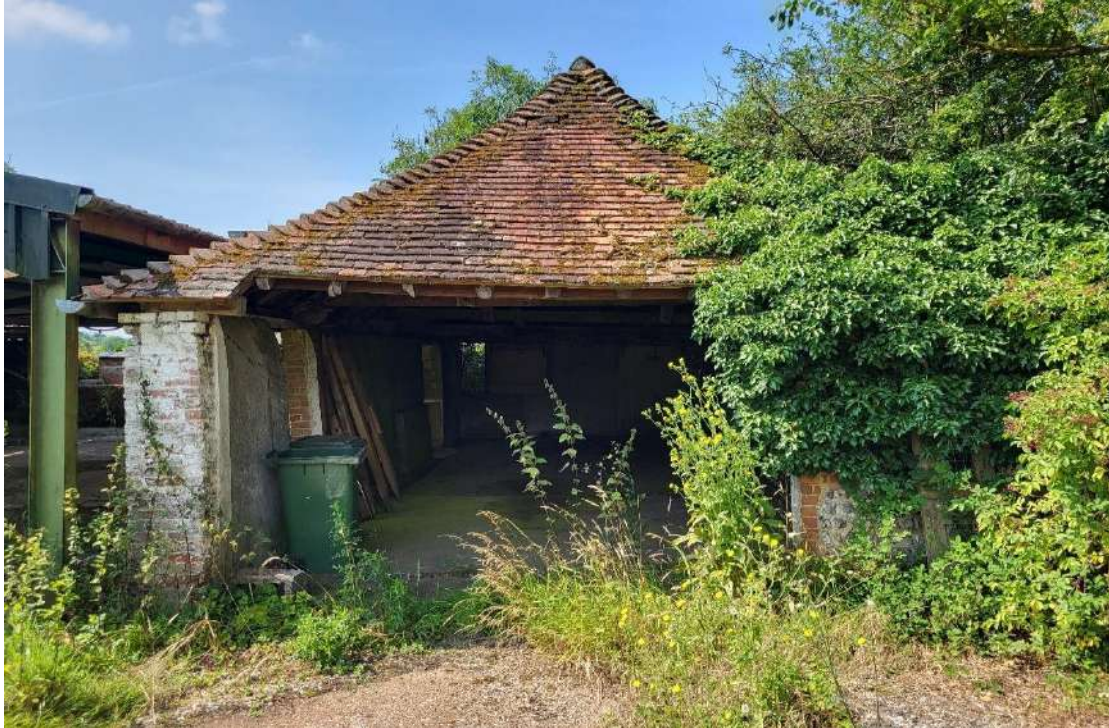
Internally, it would appear that the unit was probably always masonry and, indeed, some of the walls are of flint cobble and infill construction, with interior facings. Some later brickwork also survives, though the unit is somewhat of a derelict shell.

Serious structural problems prevail, despite modern attempts to repair and stabilise the structure. Some of these 'repairs' have resulted in loss of fabric, for instance, the removal of the forward tie where it has failed and been replaced with a softwood upper bolted brace.

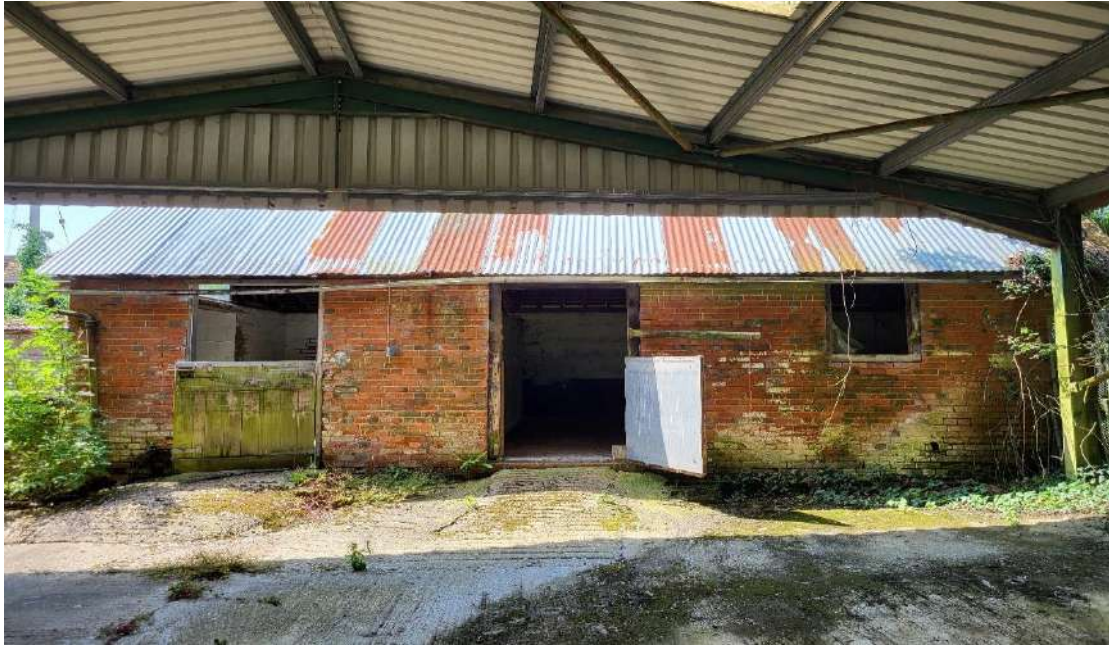
## **8.5 Stables**

This building is that which can be reasonably dated to anytime between 1845 and 1874 due to its appearance on the latter map. It is brick built and retains its ties and side purlin roof intact, though with modern coverings.

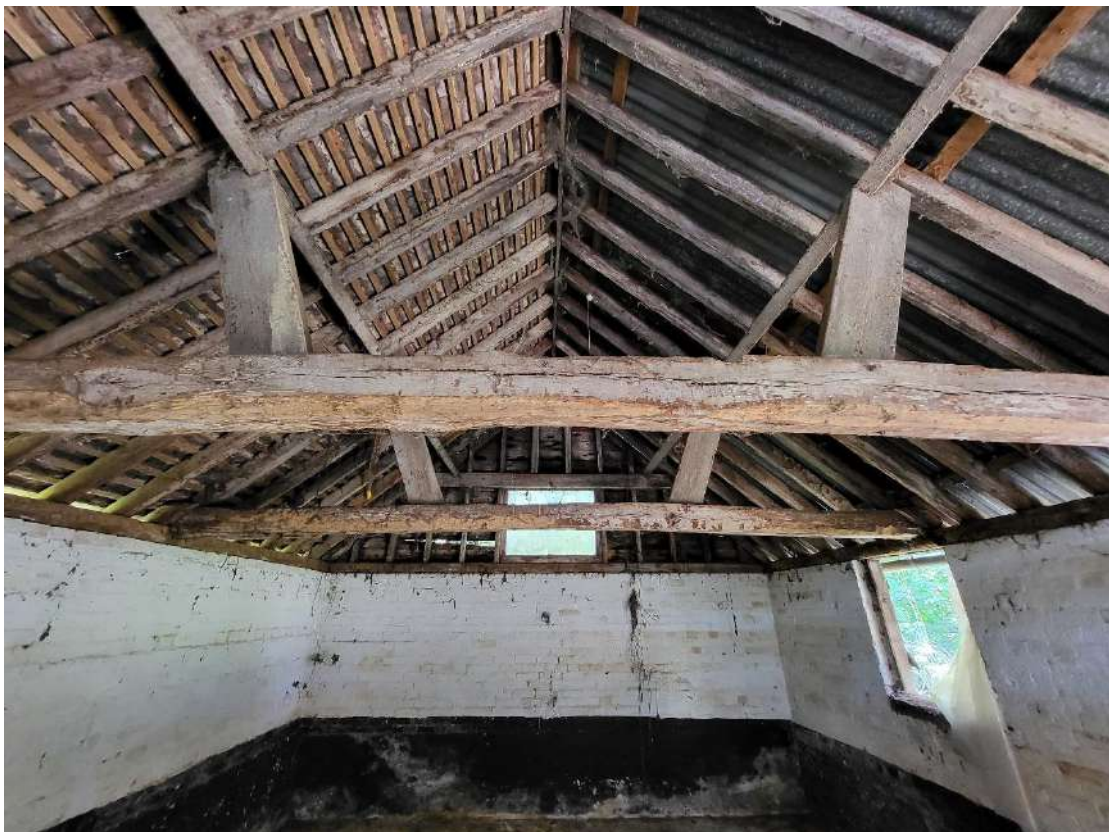
No original fenestration, or joinery survives.

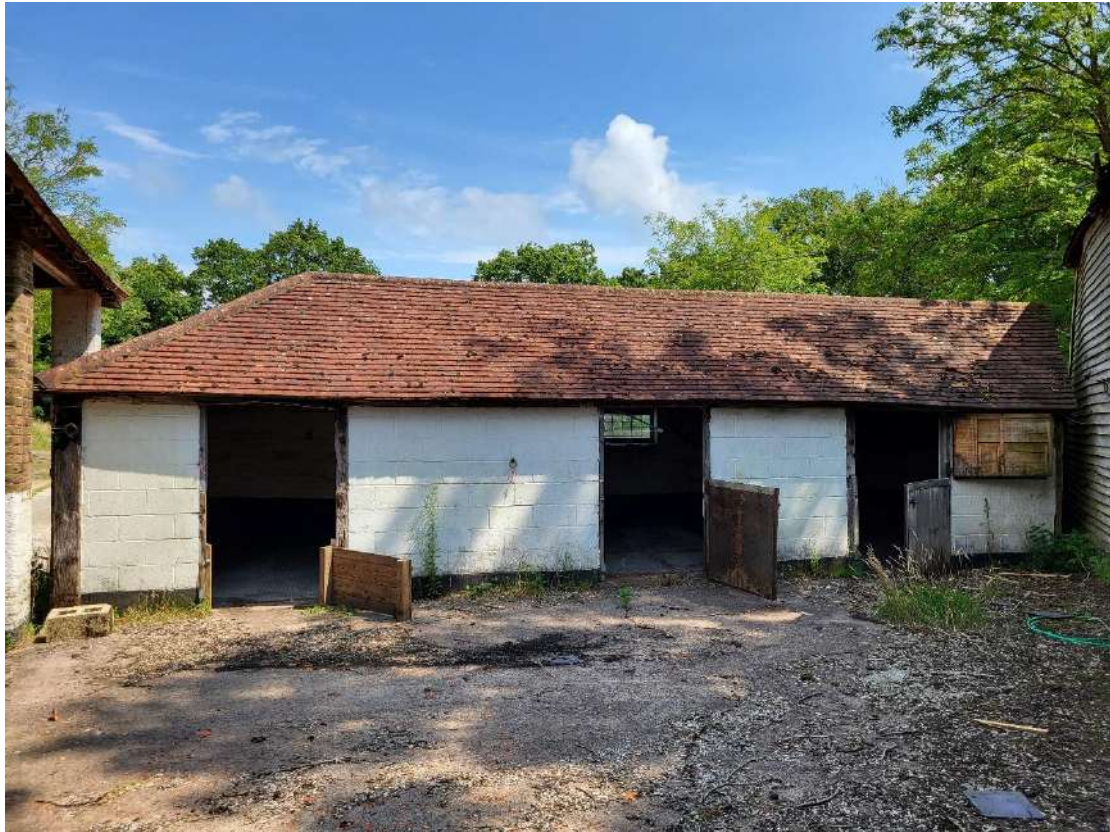
## **8.6 Stables attached to the Main Barn**

These are somewhat interesting, as they are not originally stables. Whilst much of the frontage and also some other elements were re-built in the last 50 years or so, this low run of units was formerly a series of open cattle byres.

This is evidenced by the frontage timber framing, now infilled with modern block.

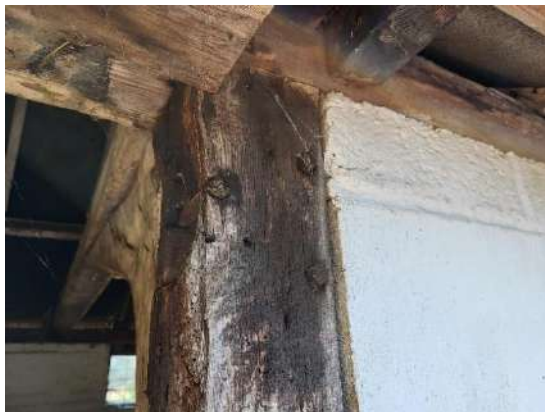
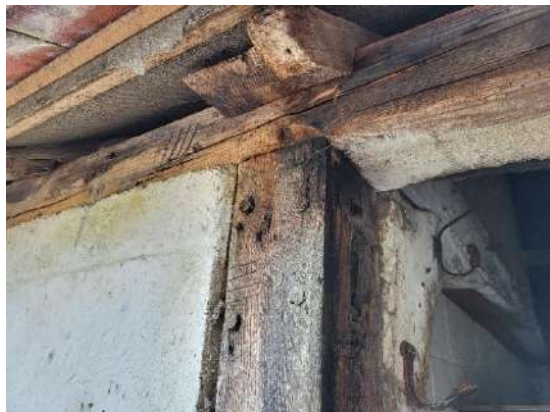
These show that the unit had dropped head plates and no infilling originally.

Again, the uprights are braced with iron nailed brackets, something of a feature of this farm during the 18<sup>th</sup> century.

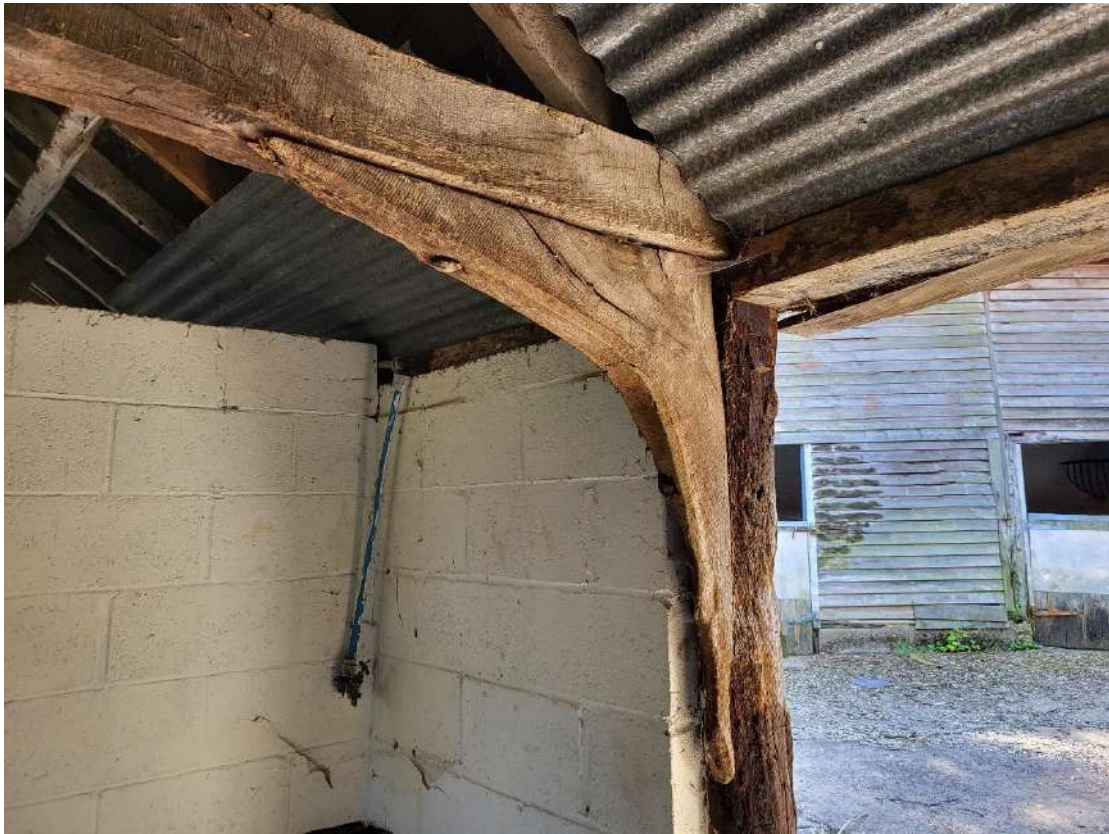
The roof frame is now substantially replaced with a much later 19<sup>th</sup>, or even early 20<sup>th</sup> century side purlin frame.

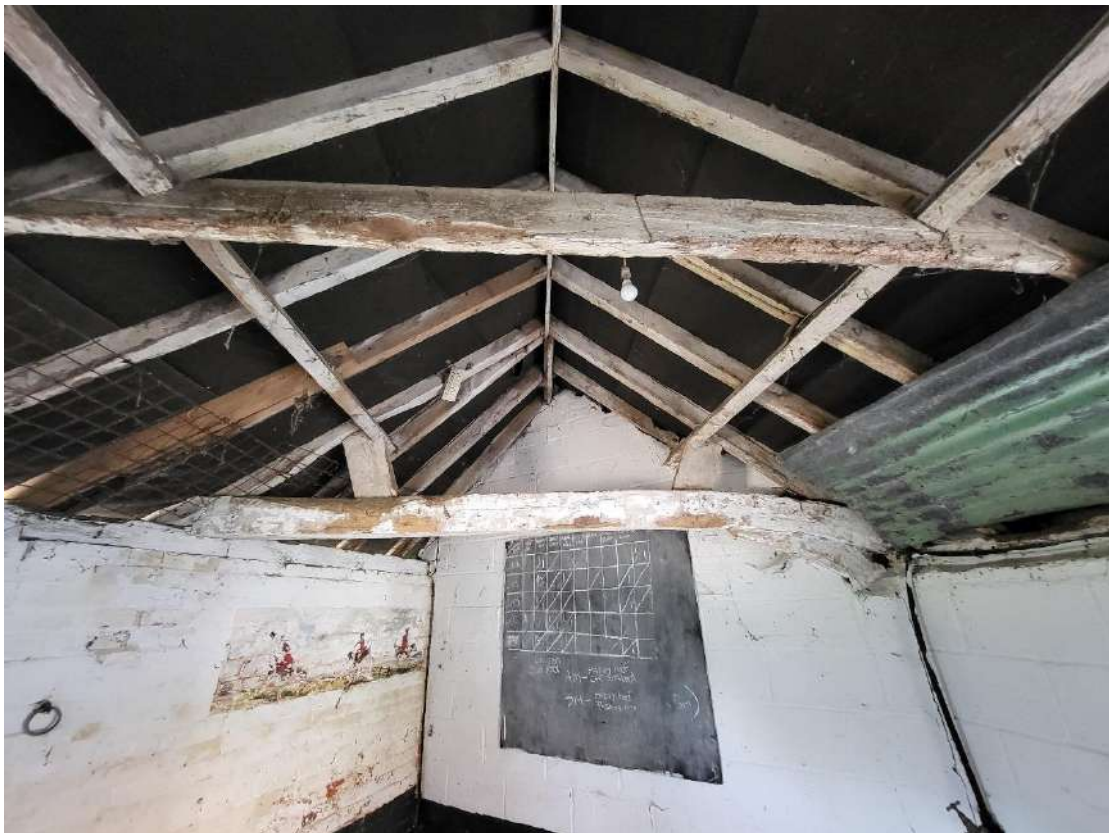
The back wall upon which this cattle byre building was built was actually older than the attached structure, as the frame elements were built off from it by virtue of raising the height of the wall.

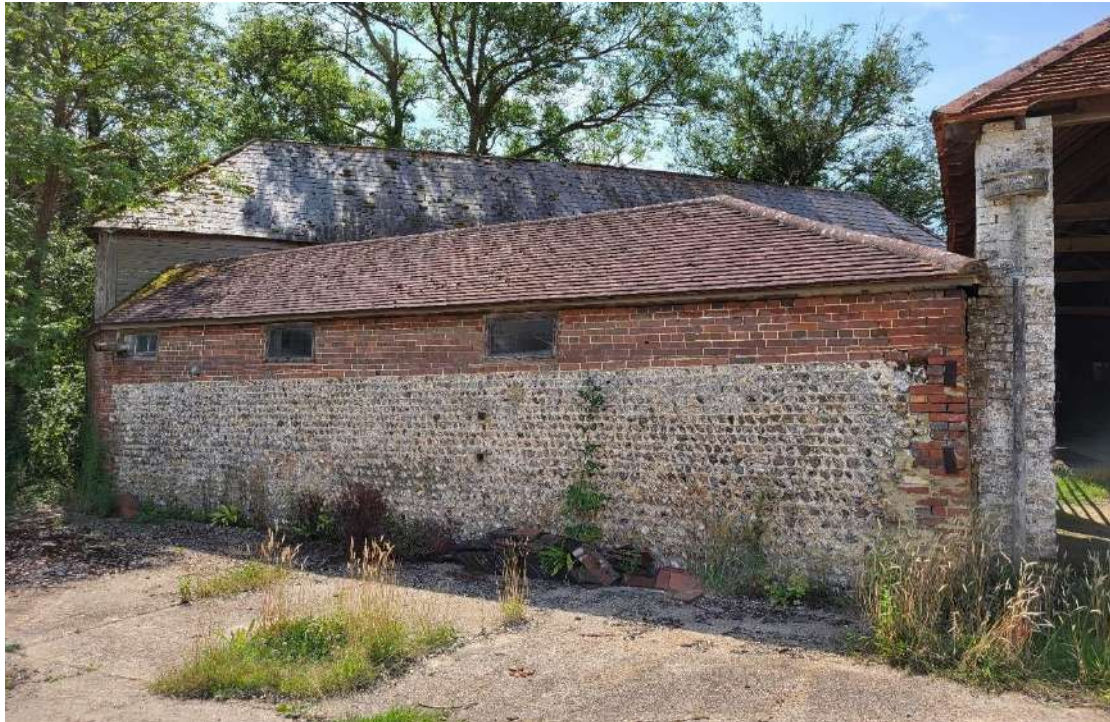
We would estimate that the wall is early 18<sup>th</sup> century in date, with the byres being added within around a generation towards the mid 18<sup>th</sup> century.

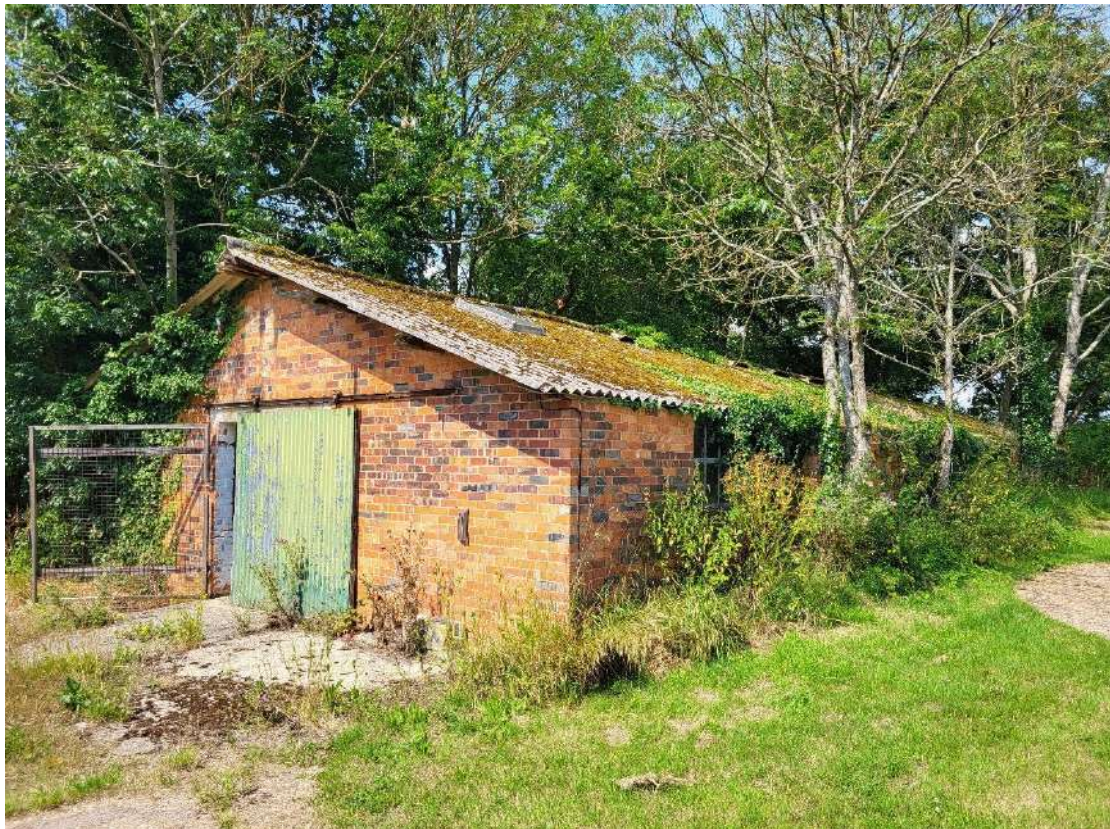
## **8.7 Dairy**

This post WW2 building occupies land to the north east of the former farmyard. It comprises a brick built structure with a corrugated cement sheet roof. There is little of note within, and the building is now in derelict condition.

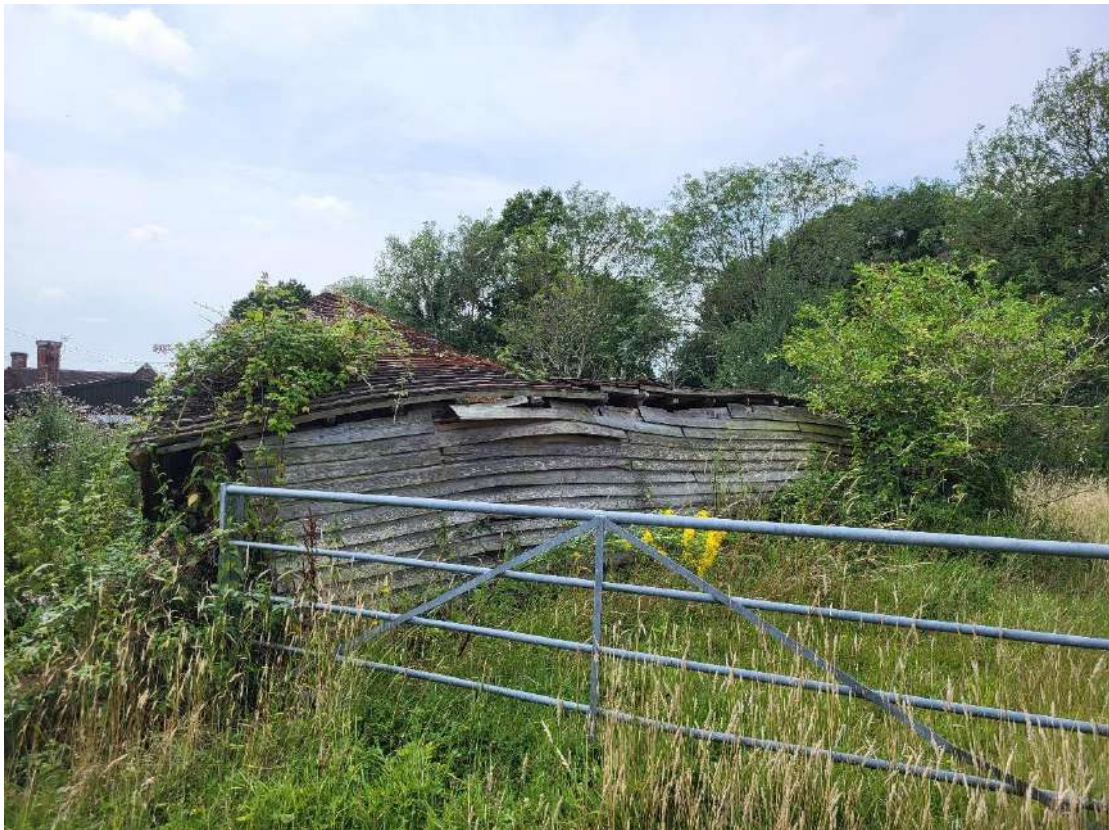
## **8.8 Ruined Cart Shed**

This timber framed structure is depicted on the 1845 tithe map and, from what limited structure remains visible, this is a car shed of the early 18<sup>th</sup> century. The frame is in oak with collared rafters and some stud intersecting panel bracing noted.

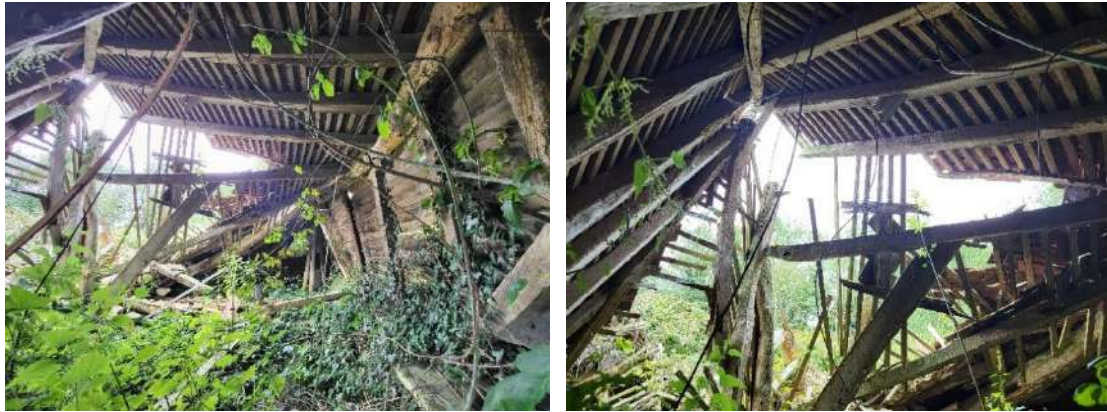
Like the main barn, the ties are held with iron nailed brackets and this likely suggests a similar date of erection and also probably the same carpenter.

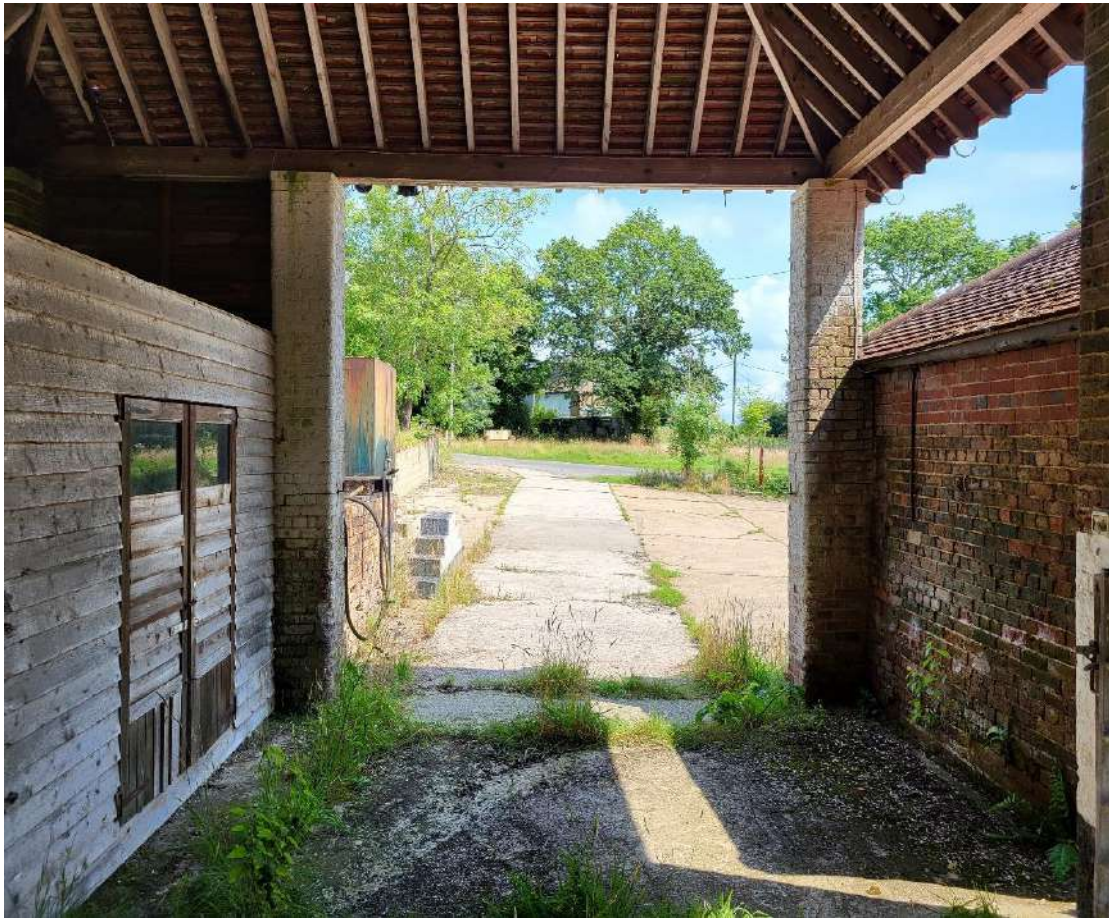
The main driveway around the south of the house and also leading from the farm yard back up north to the main road is also broadly on this same track as earlier mapping (certainly the later OS maps). The former main route to the farm yard is now somewhat 'obscured' by later change, but follows the line of the straight concrete track shown centrally in the image overleaf:
