**Arboricultural Report**  
**composed of**  
**Arboricultural Impact Assessment**  
**Arboricultural Method Statement**  
**& Tree Protection Plan**

Mrs R Shaw  
Pound Place  
Mill Lane  
Partridge Green  
RH13 8JU

Written by  
Barry Holdsworth MBA, RHS. Dip, MCI Hort, M.Arbor.A, MCMI  
Horticultural Consultant

22nd December 2025

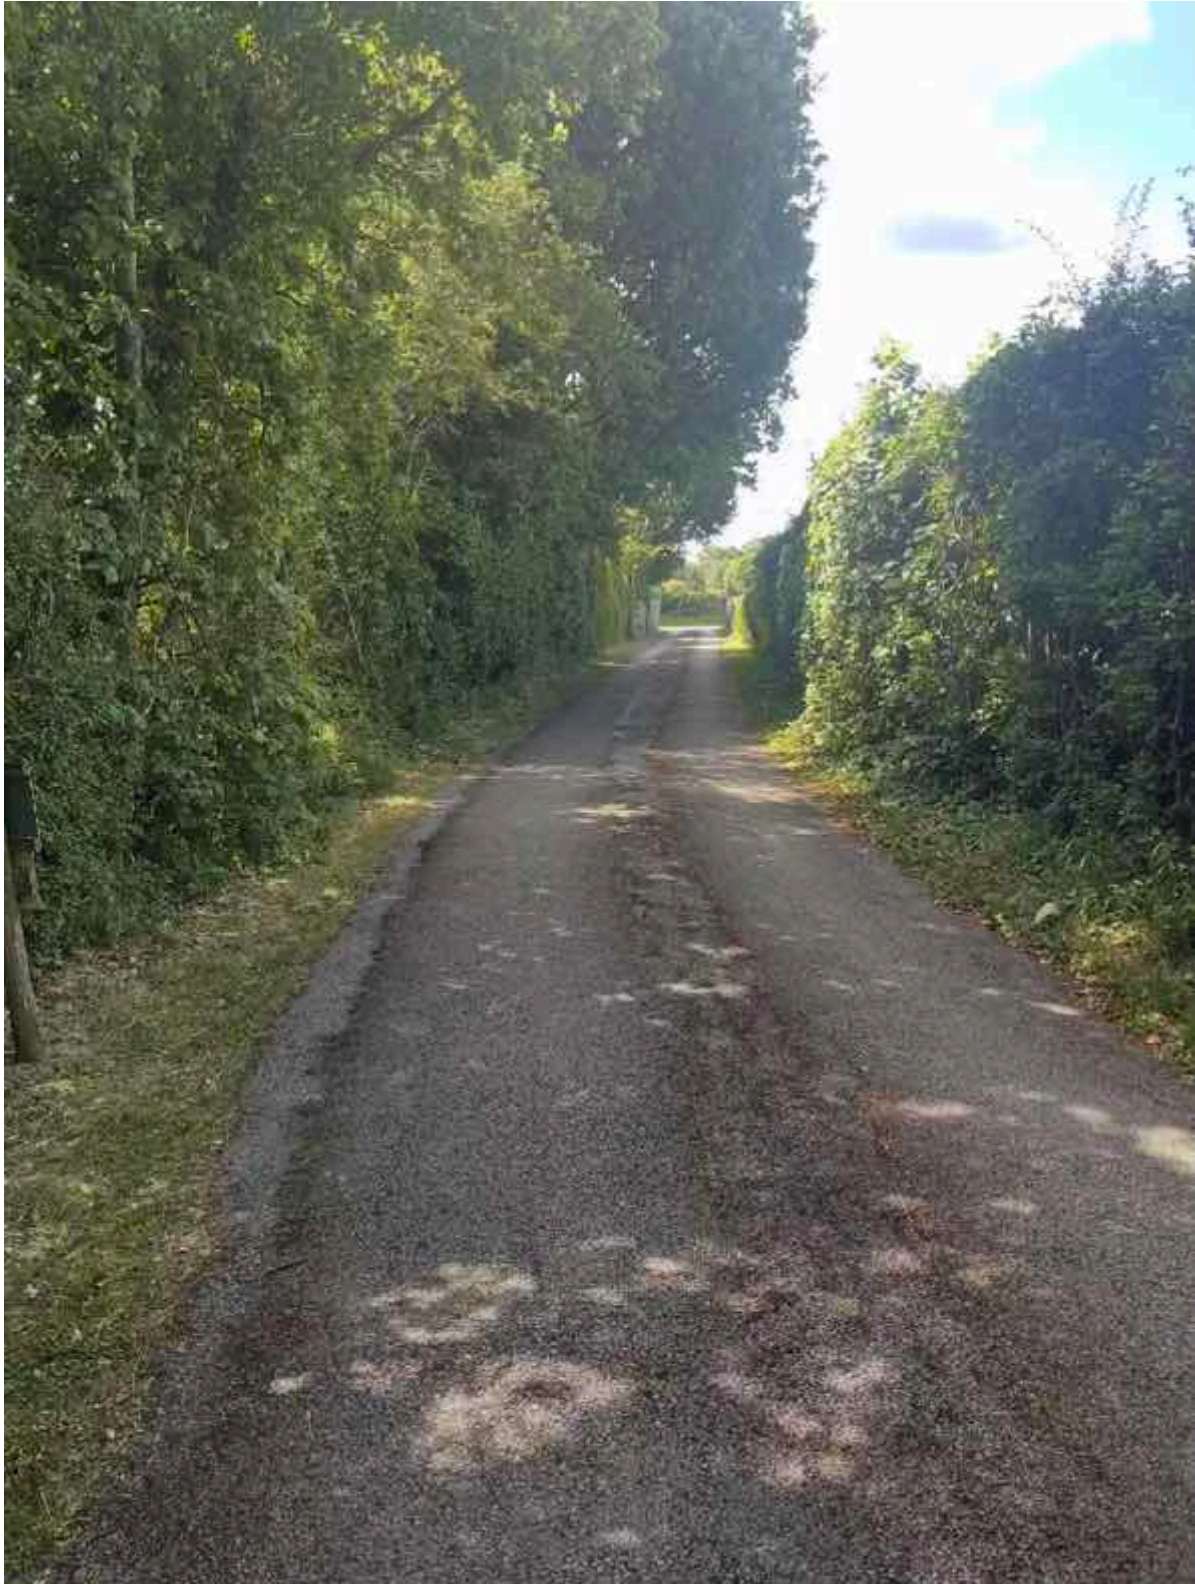
The existing drive from Mill Lane looking south

The existing tarmac drive will be used as access for the construction works and the new build thereafter. In order to protect the roots of T15 ground boarding will be laid over the RPA of T15 for the duration of the build. In addition T15 will be lifted to 5m above ground level to allow access for the construction traffic and tree protection fencing will run along the length of the track where the existing post and rail fence is found.
